**Proposed Commercial Development  
at Lot 520, Payanta Place,  
NIGHTCLIFF, for Randall Olsen**

### 13 Building Asbestos Audit Register (MLA Offices)

#### 13.1 Asbestos Audit Inspection (Asset No: MLA-NF)

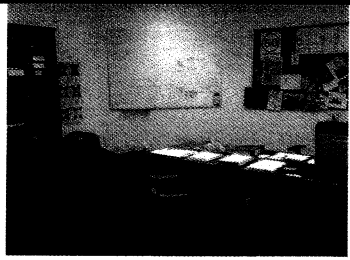
| Location | Room 1- MLA Office | |

| Asbestos Type | No Asbestos Detected | |
| Recommendation | No Further Action Required | NIL |

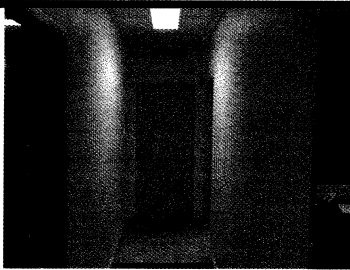
| Location | Room 2- Passage | |

| Asbestos Type | No Asbestos Detected | |
| Recommendation | No Further Action Required | NIL |

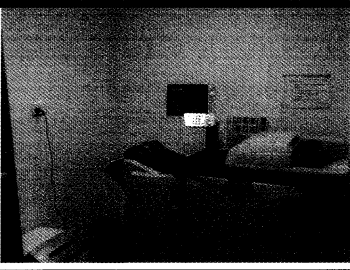
| Location | Room 4- Photo Copy | |

| Asbestos Type | No Asbestos Detected | |
| Recommendation | No Further Action Required | NIL |

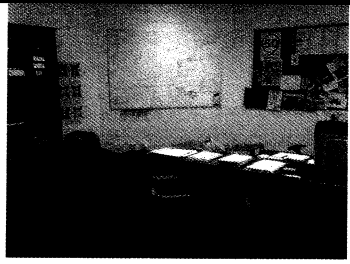
| <b>Location</b> | Room 1- MLA Office | |

| <b>Asbestos Type</b> | No Asbestos Detected | |
| <b>Recommendation</b> | No Further Action Required | |

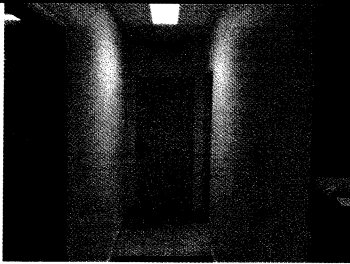
| <b>Location</b> | Room 2- Passage | |

| <b>Asbestos Type</b> | No Asbestos Detected | |
| <b>Recommendation</b> | No Further Action Required | |

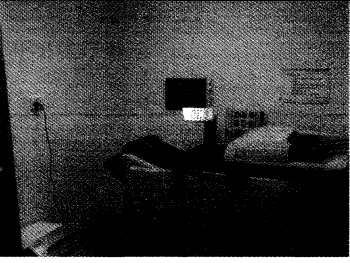
| <b>Location</b> | Room 4- Photo Copy | |

| <b>Asbestos Type</b> | No Asbestos Detected | |
| <b>Recommendation</b> | No Further Action Required | |

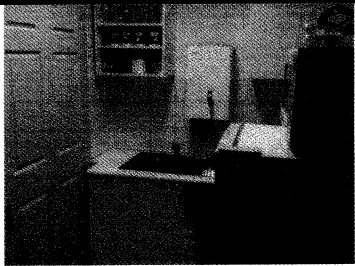
| <b>Location</b> | Room 5-Kitchen | |

| <b>Asbestos Type</b> | No Asbestos Detected | |
| <b>Recommendation</b> | No Further Action Required | <b>NIL</b> |

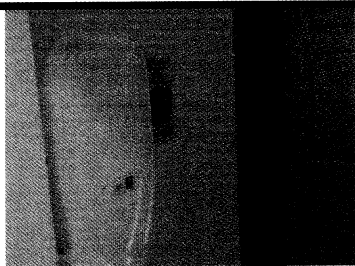
| <b>Location</b> | Room 6-Baby Change Area | |

| <b>Asbestos Type</b> | No Asbestos Detected | |
| <b>Recommendation</b> | No Further Action Required | <b>NIL</b> |

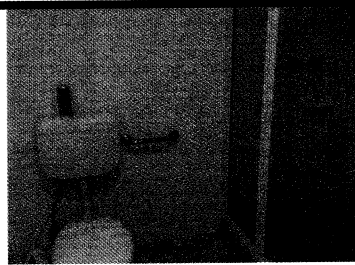
| <b>Location</b> | Room 7- Bathroom | |

| <b>Asbestos Type</b> | No Asbestos Detected | |
| <b>Recommendation</b> | No Further Action Required | <b>NIL</b> |

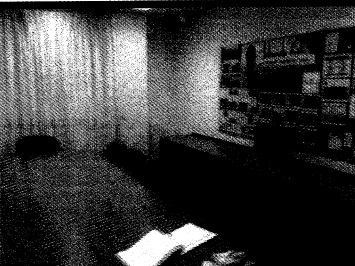
| <b>Location</b> | Room 8- Community Room | |

| <b>Asbestos Type</b> | No Asbestos Detected | |
| <b>Recommendation</b> | No Further Action Required | <b>NIL</b> |

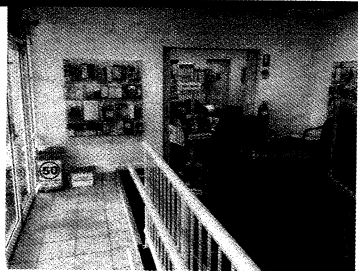
| <b>Location</b> | Room 9-Foyer | |

| <b>Asbestos Type</b> | No Asbestos Detected | |
| <b>Recommendation</b> | No Further Action Required | |

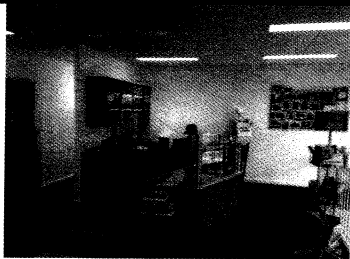
| <b>Location</b> | Room 10-Reception | |

| <b>Asbestos Type</b> | No Asbestos Detected | |
| <b>Recommendation</b> | No Further Action Required | |
