ASBESTOS REGISTER

NO. NT0686a

Randazzo C & G Developments

5 Bishop Street, Woolner

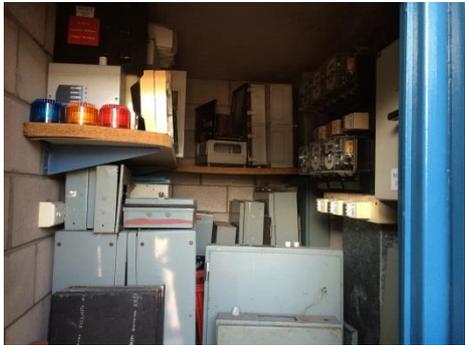
EXTERNAL			
Location	Type of Material		
1. Electrical switchboard in store and switchroom: backing board.	Area accessed but not sampled. Based on findings in similar areas, it is highly likely to contain asbestos.

Recommendation and Action			
Refer to Section 7.0: Policies & Management Procedures			
Situational Asbestos Risk Assessment:			
Friability	Condition	Signage	Risk Rating
Non-friable	Stable	Installed 1 small warning sign	Low
INTERNAL – No asbestos noted
