**Asbestos Containing Materials Survey
And
Register
Moil Shopping Centre**

Property Name: Moil Shopping Centre
Property Address: 8 Moil Cres. Darwin, NT
Prepared for: John Nicolakis

Prepared by: Gerry Koukouvas
Northern Trade Solutions

Date: 22.01.2015
Register Version: 01

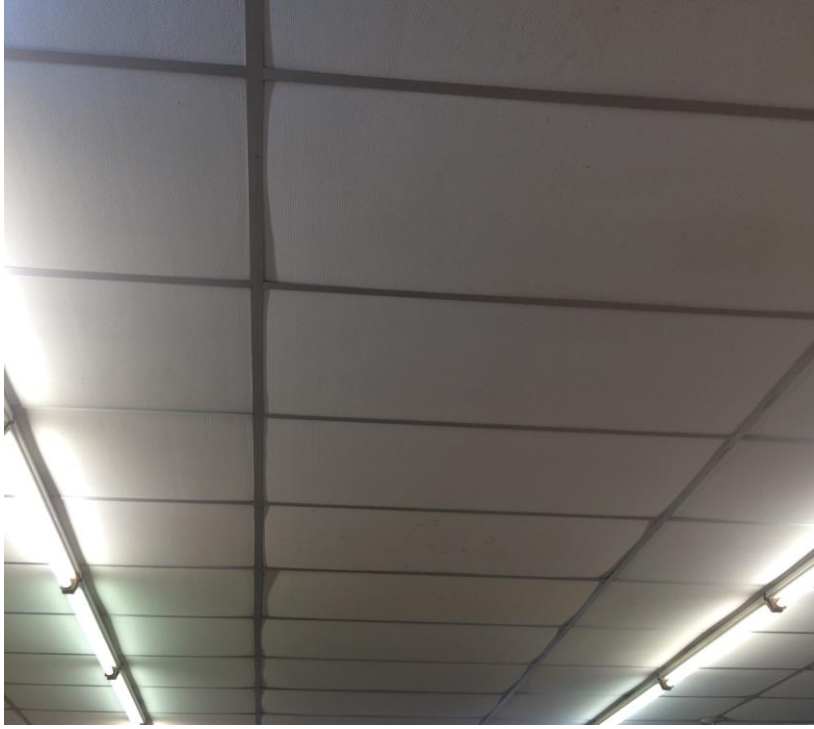
DATE OF ASSESSMENT	14.01.2015	Photo I.D. A2

LOCATION	Moil Shopping Centre – All Tenancies	
SAMPLE I.D	A2	
LOCATION DETAILS	Ceilings to all Tenancies	
BUILDING MATERIAL BUILDING TYPE	Cement based grid ceiling tile	
MATERIAL CONDITION	Fair	
ASSESSOR	Koukouvas NTWS-AA-451964

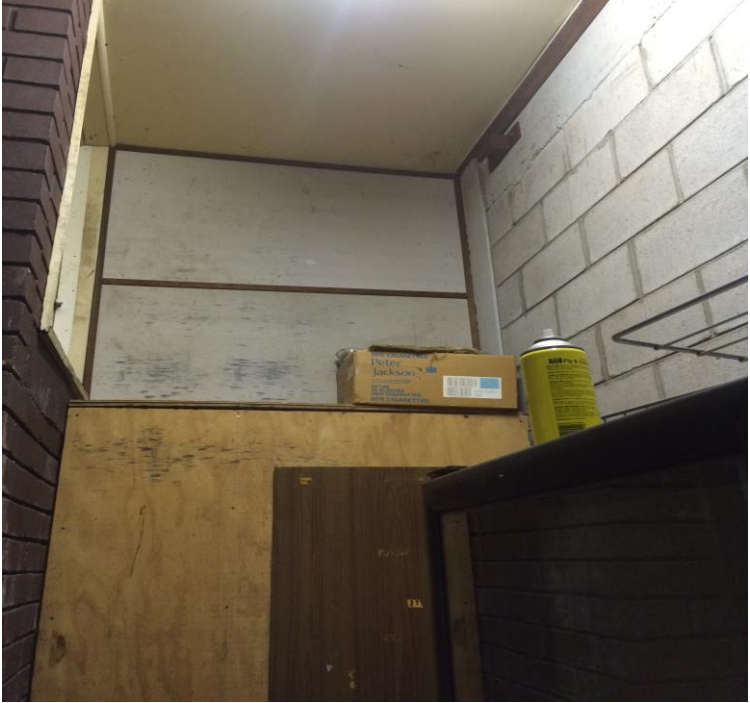
DATE OF ASSESSMENT	14.01.2014	Photo I.D. A3

LOCATION	Moil Shopping Centre Moil - Super Market	
SAMPLE I.D	A3	
LOCATION DETAILS	Machine Room Mezzanine Wall	
BUILDING MATERIAL BUILDING TYPE	Cement Based Compressed Sheeting	
MATERIAL CONDITION	Good	
ASSESSOR	Koukouvas NTWS-AA-451964

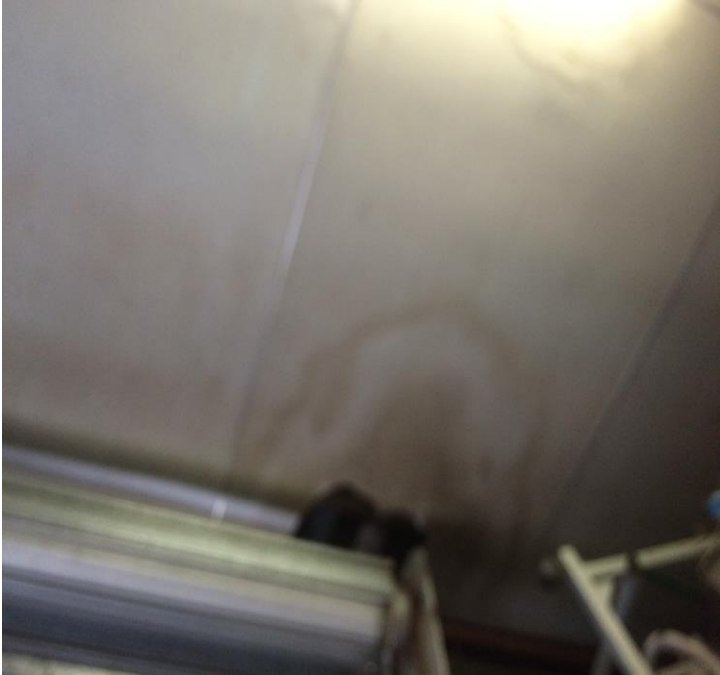
DATE OF ASSESSMENT	14.01.2015	Photo I.D. A4

LOCATION	Moil Shopping Centre – Moil Supermarket	
SAMPLE I.D	A4	
LOCATION DETAILS	Loading area	
BUILDING MATERIAL BUILDING TYPE	Cement Based compressed sheeting	
MATERIAL CONDITION	Damaged	
ASSESSOR	Koukouvas NTWS-AA-451964

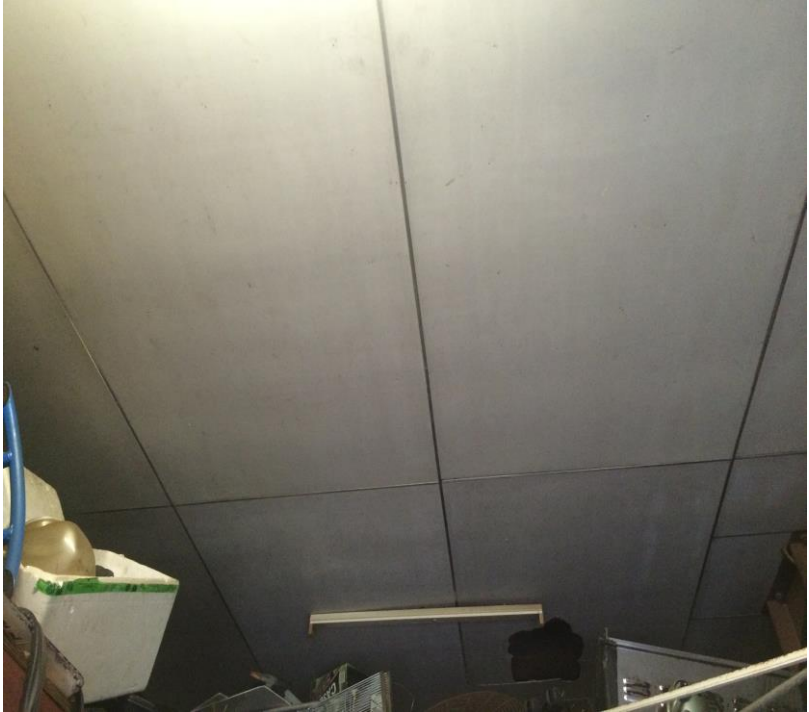
DATE OF ASSESSMENT	14.01.2015	Photo I.D. A5

LOCATION	Moil Shopping Centre Moil Super market	
SAMPLE I.D	A5	
LOCATION DETAILS	Store Area	
BUILDING MATERIAL BUILDING TYPE	Cement Based compressed Sheeting	
MATERIAL CONDITION	Damaged	
ASSESSOR	Koukouvas NTWS-AA-451964
