**ASBESTOS REGISTER
No. NT0581**

**CENTREPOINT BUILDING
12 GREGORY TERRACE
ALICE SPRINGS NT**

Date: August 2013
Register No: NT0581
Register Version: V01
Our Ref: DK/sk

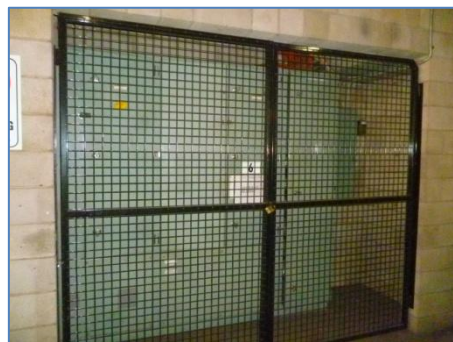
CAR PARK

1. Metre Board Room- No Access – Backing Board (?m ²)	Not accessed or sampled. Based on past experiences in similar areas, asbestos in some form may exist. It is recommended that if work is contemplated in this area, due care & diligence should be exercised		
Recommendation and Action			
Refer to Asbestos Management Plan & Section 7.0: Policies and Recommendations			
Situational Asbestos Risk Assessment:			
Friability	Condition	Signage	Risk Rating
Non friable	Stable	Install 1 small warning sign	Low

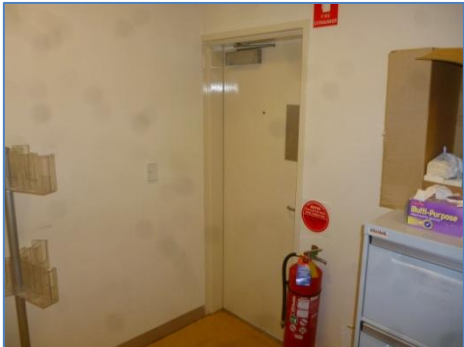
G1A - Internal			
Location		Type of Material

2. Wormald Fire Door, 1976.Car Park access door.(2m ²)		Not accessed or sampled. Based on past experiences in similar areas, asbestos in some form may exist. It is recommended that if work is contemplated in this area, due care & diligence should be exercised	
Recommendation and Action			
Refer to Asbestos Management Plan & Section 7.0: Policies and Recommendations			
Situational Asbestos Risk Assessment:			
Friability	Condition	Signage	Risk Rating
Friable when exposed	Stable	Install 2 small warning signs	Low

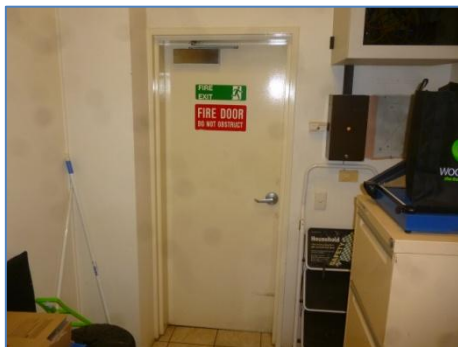
EXTERNALS – G2B			
Location		Type of Material

3. Rear door to car park. Wormald fire door, undated. (2m ²)		Not accessed or sampled. Based on past experiences in similar areas, asbestos in some form may exist. It is recommended that if work is contemplated in this area, due care & diligence should be exercised	
Recommendation and Action			
Refer to Asbestos Management Plan & Section 7.0: Policies and Recommendations			
Situational Asbestos Risk Assessment:			
Friability	Condition	Signage	Risk Rating
Friable when exposed	Stable	Install 2 small warning signs	Low

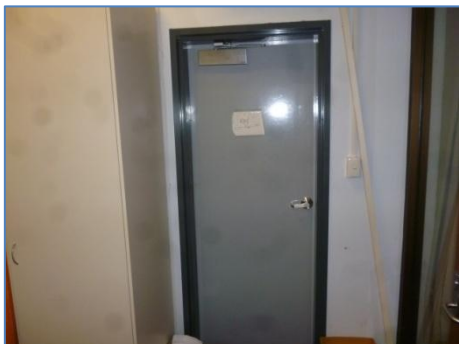
G5 INTERNAL			
Location		Type of Material

4. Rear exit door - Car park Access –Tagged “Wormald 1982” (2m ²)		Not accessed or sampled. Based on past experiences in similar areas, asbestos in some form may exist. It is recommended that if work is contemplated in this area, due care & diligence should be exercised	
Recommendation and Action			
Refer to Asbestos Management Plan & Section 7.0: Policies and Recommendations			
Situational Asbestos Risk Assessment:			
Friability	Condition	Signage	Risk Rating
Non friable	Stable	Install 2 small warning signs	Low

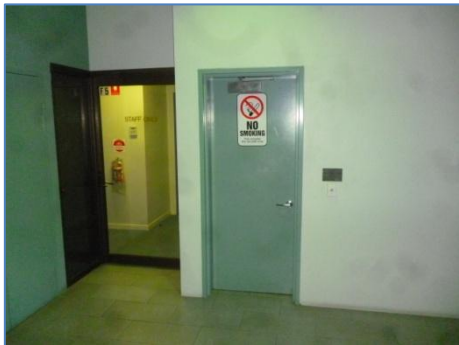
FIRST FLOOR – Common Area			
Location		Type of Material

5. Fire escape door adjacent AB Investments office. Tagged “Wormald 1982” (2m ²)		Not accessed or sampled. Based on past experiences in similar areas, asbestos in some form may exist. It is recommended that if work is contemplated in this area, due care & diligence should be exercised	
Recommendation and Action			
Refer to Asbestos Management Plan & Section 7.0: Policies and Recommendations			
Situational Asbestos Risk Assessment:			
Friability	Condition	Signage	Risk Rating
Non friable	Stable	Install 2 small warning signs on each floor	Low
