**ASBESTOS REGISTER  
No. NT0557b**

**NIGHTCLIFF LIBRARY  
10 PAVONIA PLACE  
NIGHTCLIFF NT**

Date: June 2013  
Register No: NT0557b  
Register Version: 01  
Our Ref: TB/sk

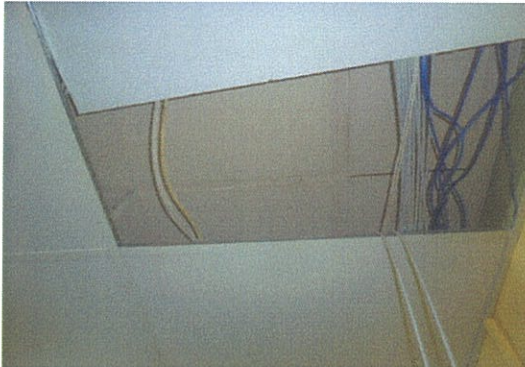
1. Ceiling lining above suspended ceiling – East Library room (extent unknown)		Fibre cement sheet material containing white (Chrysotile) asbestos (sample no.1)	
Recommendation and Action			
Refer to Asbestos Management Plan & Section 7.0: Policies and Recommendations			
Situational Asbestos Risk Assessment			
Friability	Condition	Signage	Risk Rating
Non Friable	Stable	Recommend #: 20 small	Low

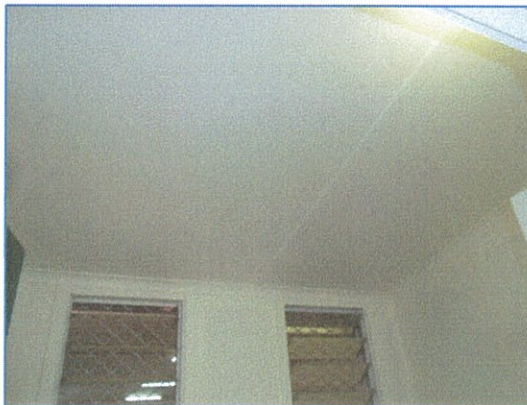
2. Ceiling lining in Staff toilet (6m <sup>2</sup> )		Fibre cement sheet material containing white (Chrysotile) asbestos (sample no.2)	
Recommendation and Action			
Refer to Asbestos Management Plan & Section 7.0: Policies and Recommendations			
Situational Asbestos Risk Assessment			
Friability	Condition	Signage	Risk Rating
Non Friable	Stable	Recommend #: 2 small	Low

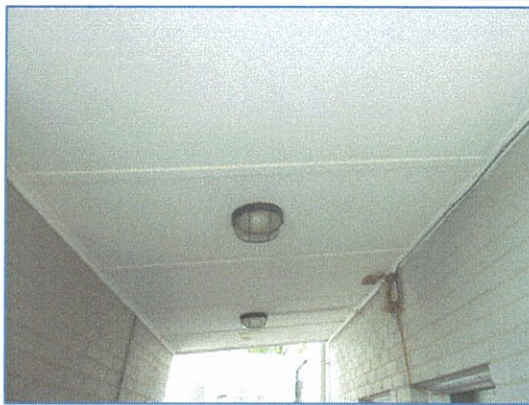
4. Ceiling lining between Main Bldg & Toilets (12m <sup>2</sup> )		Fibre cement sheet material containing white (Chrysotile) & grey/brown (Amosite) asbestos (sample no.4)	
Recommendation and Action			
Refer to Asbestos Management plan & Section 7.0: Policies and Recommendations			
Situational Asbestos Risk Assessment			
Friability	Condition	Signage	Risk Rating
Non Friable	Stable	Recommend #: 2 small	Low

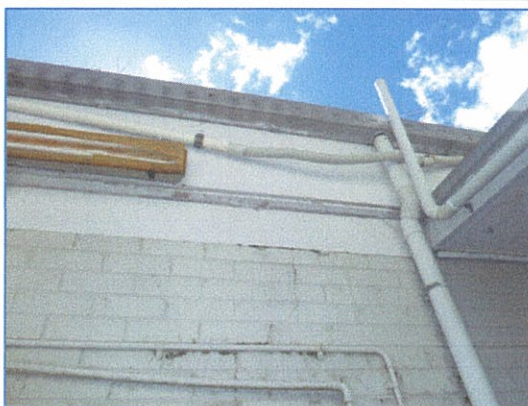
5. Fascia panel to Southern elevation (30m <sup>2</sup> )		Fibre cement sheet material containing white (Chrysotile) asbestos (sample no.3)	
Recommendation and Action			
Refer to Asbestos Management plan & Section 7.0: Policies and Recommendations			
Situational Asbestos Risk Assessment			Risk Rating
Friability	Condition	Signage	
Non Friable	Stable	Recommend #: 10 small	
			Low
