ASBESTOS REGISTER UPDATE

DATE: NOVEMBER 2018

SITE REFERENCE:
NT0557a

**PAGEMARTIN PTY LTD
NIGHTCLIFF POLICE STATION
10 PAVONIA PLACE, NIGHTCLIFF NT 0812**

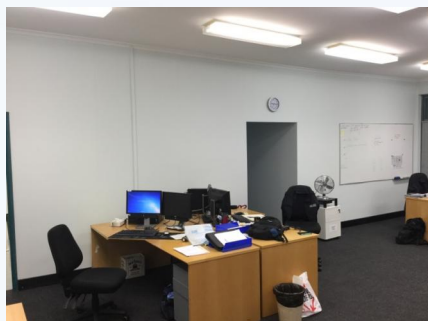
NO.: 1
 PHOTO NO.: J159257-NT0557A-PHOTO002
 RESULT: ASBESTOS - PREVIOUSLY SAMPLED POSITIVE
 BUILDING/LEVEL: NIGHTCLIFF POLICE STATION - GROUND LEVEL
 ROOM/LOCATION: MAJOR CRASH OFFICE - SOUTH
 FEATURE/MATERIAL: WALL LINING - FIBRE CEMENT SHEETING
 SAMPLE NO.: PREVIOUSLY SAMPLED AEC 5-2013

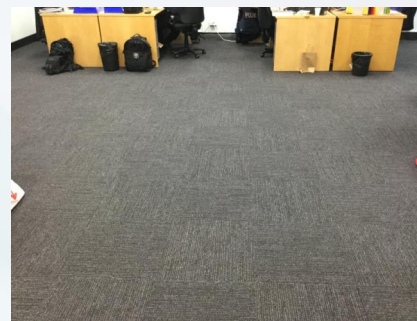
NO.: 2
 PHOTO NO.: J159257-NT0557A-PHOTO005
 RESULT: ASBESTOS - PREVIOUSLY SAMPLED POSITIVE
 BUILDING/LEVEL: NIGHTCLIFF POLICE STATION - GROUND LEVEL
 ROOM/LOCATION: MAJOR CRASH OFFICE - THROUGHOUT
 FEATURE/MATERIAL: FLOOR - ADHESIVE
 SAMPLE NO.: PREVIOUSLY SAMPLED AEC AS PER 1-2013

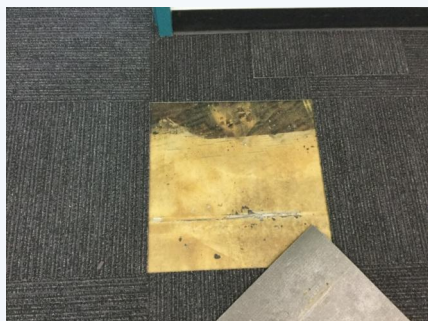
NO.: 2
 PHOTO NO.: J159257-NT0557A-PHOTO004
 RESULT: ASBESTOS - PREVIOUSLY SAMPLED POSITIVE
 BUILDING/LEVEL: NIGHTCLIFF POLICE STATION - GROUND LEVEL
 ROOM/LOCATION: MAJOR CRASH OFFICE - THROUGHOUT
 FEATURE/MATERIAL: FLOOR - ADHESIVE
 SAMPLE NO.: PREVIOUSLY SAMPLED AEC AS PER 1-2013

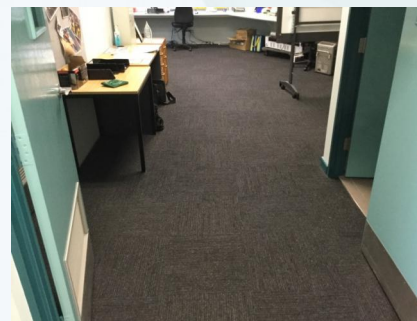
3	Office Area - Throughout Floor - Adhesive - Includes Cloak Room & Armoury	Asbestos	Previously Sampled AEC 1-2013	Previously Sampled Positive	J159257-NT05 57a-Photo013 J159257-NT05 57a-Photo014	100 m ²	Good	Non Friable	Low	Low	Not Labelled	23/11/2023	P4	Maintain in current condition, label and incorporate into an AMP. Remove by licensed asbestos contractor prior to demolition or refurbishment.	
4	Conference Room - Throughout Floor - Adhesive - Under Existing Carpet Tiles	Asbestos	Previously Sampled AEC As Per 1-2013	Previously Sampled Positive	J159257-NT05 57a-Photo006 J159257-NT05 57a-Photo007	70 m ²	Good	Non Friable	Low	Low	Not Labelled	23/11/2023	P4	Maintain in current condition, label and incorporate into an AMP. Remove by licensed asbestos contractor prior to demolition or refurbishment.	
5	Compactus Room - Throughout Floor - Adhesive - Under Existing Carpet Tiles & Vinyl Tiles	Asbestos	Previously Sampled AEC As Per 1-2013	Previously Sampled Positive	J159257-NT05 57a-Photo017	10 m ²	Good	Non Friable	Low	Low	Not Labelled	23/11/2023	P4	Maintain in current condition, label and incorporate into an AMP. Remove by licensed asbestos contractor prior to demolition or refurbishment.

NO.: 3
 PHOTO NO.: J159257-NT0557A-PHOTO013
 RESULT: ASBESTOS - PREVIOUSLY SAMPLED POSITIVE
 BUILDING/LEVEL: NIGHTCLIFF POLICE STATION - GROUND LEVEL
 ROOM/LOCATION: OFFICE AREA - THROUGHOUT
 FEATURE/MATERIAL: FLOOR - ADHESIVE
 SAMPLE NO.: PREVIOUSLY SAMPLED AEC 1-2013

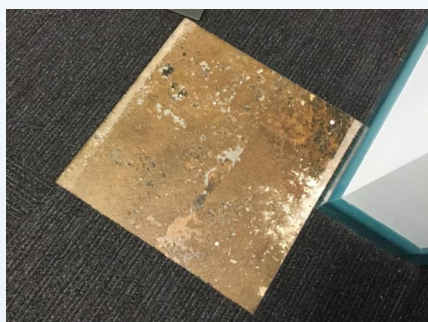
NO.: 3
 PHOTO NO.: J159257-NT0557A-PHOTO014
 RESULT: ASBESTOS - PREVIOUSLY SAMPLED POSITIVE
 BUILDING/LEVEL: NIGHTCLIFF POLICE STATION - GROUND LEVEL
 ROOM/LOCATION: OFFICE AREA - THROUGHOUT
 FEATURE/MATERIAL: FLOOR - ADHESIVE
 SAMPLE NO.: PREVIOUSLY SAMPLED AEC 1-2013

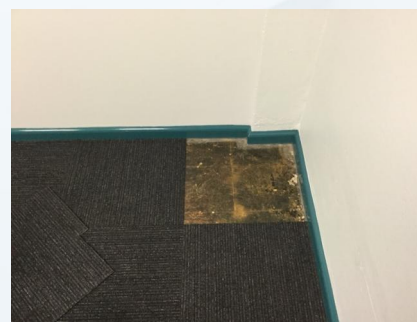
NO.: 4
 PHOTO NO.: J159257-NT0557A-PHOTO006
 RESULT: ASBESTOS - PREVIOUSLY SAMPLED POSITIVE
 BUILDING/LEVEL: NIGHTCLIFF POLICE STATION - GROUND LEVEL
 ROOM/LOCATION: CONFERENCE ROOM - THROUGHOUT
 FEATURE/MATERIAL: FLOOR - ADHESIVE
 SAMPLE NO.: PREVIOUSLY SAMPLED AEC AS PER 1-2013

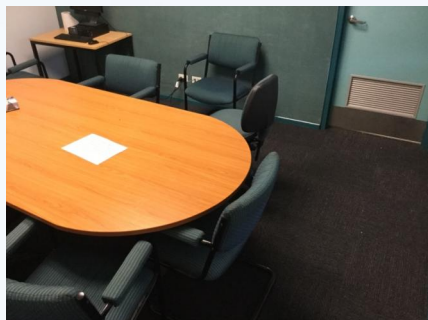
NO.: 4
 PHOTO NO.: J159257-NT0557A-PHOTO007
 RESULT: ASBESTOS - PREVIOUSLY SAMPLED POSITIVE
 BUILDING/LEVEL: NIGHTCLIFF POLICE STATION - GROUND LEVEL
 ROOM/LOCATION: CONFERENCE ROOM - THROUGHOUT
 FEATURE/MATERIAL: FLOOR - ADHESIVE
 SAMPLE NO.: PREVIOUSLY SAMPLED AEC AS PER 1-2013

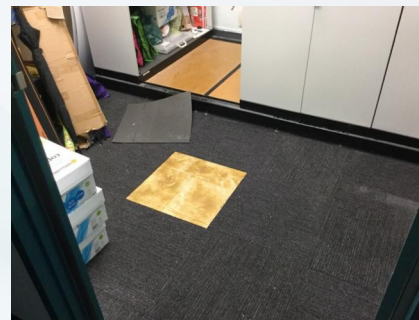
NO.: 5
 PHOTO NO.: J159257-NT0557A-PHOTO017
 RESULT: ASBESTOS - PREVIOUSLY SAMPLED POSITIVE
 BUILDING/LEVEL: NIGHTCLIFF POLICE STATION - GROUND LEVEL
 ROOM/LOCATION: COMPACTUS ROOM - THROUGHOUT
 FEATURE/MATERIAL: FLOOR - ADHESIVE
 SAMPLE NO.: PREVIOUSLY SAMPLED AEC AS PER 1-2013

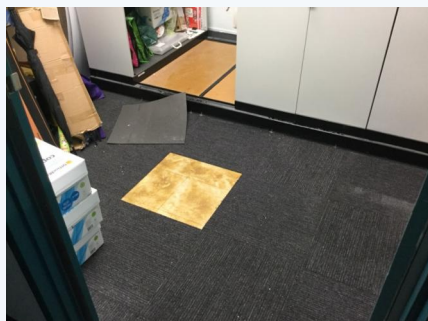
6	Compactus Room - Throughout Floor Covering - Vinyl Tiles - Under Existing Carpet Tiles	Asbestos	J159257-NT0557a-001	Positive	J159257-NT05 57a-Photo008	10 m ²	Good	Non Friable	Low	Low	Not Labelled	23/11/2023	P4	Maintain in current condition, label and incorporate into an AMP. Remove by licensed asbestos contractor prior to demolition or refurbishment.	
7	Locker Room - Throughout Floor - Adhesive - Under Existing Carpet Tiles & Vinyl Tiles	Asbestos	Previously Sampled AEC As Per 1-2013	Previously Sampled Positive	J159257-NT05 57a-Photo016	10 m ²	Good	Non Friable	Low	Low	Not Labelled	23/11/2023	P4	Maintain in current condition, label and incorporate into an AMP. Remove by licensed asbestos contractor prior to demolition or refurbishment.	
8	Locker Room - Throughout Floor Covering - Vinyl Tiles - Under Existing Carpet Tiles	Asbestos	Similar To: J159257-NT0557a-001	Presumed Positive	J159257-NT05 57a-Photo009	10 m ²	Good	Non Friable	Low	Low	Not Labelled	23/11/2023	P4	Maintain in current condition, label and incorporate into an AMP. Remove by licensed asbestos contractor prior to demolition or refurbishment.

NO.: 6
 PHOTO NO.: J159257-NT0557A-PHOTO008
 RESULT: ASBESTOS - POSITIVE
 BUILDING/LEVEL: NIGHTCLIFF POLICE STATION - GROUND LEVEL
 ROOM/LOCATION: COMPACTUS ROOM - THROUGHOUT
 FEATURE/MATERIAL: FLOOR COVERING - VINYL TILES
 SAMPLE NO.: J159257-NT0557A-001

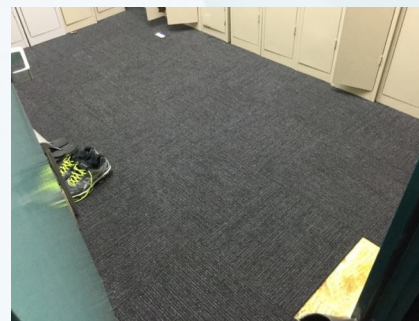
NO.: 7
 PHOTO NO.: J159257-NT0557A-PHOTO016
 RESULT: ASBESTOS - PREVIOUSLY SAMPLED POSITIVE
 BUILDING/LEVEL: NIGHTCLIFF POLICE STATION - GROUND LEVEL
 ROOM/LOCATION: LOCKER ROOM - THROUGHOUT
 FEATURE/MATERIAL: FLOOR - ADHESIVE
 SAMPLE NO.: PREVIOUSLY SAMPLED AEC AS PER 1-2013

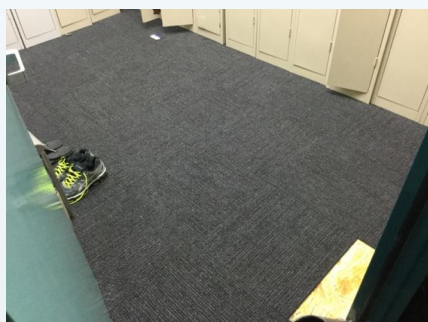
NO.: 8
 PHOTO NO.: J159257-NT0557A-PHOTO009
 RESULT: ASBESTOS - PRESUMED POSITIVE
 BUILDING/LEVEL: NIGHTCLIFF POLICE STATION - GROUND LEVEL
 ROOM/LOCATION: LOCKER ROOM - THROUGHOUT
 FEATURE/MATERIAL: FLOOR COVERING - VINYL TILES
 SAMPLE NO.: SIMILAR TO: J159257-NT0557A-001

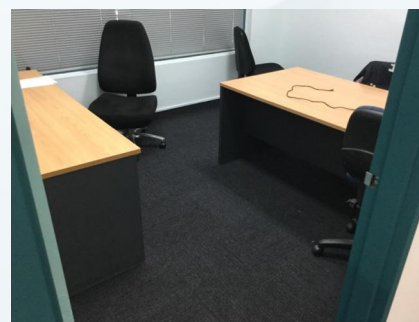
9	Supervisors Office - Throughout Floor - Adhesive - Under Existing Carpet Tiles & In Parts, Vinyl Tiles	Asbestos	Previously Sampled AEC As Per 1-2013	Previously Sampled Positive	J159257-NT05 57a-Photo012	10 m ²	Good	Non Friable	Low	Low	Not Labelled	23/11/2023	P4	Maintain in current condition, label and incorporate into an AMP. Remove by licensed asbestos contractor prior to demolition or refurbishment.

NO.: 9
 PHOTO NO.: J159257-NT0557A-PHOTO012
 RESULT: ASBESTOS - PREVIOUSLY SAMPLED POSITIVE
 BUILDING/LEVEL: NIGHTCLIFF POLICE STATION - GROUND LEVEL
 ROOM/LOCATION: SUPERVISORS OFFICE - THROUGHOUT
 FEATURE/MATERIAL: FLOOR - ADHESIVE
 SAMPLE NO.: PREVIOUSLY SAMPLED AEC AS PER 1-2013

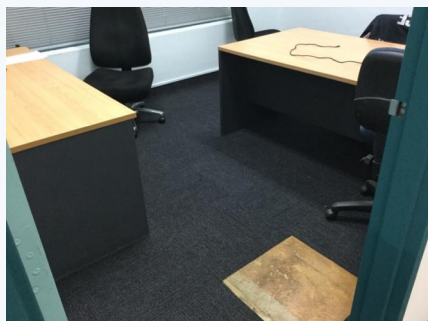
NO.: 10
 PHOTO NO.: J159257-NT0557A-PHOTO011
 RESULT: ASBESTOS - PRESUMED POSITIVE
 BUILDING/LEVEL: NIGHTCLIFF POLICE STATION - GROUND LEVEL
 ROOM/LOCATION: SUPERVISORS OFFICE - THROUGHOUT
 FEATURE/MATERIAL: FLOOR COVERING - VINYL TILES
 SAMPLE NO.: SIMILAR TO: J159257-NT0557A-001

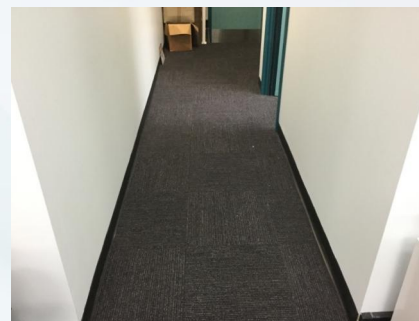
11	Corridor - Throughout Floor - Adhesive - Adjacent Compactus & Locker Rooms. Under Existing Carpet Tiles & Vinyl Tiles	Asbestos	Similar To: J159257-NT0557a-001	Presumed Positive	J159257-NT0557a-Photo010	10 m ²	Good	Non Friable	Low	Low	Not Labelled	23/11/2023	P4	Maintain in current condition, label and incorporate into an AMP. Remove by licensed asbestos contractor prior to demolition or refurbishment.	
12	Corridor - Throughout Floor Covering - Vinyl Tiles - Adjacent Compactus & Locker Rooms. Under Existing Carpet Tiles	Asbestos	Similar To: J159257-NT0557a-001	Presumed Positive	J159257-NT0557a-Photo018	10 m ²	Good	Non Friable	Low	Low	Not Labelled	23/11/2023	P4	Maintain in current condition, label and incorporate into an AMP. Remove by licensed asbestos contractor prior to demolition or refurbishment.	
13	Cleaners Store Fire Door - Fire Door Core - TYCO Doorset 06418 AS/NZS A05.1 A97 PH: 07 3267 8444	Asbestos	Not Sampled Restricted Access	Presumed Positive	J159257-NT0557a-Photo015	1 Unit/s	Good	Friable	Low	Low	Not Labelled	23/11/2023	P3	Confirm status, label, maintain in current condition and incorporate into an AMP. Remove by licensed asbestos contractor prior to demolition or refurbishment.

NO.: 11
 PHOTO NO.: J159257-NT0557A-PHOTO010
 RESULT: ASBESTOS - PRESUMED POSITIVE
 BUILDING/LEVEL: NIGHTCLIFF POLICE STATION - GROUND LEVEL
 ROOM/LOCATION: CORRIDOR - THROUGHOUT
 FEATURE/MATERIAL: FLOOR - ADHESIVE
 SAMPLE NO.: SIMILAR TO: J159257-NT0557A-001

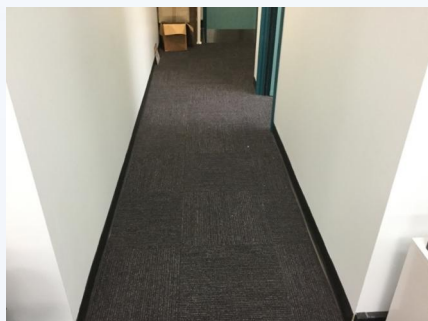
NO.: 12
 PHOTO NO.: J159257-NT0557A-PHOTO018
 RESULT: ASBESTOS - PRESUMED POSITIVE
 BUILDING/LEVEL: NIGHTCLIFF POLICE STATION - GROUND LEVEL
 ROOM/LOCATION: CORRIDOR - THROUGHOUT
 FEATURE/MATERIAL: FLOOR COVERING - VINYL TILES
 SAMPLE NO.: SIMILAR TO: J159257-NT0557A-001

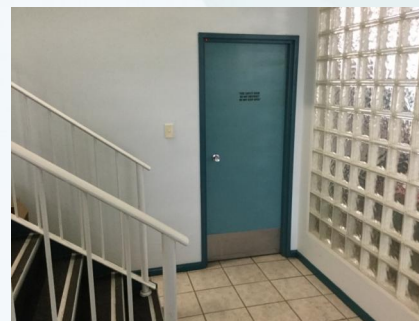
NO.: 13
 PHOTO NO.: J159257-NT0557A-PHOTO015
 RESULT: ASBESTOS - PRESUMED POSITIVE
 BUILDING/LEVEL: NIGHTCLIFF POLICE STATION - GROUND LEVEL
 ROOM/LOCATION: CLEANERS STORE
 FEATURE/MATERIAL: FIRE DOOR - FIRE DOOR CORE
 SAMPLE NO.: NOT SAMPLED RESTRICTED ACCESS

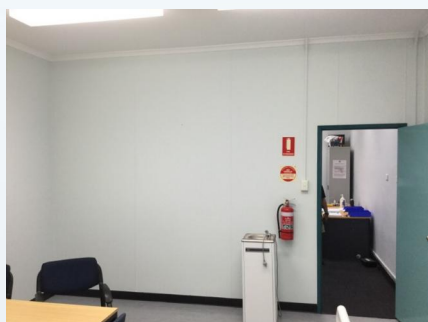
14	Staff Lunch Room - North Wall Lining - Fibre Cement Sheeting	Asbestos	Previously Sampled AEC As per 5-3013	Previously Sampled Positive	J159257-NT0557a-Photo018	12 m ²	Good	Non Friable	Low	Low	Not Labelled	23/11/2023	P4	Maintain in current condition, label and incorporate into an AMP. Remove by licensed asbestos contractor prior to demolition or refurbishment.	
15	Staff Lunch Room - Throughout Floor Covering - Vinyl Tiles	Asbestos	Previously Sampled AEC 4-2013	Previously Sampled Negative											
16	Male Toilets - Throughout Cubicle Partitions - Fibre Cement Sheeting	Asbestos	Previously Sampled AEC 3-2013	Previously Sampled Negative											
17	Female Toilets - Throughout Cubicle Partitions - Fibre Cement Sheeting	Asbestos	Previously Sampled AEC 2-2013	Previously Sampled Negative											
Nightcliff Police Station - Interior - Level 1															
18	PABX Room - Throughout Floor Covering - Vinyl Tiles	Asbestos	Previously Sampled AEC As Per 4-2013	Previously Sampled Negative

NO.: 14
 PHOTO NO.: J159257-NT0557A-PHOTO018
 RESULT: ASBESTOS - PREVIOUSLY SAMPLED POSITIVE
 BUILDING/LEVEL: NIGHTCLIFF POLICE STATION - GROUND LEVEL
 ROOM/LOCATION: STAFF LUNCH ROOM - NORTH
 FEATURE/MATERIAL: WALL LINING - FIBRE CEMENT SHEETING
 SAMPLE NO.: PREVIOUSLY SAMPLED AEC AS PER 5-3013
