ASBESTOS REGISTER UPDATE

DATE: NOVEMBER 2018

SITE REFERENCE:
NT0557b

PAGEMARTIN PTY LTD
NIGHTCLIFF LIBRARY
10 PAVONIA PLACE, NIGHTCLIFF NT 0812

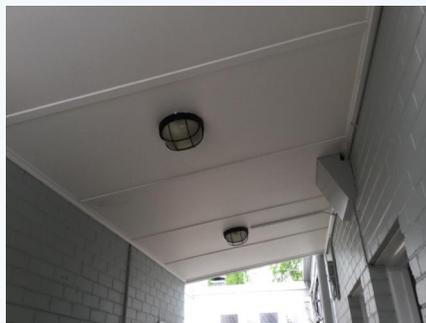
NO.: 2
 PHOTO NO.: J159257-NT0557B-PHOTO007
 RESULT: ASBESTOS - PREVIOUSLY SAMPLED POSITIVE
 BUILDING/LEVEL: NIGHTCLIFF LIBRARY - GROUND LEVEL
 ROOM/LOCATION: BREEZEWAY - THROUGHOUT
 FEATURE/MATERIAL: CEILING LINING - FIBRE CEMENT SHEETING
 SAMPLE NO.: PREVIOUSLY SAMPLED AEC 4-2013

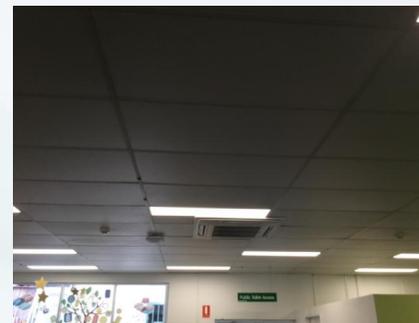
Nightcliff Library - Interior - Ground Level															
3	Library - East Ceiling Lining - Fibre Cement Sheeting - Item Is Above Existing Suspended Ceiling	Asbestos	Previously Sampled AEC 1-2013	Previously Sampled Positive	J159257-NT05 57b-Photo009 J159257-NT05 57b-Photo008	120 m ²	Good	Non Friable	Low	Low	Not Labelled	24/10/2023	P4	Maintain in current condition, label and incorporate into an AMP. Remove by licensed asbestos contractor prior to demolition or refurbishment.	
4	Public Toilet - Throughout Ceiling Lining - Fibre Cement Sheeting	Asbestos	Previously Sampled AEC As Per 2-2013	Previously Sampled Positive	J159257-NT05 57b-Photo003 J159257-NT05 57b-Photo004	6 m ²	Good	Non Friable	Low	Low	Not Labelled	24/10/2023	P4	Maintain in current condition, label and incorporate into an AMP. Remove by licensed asbestos contractor prior to demolition or refurbishment.	
5	Staff Toilet - Throughout Ceiling Lining - Fibre Cement Sheeting	Asbestos	Previously Sampled AEC 2-2013	Previously Sampled Positive	J159257-NT05 57b-Photo002 J159257-NT05 57b-Photo001	6 m ²	Good	Non Friable	Low	Low	Not Labelled	24/10/2023	P4	Maintain in current condition, label and incorporate into an AMP. Remove by licensed asbestos contractor prior to demolition or refurbishment.

NO.: 3
 PHOTO NO.: J159257-NT0557B-PHOTO009
 RESULT: ASBESTOS - PREVIOUSLY SAMPLED POSITIVE
 BUILDING/LEVEL: NIGHTCLIFF LIBRARY - GROUND LEVEL
 ROOM/LOCATION: LIBRARY - EAST
 FEATURE/MATERIAL: CEILING LINING - FIBRE CEMENT SHEETING
 SAMPLE NO.: PREVIOUSLY SAMPLED AEC 1-2013

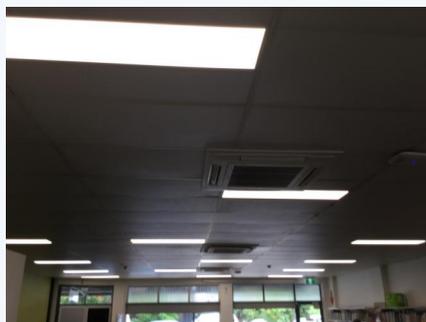
NO.: 3
 PHOTO NO.: J159257-NT0557B-PHOTO008
 RESULT: ASBESTOS - PREVIOUSLY SAMPLED POSITIVE
 BUILDING/LEVEL: NIGHTCLIFF LIBRARY - GROUND LEVEL
 ROOM/LOCATION: LIBRARY - EAST
 FEATURE/MATERIAL: CEILING LINING - FIBRE CEMENT SHEETING
 SAMPLE NO.: PREVIOUSLY SAMPLED AEC 1-2013

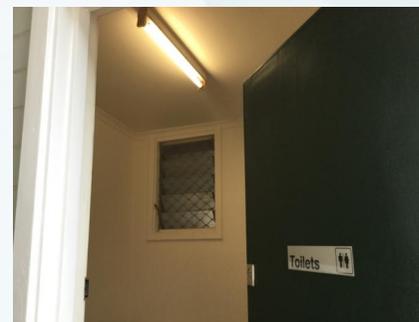
NO.: 4
 PHOTO NO.: J159257-NT0557B-PHOTO003
 RESULT: ASBESTOS - PREVIOUSLY SAMPLED POSITIVE
 BUILDING/LEVEL: NIGHTCLIFF LIBRARY - GROUND LEVEL
 ROOM/LOCATION: PUBLIC TOILET - THROUGHOUT
 FEATURE/MATERIAL: CEILING LINING - FIBRE CEMENT SHEETING
 SAMPLE NO.: PREVIOUSLY SAMPLED AEC AS PER 1-2013

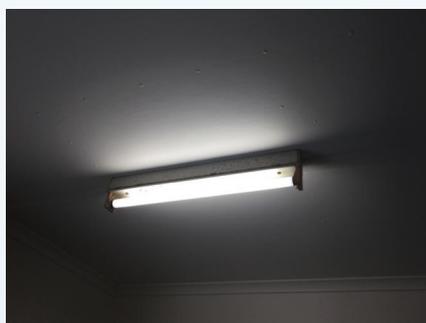
NO.: 4
 PHOTO NO.: J159257-NT0557B-PHOTO004
 RESULT: ASBESTOS - PREVIOUSLY SAMPLED POSITIVE
 BUILDING/LEVEL: NIGHTCLIFF LIBRARY - GROUND LEVEL
 ROOM/LOCATION: PUBLIC TOILET - THROUGHOUT
 FEATURE/MATERIAL: CEILING LINING - FIBRE CEMENT SHEETING
 SAMPLE NO.: PREVIOUSLY SAMPLED AEC AS PER 2-2013

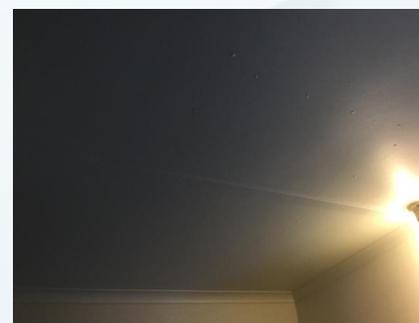
NO.: 5
 PHOTO NO.: J159257-NT0557B-PHOTO002
 RESULT: ASBESTOS - PREVIOUSLY SAMPLED POSITIVE
 BUILDING/LEVEL: NIGHTCLIFF LIBRARY - GROUND LEVEL
 ROOM/LOCATION: STAFF TOILET - THROUGHOUT
 FEATURE/MATERIAL: CEILING LINING - FIBRE CEMENT SHEETING
 SAMPLE NO.: PREVIOUSLY SAMPLED AEC 2-2013

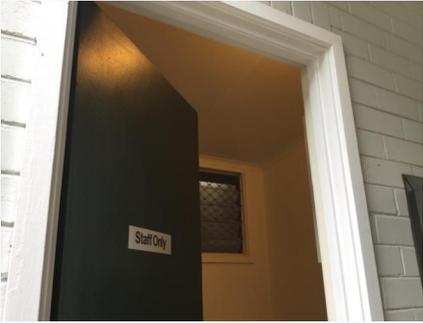
NO.: 5
PHOTO NO.: J159257-NT0557B-PHOTO001
RESULT: **ASBESTOS - PREVIOUSLY SAMPLED POSITIVE**
BUILDING/LEVEL: **NIGHTCLIFF LIBRARY - GROUND LEVEL**
ROOM/LOCATION: **STAFF TOILET - THROUGHOUT**
FEATURE/MATERIAL: **CEILING LINING - FIBRE CEMENT SHEETING**
SAMPLE NO.: **PREVIOUSLY SAMPLED AEC 2-2013**
