**ASBESTOS REGISTER  
No. NT0557a**

**NIGHTCLIFF POLICE STATION  
10 PAVONIA PLACE  
NIGHTCLIFF NT**

Date: June 2013  
Register No: NT0557  
Register Version: 01  
Our Ref: TB/sk

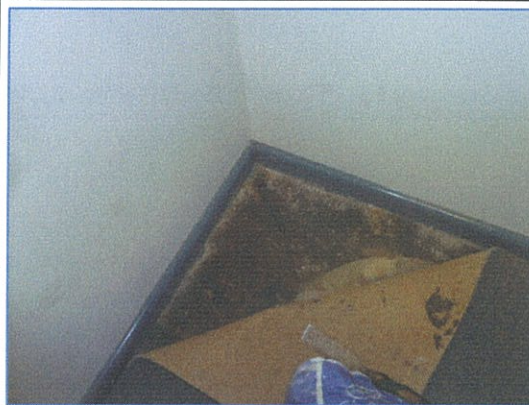
1. Adhesive Floor covering under existing carpet in Reception area		Black adhesive material containing white (Chrysotile) asbestos (sample no.1)	
Recommendation and Action			
Refer to Asbestos Management Plan & Section 7.0: Policies and Recommendations			
Situational Asbestos Risk Assessment			
Friability	Condition	Signage	Risk Rating
Non Friable	Poor	Recommend #: 30 small	Moderate

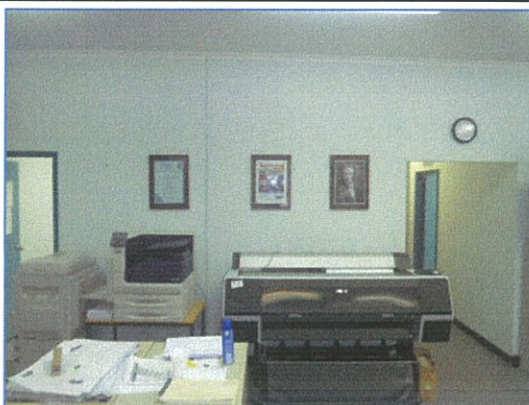
2. Wall lining – Southern wall in Major Crash Office & Northern wall in Staff Lunch room (90m <sup>2</sup> )		Fibre cement sheet material containing white (Chrysotile) & grey/brown (Amosite) asbestos (sample no.5)	
Recommendation and Action			
Refer to Asbestos Management Plan & Section 7.0: Policies and Recommendations			
Situational Asbestos Risk Assessment			
Friability	Condition	Signage	Risk Rating
Non Friable	Stable	Recommend #: 6 small	Low
