ASBESTOS REGISTER

NO. NT0686c

RCG Centre

RCG Centre, 47 Mitchel St. Darwin 0800

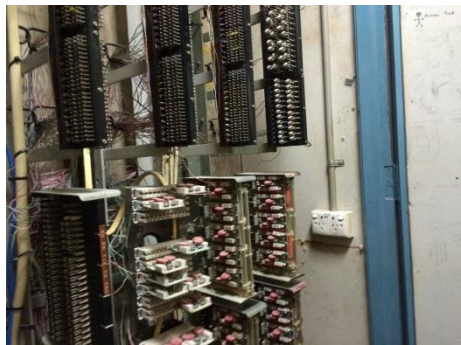
| Location | Type of Material | | |
|--|--|--|---|
| 1. Wall lining to Comms cupboard (2m ²) | Fibre cement sheet material containing white (Chrysotile) asbestos (sample no.1) | | |
| Non-friable | Stable | Installed 1 small warning signs | Low |

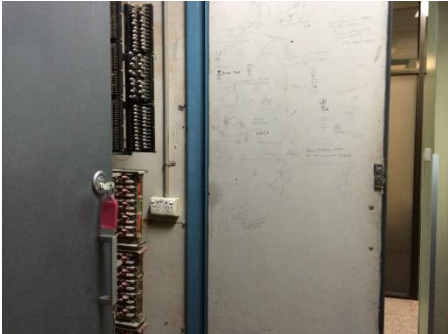
| Location | Type of Material | | |
|---|---|---|---|
| 2. Inner door lining to Comms cupboard (4m ²) | Fibre cement sheet material containing white (Chrysotile) and grey/brown (Amosite) asbestos (sample no.2) | | |
| Non-friable | Stable | Installed 1 small warning signs | Low |

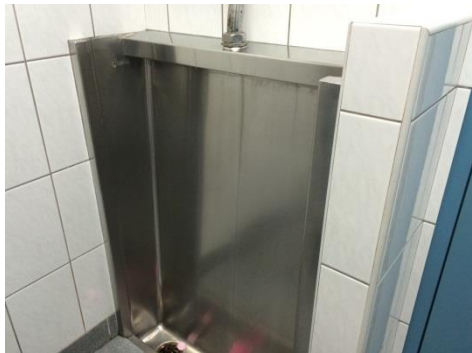
| Location | Type of Material | | |
|--|--|---|---|
| 3. Sealant to urinal in male toilet (1m ²) | Area not accessed or sampled. Based on past experience in similar areas, asbestos in some form may exist. It is recommended that if work is contemplated in this area, due care and diligence should be exercised. | | |
| Non-friable | Stable | Installed 1 small warning signs | Low |

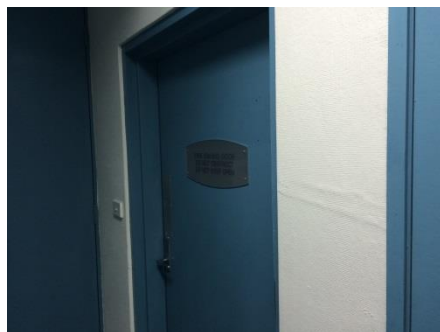
| Location | Type of Material | | |
|--|---|--|---|
| 4. Fire door opposite toilets (2m ²) | Core material containing white (Chrysotile) and grey/brown (Amosite) asbestos (sample no.6) | | |
| Friable when exposed | Stable | Installed 1 small warning signs | Medium |

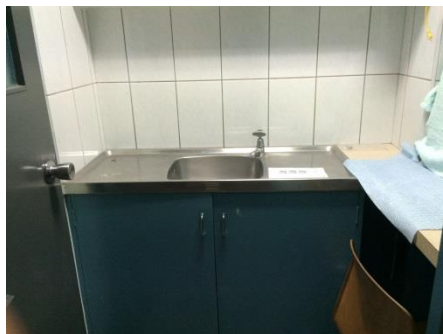
| Location | Type of Material | | |
|---|--|---|---|
| 5. Sound dampener under kitchen sink in utility room (1m ²) | Insulation material containing white (Chrysotile) asbestos (sample no.4) | | |
| Non-friable | Stable | Installed 1 small warning signs | Low |

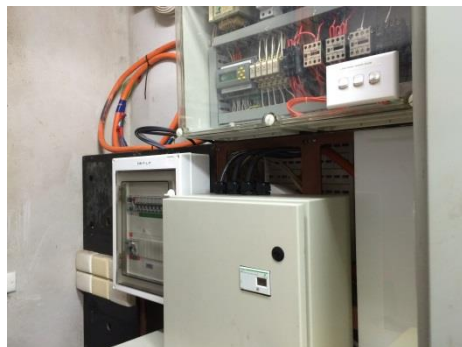
| Location | Type of Material | | |
|---|---|--|---|
| 6. Electrical switchboard in switch room: backing board | Area accessed but not sampled. Based on findings in similar areas, it is highly likely to contain asbestos. | | |

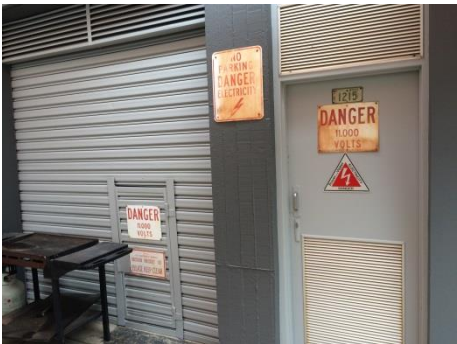
| GROUND LEVEL, EXTERNAL | | | |
|---|---|--|---|
| 7. PAWA Substation <i>*No access for this inspection</i> | | Area not accessed or sampled. Based on past experience in similar areas, asbestos in some form may exist. It is recommended that if work is contemplated in this area, due care and diligence should be exercised. | |

| GROUND LEVEL, EXTERNAL | | | |
|---|---|--|---|
| Refer to Section 7.0: Policies & Management Procedures | | | |

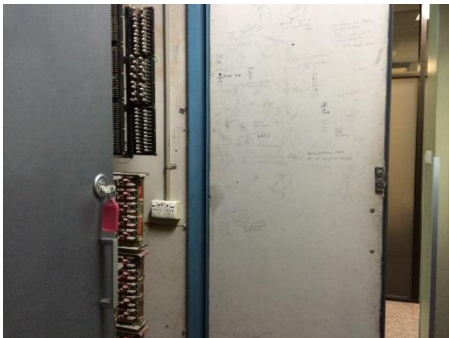
| 9. Inner door lining to Comms cupboard (4m ²) | | Fibre cement sheet material containing white (Chrysotile) and grey/brown (Amosite) asbestos (per sample no.2) | |
| Non-friable | Stable | Installed 1 small warning signs | Low |

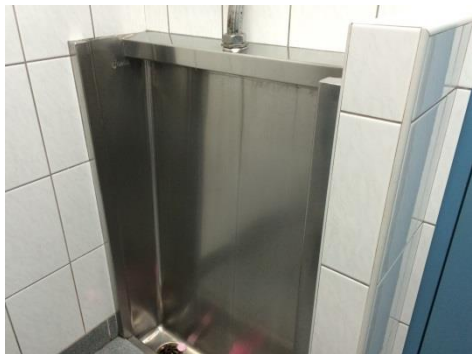
| LEVEL 1, INTERNAL (Cont.) | | | |
|---|---|--|---|
| 10. Sealant to urinal in male toilet (1m ²) | | Area not accessed or sampled. Based on past experience in similar areas, asbestos in some form may exist. It is recommended that if work is contemplated in this area, due care and diligence should be exercised. | |

| LEVEL 1, INTERNAL (Cont.) | | | |
|---|---|--|---|
| Refer to Section 7.0: Policies & Management Procedures | | | |

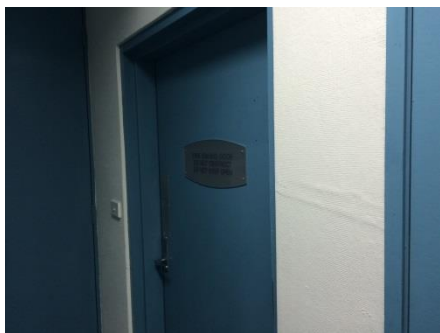
| Location | | Type of Material | |
|--|---|---|---|
| 11. Fire door opposite toilets (2m ²) | | Core material containing white (Chrysotile) and grey/brown (Amosite) asbestos (per sample no.6) | |

| Location | | Type of Material | |
|--|---|---|---|
| Refer to Section 7.0: Policies & Management Procedures | | | |

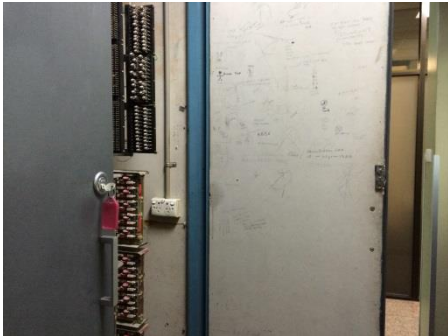
| 13. Inner door lining to Comms cupboard (4m ²) | | Fibre cement sheet material containing white (Chrysotile) and grey/brown (Amosite) asbestos (per sample no.2) | |
| Non-friable | Stable | Installed 1 small warning signs | Low |

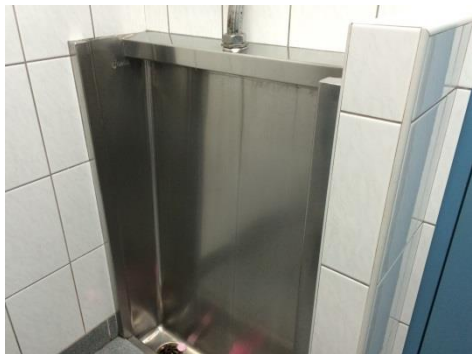
| LEVEL 2, INTERNAL (Cont.) | | | |
|---|---|--|---|
| 14. Sealant to urinal in male toilet (1m ²) | | Area not accessed or sampled. Based on past experience in similar areas, asbestos in some form may exist. It is recommended that if work is contemplated in this area, due care and diligence should be exercised. | |

| LEVEL 2, INTERNAL (Cont.) | | | |
|---|---|--|---|
| Refer to Section 7.0: Policies & Management Procedures | | | |

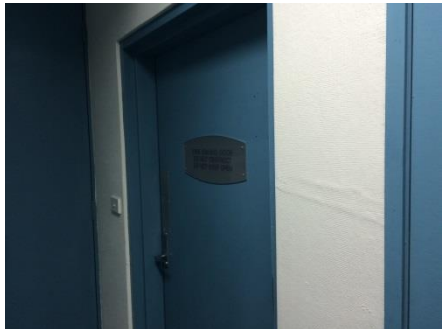
| 15. Fire door opposite toilets (2m ²) | | Core material containing white (Chrysotile) and grey/brown (Amosite) asbestos (per sample no.6) | |

| Refer to Section 7.0: Policies & Management Procedures | | | |

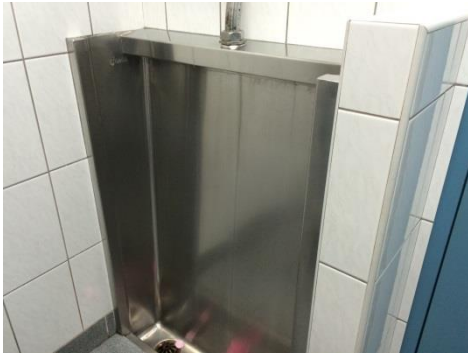
| LEVEL 3, INTERNAL (Cont.) | | | | | | | |
|---|--|--|--|---|--|---|--|
| 18. Sealant to urinal in male toilet (1m ²) | | Area not accessed or sampled. Based on past experience in similar areas, asbestos in some form may exist. It is recommended that if work is contemplated in this area, due care and diligence should be exercised. | | | | | |

| LEVEL 3, INTERNAL (Cont.) | | | | | | | |
|---|--|--|--|---|--|---|--|
| Refer to Section 7.0: Policies & Management Procedures | | | | | | | |

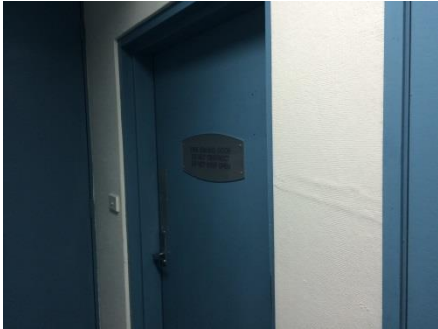
| Location | | Type of Material | | | | | |
|--|--|---|--|---|--|---|--|
| 19. Fire door opposite toilets (2m ²) | | Core material containing white (Chrysotile) and grey/brown (Amosite) asbestos (per sample no.6) | | | | | |

| Location | | Type of Material | | | | | |
|--|--|---|--|---|--|---|--|
| Refer to Section 7.0: Policies & Management Procedures | | | | | | | |

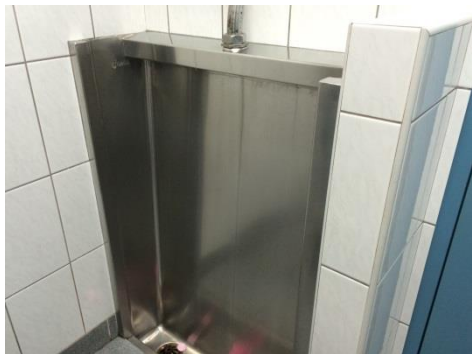
| LEVEL 4, INTERNAL (Cont.) | | | |
|---|---|--|---|
| 22. Sealant to urinal in male toilet (1m ²) | | Area not accessed or sampled. Based on past experience in similar areas, asbestos in some form may exist. It is recommended that if work is contemplated in this area, due care and diligence should be exercised. | |

| LEVEL 4, INTERNAL (Cont.) | | | |
|---|---|--|---|
| Refer to Section 7.0: Policies & Management Procedures | | | |

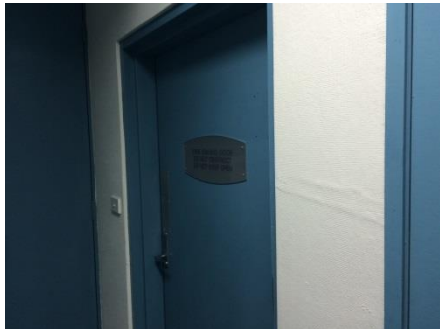
| Location | | Type of Material | |
|--|---|---|---|
| 23. Fire door opposite toilets (2m ²) | | Core material containing white (Chrysotile) and grey/brown (Amosite) asbestos (per sample no.6) | |

| Location | | Type of Material | |
|--|---|---|---|
| Refer to Section 7.0: Policies & Management Procedures | | | |

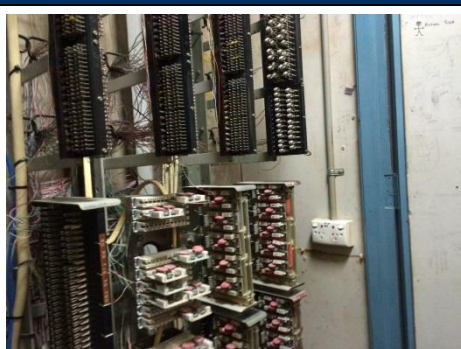
| LEVEL 5, INTERNAL | | | |
|--|--|--|---|
| 25. Wall lining to Comms cupboard (2m ²) | Fibre cement sheet material containing white (Chrysotile) asbestos (per sample no.1) | | |
| Non-friable | Stable | Installed 1 small warning signs | Low |

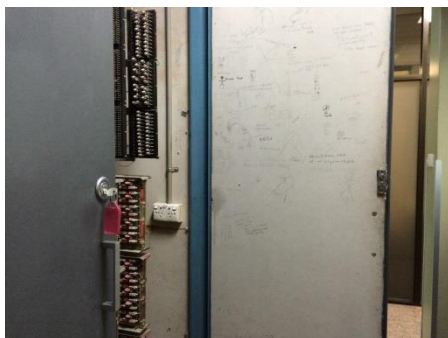
| Location | Type of Material | | |
|--|---|---|---|
| 26. Inner door lining to Comms cupboard (4m ²) | Fibre cement sheet material containing white (Chrysotile) and grey/brown (Amosite) asbestos (per sample no.2) | | |

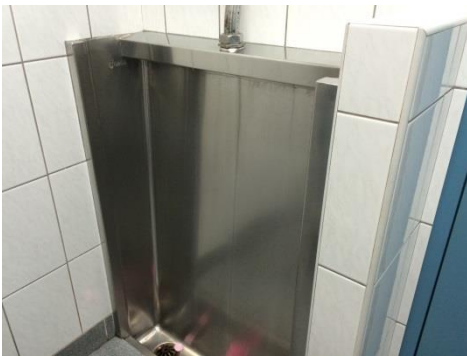
| LEVEL 5, INTERNAL (Cont.) | | | |
|--|---|--|---|
| 27. Sealant to urinal in male toilet (1m ²) | | Area not accessed or sampled. Based on past experience in similar areas, asbestos in some form may exist. It is recommended that if work is contemplated in this area, due care and diligence should be exercised. | |
| Non-friable | Stable | Installed 1 small warning signs | Low |

| LEVEL 5, INTERNAL (Cont.) | | | |
|--|---|--|---|
| Refer to Section 7.0: Policies & Management Procedures | | | |

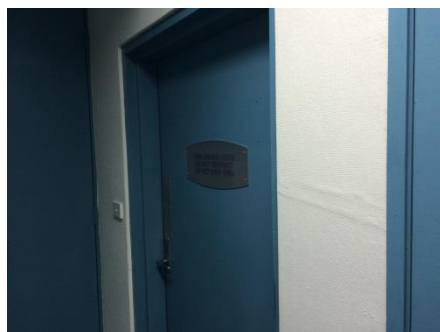
| Location | Type of Material | | |
|--|---|---|---|
| 28. Fire door opposite toilets (2m ²) | Core material containing white (Chrysotile) and grey/brown (Amosite) asbestos (per sample no.6) | | |

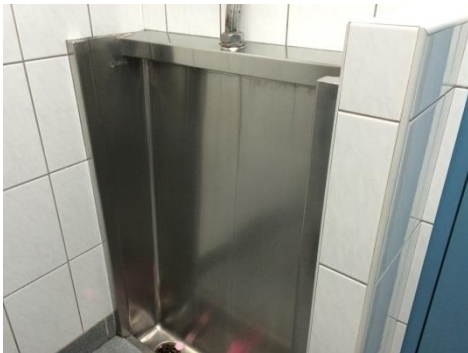
| LEVEL 6, INTERNAL (Cont.) | | | |
|---|--|---|---|
| 32. Sealant to urinal in male toilet (1m ²) | Area not accessed or sampled. Based on past experience in similar areas, asbestos in some form may exist. It is recommended that if work is contemplated in this area, due care and diligence should be exercised. | | |
| Non-friable | Stable | Installed 1 small warning signs | Low |

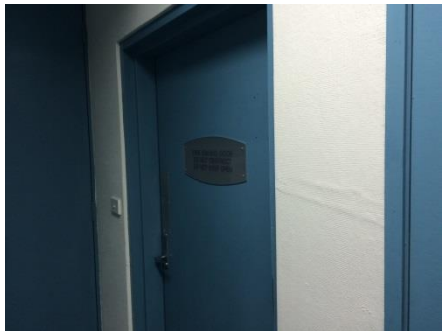
| Location | Type of Material | | |
|--|---|---|---|
| 33. Fire door opposite toilets (2m ²) | Core material containing white (Chrysotile) and grey/brown (Amosite) asbestos (per sample no.6) | | |

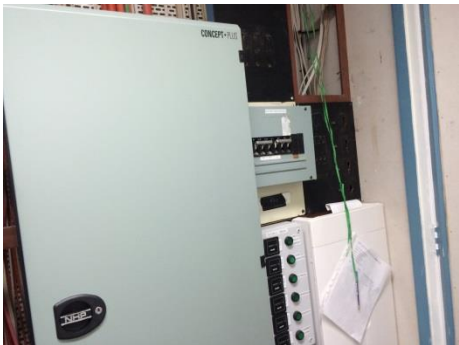
| LEVEL 6, INTERNAL (Cont.) | | | |
|---|--|--|---|
| 34. Comms cupboard: backing board (1m ²) | Area accessed but not sampled. Based on findings in similar areas, it is highly likely to contain asbestos. | | |

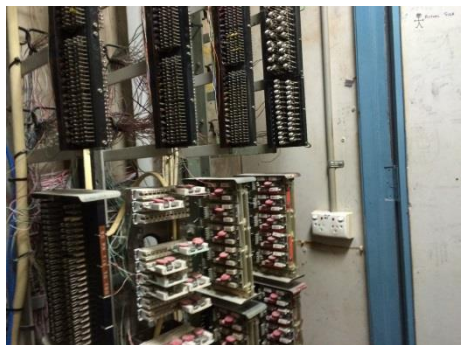
| Location | Type of Material | | |
|--|--|---|---|
| 35. Wall lining to Comms cupboard (2m ²) | Fibre cement sheet material containing white (Chrysotile) asbestos (per sample no.1) | | |
| Non-friable | Stable | Installed 1 small warning signs | Low |

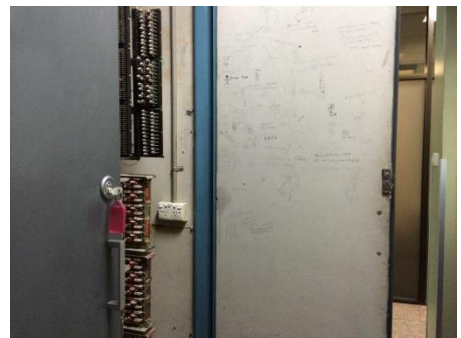
| Location | Type of Material | | |
|--|---|--|---|
| 36. Inner door lining to Comms cupboard (4m ²) | Fibre cement sheet material containing white (Chrysotile) and grey/brown (Amosite) asbestos (per sample no.2) | | |

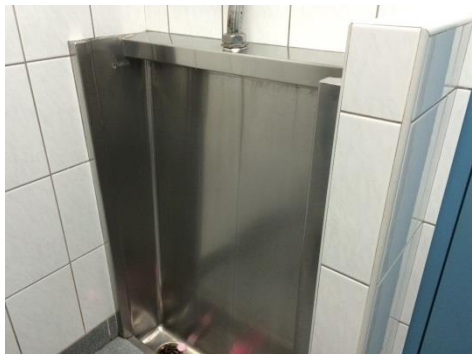
| LEVEL 7, INTERNAL (Cont.) | | | |
|---|---|--|---|
| 37. Sealant to urinal in male toilet (1m ²) | | Area not accessed or sampled. Based on past experience in similar areas, asbestos in some form may exist. It is recommended that if work is contemplated in this area, due care and diligence should be exercised. | |

| LEVEL 7, INTERNAL (Cont.) | | | |
|---|---|--|---|
| Refer to Section 7.0: Policies & Management Procedures | | | |

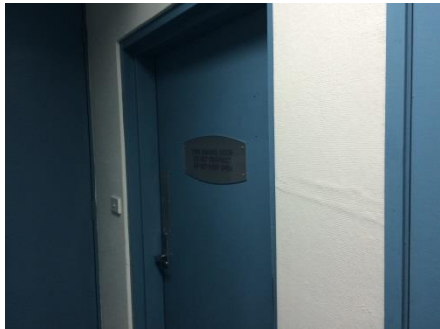
| 38. Fire door opposite toilets (2m ²) | | Core material containing white (Chrysotile) and grey/brown (Amosite) asbestos (per sample no.6) | |

| Refer to Section 7.0: Policies & Management Procedures | | | |

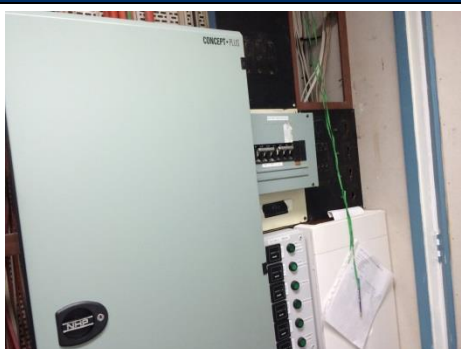
| LEVEL 7, INTERNAL (Cont.) | | | |
|--|---|---|---|
| 39. Comms cupboard: backing board (1m ²) | | Area accessed but not sampled. Based on findings in similar areas, it is highly likely to contain asbestos. | |

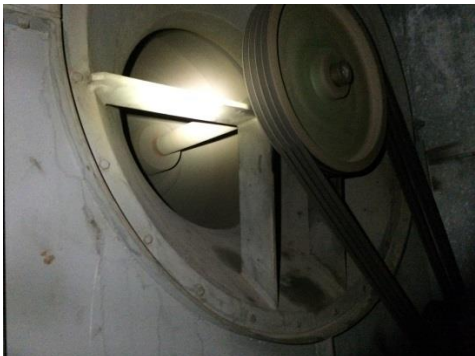
| LEVEL 8, INTERNAL | | | |
|--|---|--|---|
| 40. Rope seal to service level AC intake fan | | Area not accessed or sampled. Based on past experience in similar areas, asbestos in some form may exist. It is recommended that if work is contemplated in this area, due care and diligence should be exercised. | |

| LEVEL 8, INTERNAL | | | |
|--|---|--|---|
| Refer to Section 7.0: Policies & Management Procedures | | | |

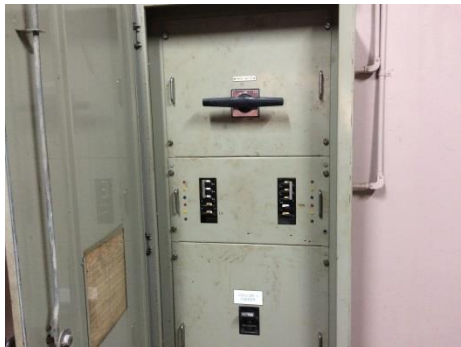
| Location | Type of Material | | |
|--|---|---|---|
| 41. Distribution board to service level: backing board | Area accessed but not sampled. Based on findings in similar areas, it is highly likely to contain asbestos. | | |
| Non-friable | Stable | Installed 1 small warning signs | Medium |

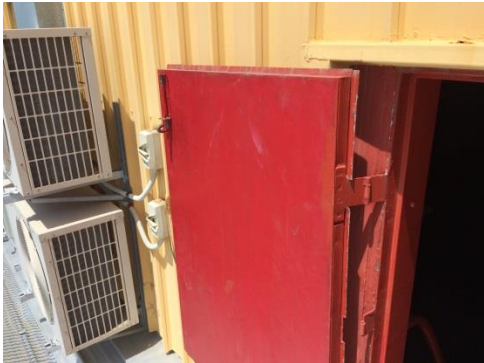
| Location | Type of Material | | |
|--|--|---|---|
| 42. Fire door (1.5m ²) | Area not accessed or sampled. Based on past experience in similar areas, asbestos in some form may exist. It is recommended that if work is contemplated in this area, due care and diligence should be exercised. | | |
