# Asbestos Containing Materials Survey - Part 5

Property Number (PMS): TPG 001  
Property Name: Territory Property Group  
Property Address: 96A Winnellie Rd, Winnellie NT

Number of Structures: 2  
Report Creation Date: 02 Nov 2016

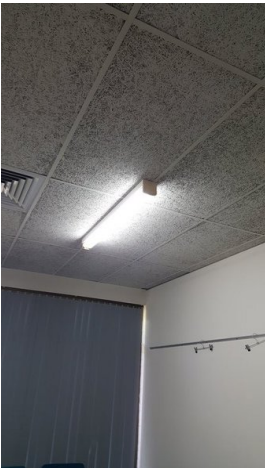
LOCATION	DETAILS	RISK	Asbestos
Deposit ID: TPG003 Sample ID: Ground, Throughout Offices Ceilings	<b>Application:</b> Linings. <b>Description:</b> Fibre & Plasreboard Tiles. <b>Accessibility:</b> Accessible <b>Amount:</b> <b>Recommendations:</b> <b>Due Date:</b>	<b>Status:</b> Not Present <b>Substance Type:</b> <b>Condition:</b> <b>Damage or Deterioration</b> <b>Potential:</b> <b>Activities that May Disturb</b> <b>Material:</b> <b>Remedial Action:</b> <b>Audit Findings:</b> <b>Assessed:</b> 2016-10-24 <b>Risk Ass.</b> None

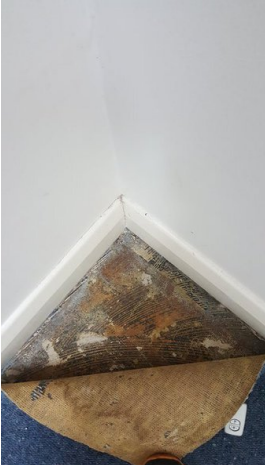
Asbestos Blackjack adhesive was detected under the carpet in the front offices. As it is under the Carpet it is considered encapsulated and poses no risk at this time as long as the carpet is not removed. The carpet is now considered contaminated on the under side and will have to be removed as Asbestos Waste by a licenced Asbestos removalist if replaced.

LOCATION	DETAILS	RISK	Asbestos
Deposit ID: TPG001 Sample ID: 001 Ground Offices Floor under carpet	<b>Application:</b> Adhesive <b>Description:</b> Black Jack <b>Accessibility:</b> Rarely Accessible <b>Amount:</b> 360 m <sup>2</sup> <b>Recommendations:</b> Affix asbestos warning labels on kick-boards and do not remove carpet. <b>Due Date:</b>	<b>Status:</b> Present <b>Substance Type:</b> <b>Condition:</b> Poor <b>Damage or Deterioration</b> Low <b>Potential:</b> <b>Activities that May Disturb</b> Maintenance/personel <b>Material:</b> <b>Remedial Action:</b> Control <b>Audit Findings:</b> Asbestos Blackjack adhesive under carpet throughout all common areas in the front Offices. <b>Assessed:</b> 2016-10-24 <b>Risk Ass.</b> P1

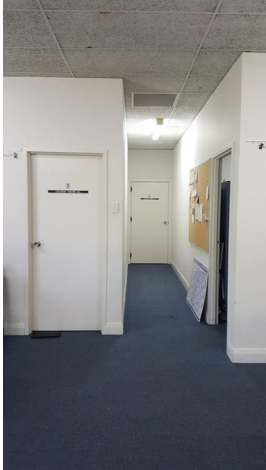
LOCATION	DETAILS	RISK	Asbestos
Deposit ID: TPG002 Sample ID: Ground Offices Walls	<b>Application:</b> Linings. <b>Description:</b> Plasterboard & Masonry. <b>Accessibility:</b> Accessible <b>Amount:</b> <b>Recommendations:</b> <b>Due Date:</b>	<b>Status:</b> Not Present <b>Substance Type:</b> <b>Condition:</b> <b>Damage or Deterioration</b> <b>Potential:</b> <b>Activities that May Disturb</b> <b>Material:</b> <b>Remedial Action:</b> <b>Audit Findings:</b> <b>Assessed:</b> 2016-10-24 <b>Risk Ass.</b> None

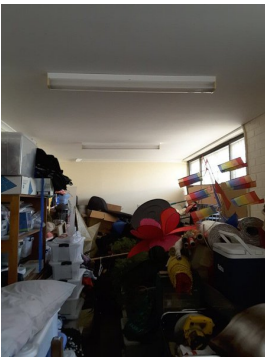
LOCATION	DETAILS	RISK	Asbestos
Deposit ID: TPG004 Sample ID: Ground Warehouse rooms Walls/ceilings

<b>Application:</b> Linings <b>Description:</b> Plasterboard <b>Accessibility:</b> Accessible <b>Amount:</b> <b>Recommendations:</b> <b>Due Date:</b>	<b>Status:</b> Not Present <b>Substance Type:</b> <b>Condition:</b> Not Applicable <b>Damage or Deterioration:</b> Not Applicable <b>Potential:</b> <b>Activities that May Disturb:</b> <b>Material:</b> <b>Remedial Action:</b> Not Applicable <b>Audit Findings:</b> All structures in the Warehouse are lined with Plasterboard. <b>Assessed:</b> 2016-10-24 <b>Risk Ass.</b> None
