# Hazardous Substances Containing Materials Survey - Part 5

Property Number (PMS): Property No. 5581633  
Property Name: Cascom Centre  
Property Address: 13-17 Scaturchio Street  
Casuarina 0811

Number of Structures: 14  
Report Creation Date: 20 Feb 2012

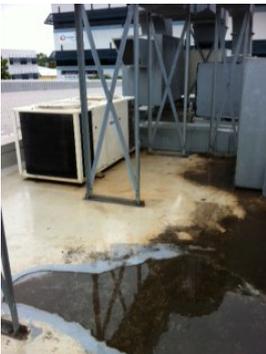
LOCATION	DETAILS	RISK	Asbestos
Deposit ID: K Stage 3 42 Sample ID: 1st Rooftop Rooftop

<b>Application:</b> Waterproofing <b>Description:</b> Membrane <b>Accessibility:</b> Accessible <b>Amount:</b> <b>Recommendations:</b> <b>Due Date:</b>	<b>Status:</b> Unknown <b>Substance Type:</b> <b>Condition:</b> Damaged <b>Damage or Deterioration:</b> Medium <b>Potential:</b> <b>Activities that May Disturb Material:</b> Water and maitainance <b>Remedial Action:</b> Maintain <b>Audit Findings:</b> No sample taken as cannot disrupt the integrity of the Waterproofing membrane. <b>Assessed:</b> 2012-02-02 <b>Risk Ass.</b> None
