ASBESTOS CONTAINING BUILDING MATERIALS SURVEY REPORT

Construction House

1 Briggs Street

Report Number 680.10035.00000.02 ASR R0 20130717

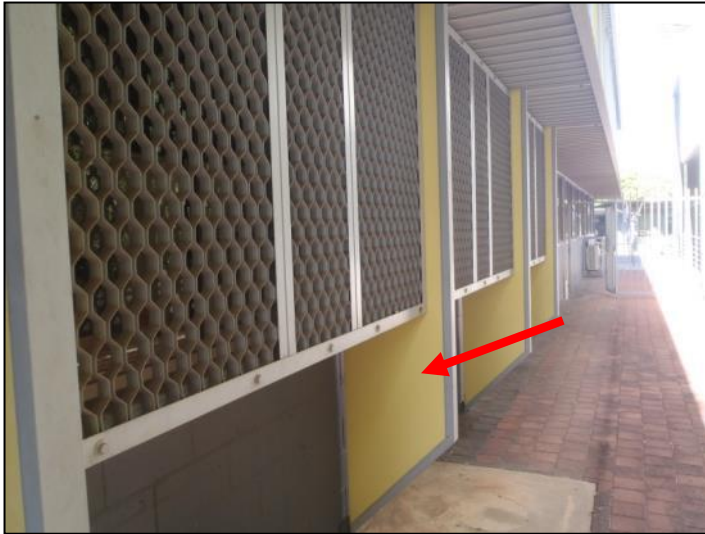
Photograph 1

Compressed cement 'baffles' to exterior of building, ground floor (**asbestos containing**).

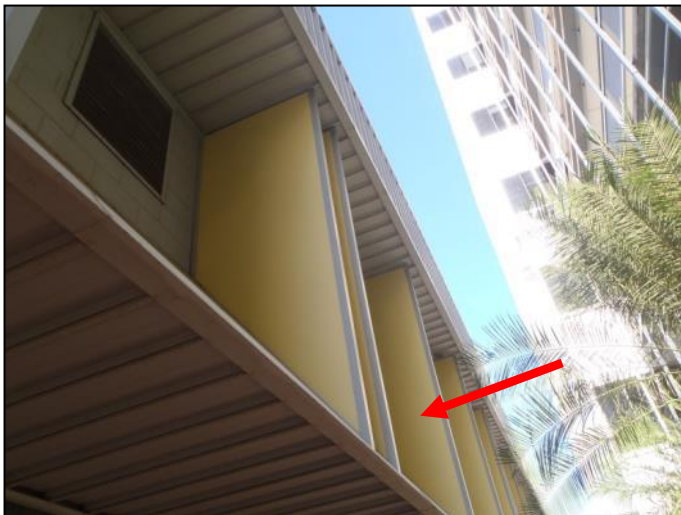
Photograph 2

Compressed cement 'baffles' to exterior of building, first floor (**asbestos containing**).

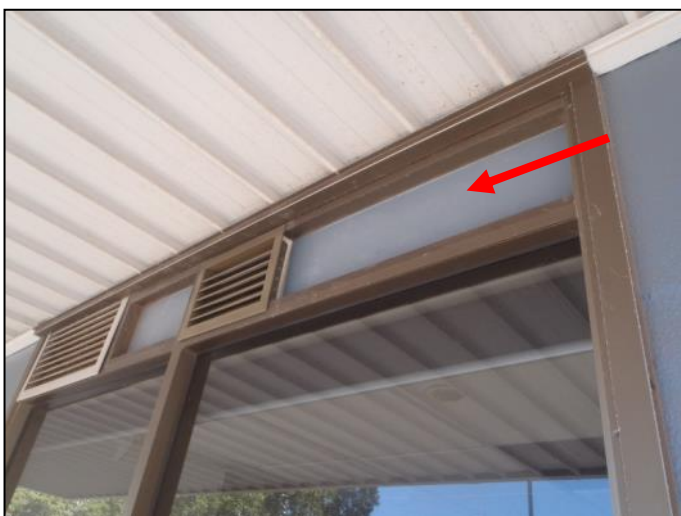
Photograph 3

Flat cement sheet infill panels above windows to east elevation, building exterior, ground floor (**assumed asbestos containing**).

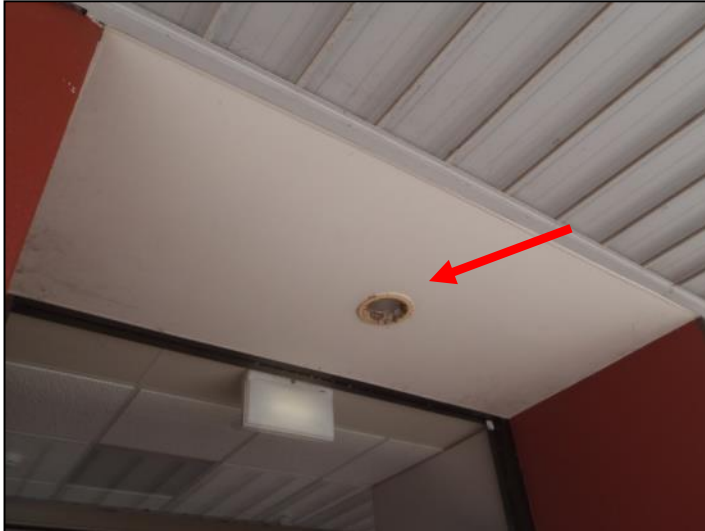
**Photograph 4**

Flat cement sheet soffit lining above entry alcove to south of east elevation
(asbestos containing).

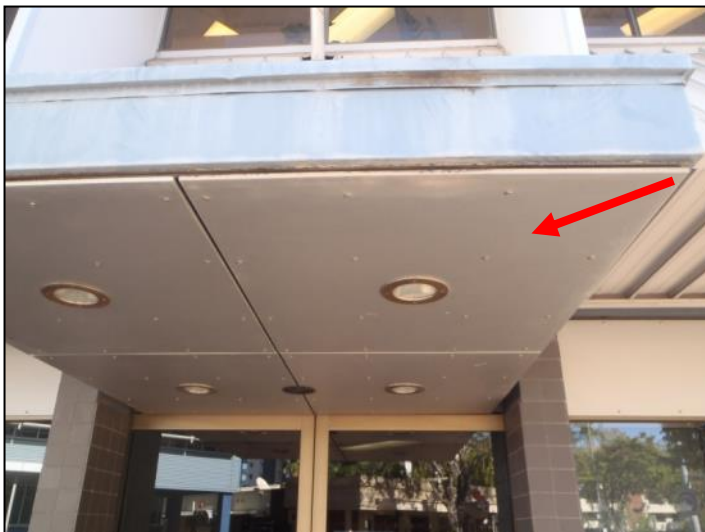
**Photograph 5**

Ground Floor, CCS soffit lining above main entry alcove to south-east corner of building, un-painted	Visually similar to item ref: 680.10035.00000/ 01	5	4.5m ²	Non-friable	1	0	1	1	3-Very Low	C1, C2, C3, C4, C5, C8, C12	Material requires labelling
Ground Floor, FCS infill panels to either side of main entry alcove	Assumed asbestos containing	6	2m ²	Non-friable	1	0	0	3	2– Very Low	C1, C2, C3, C4, C5, C12	Material requires labelling
Ground Floor, FCS soffit lining to north-east corner	Assumed asbestos containing	7	1.5m ²	Non-friable	1	0	0	3	2– Very Low	C1, C2, C3, C4, C5, C12	Material requires labelling

Compressed cement sheet soffit lining above main entry alcove to south-east corner of building, external, ground floor
(assumed asbestos containing).

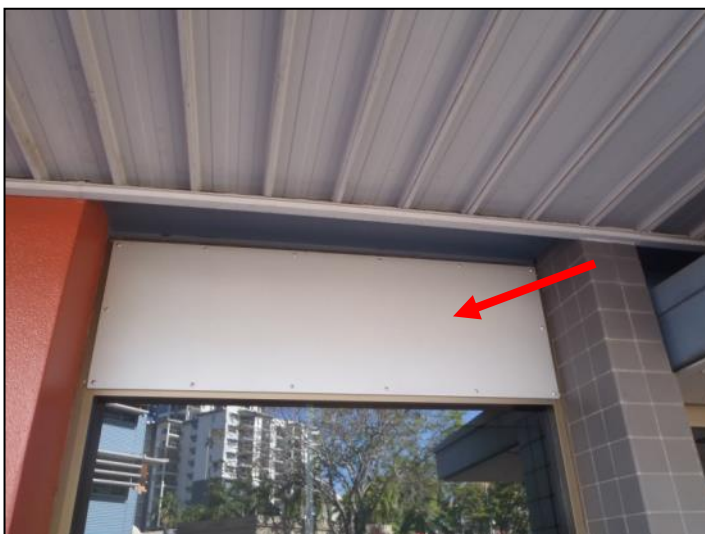
**Photograph 6**

Flat cement sheet infill panels to either side of main entry alcove, external, ground floor
(assumed asbestos containing).

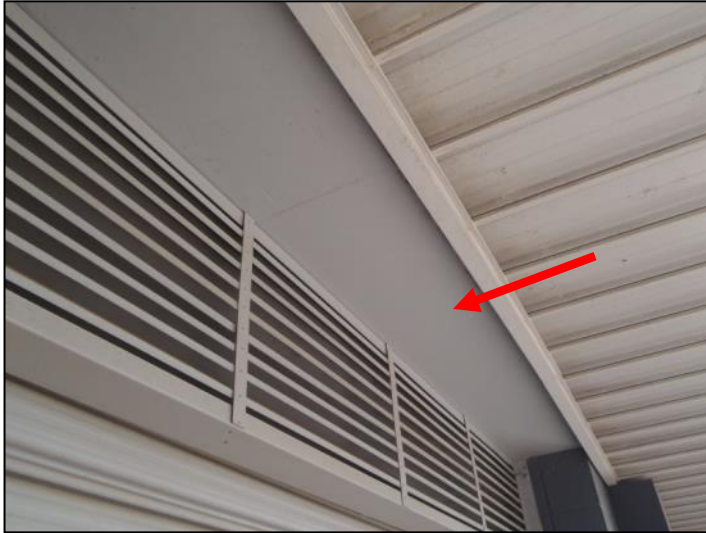
**Photograph 7**

Flat cement sheet soffit lining to north-east corner, external, ground floor
(assumed asbestos containing).

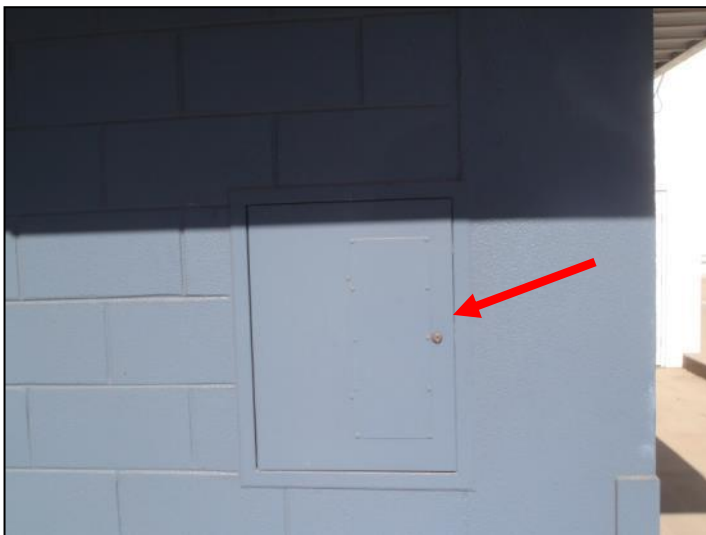
**Photograph 8**

No access to electrical cabinet to north elevation, external, ground floor
(assumed asbestos containing).

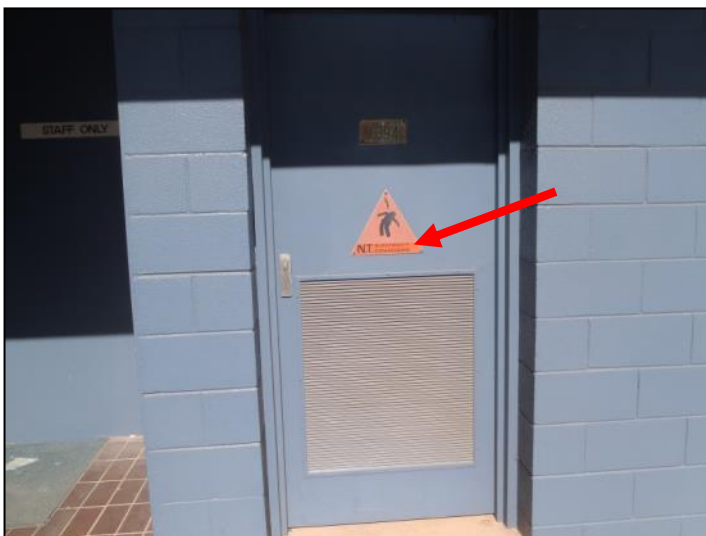
**Photograph 9**

No access to switch-room to north elevation, external, ground floor
(assumed asbestos containing).

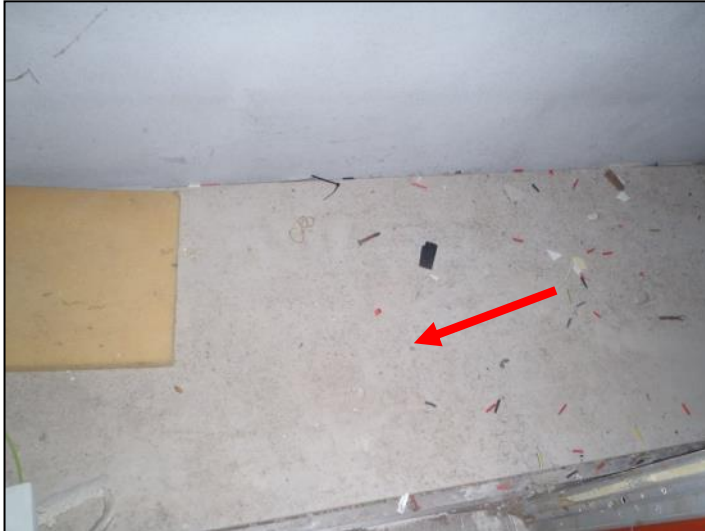
**Photograph 10**

FCS floor lining to electrical cabinet inside main entry foyer, ground floor
(asbestos containing).

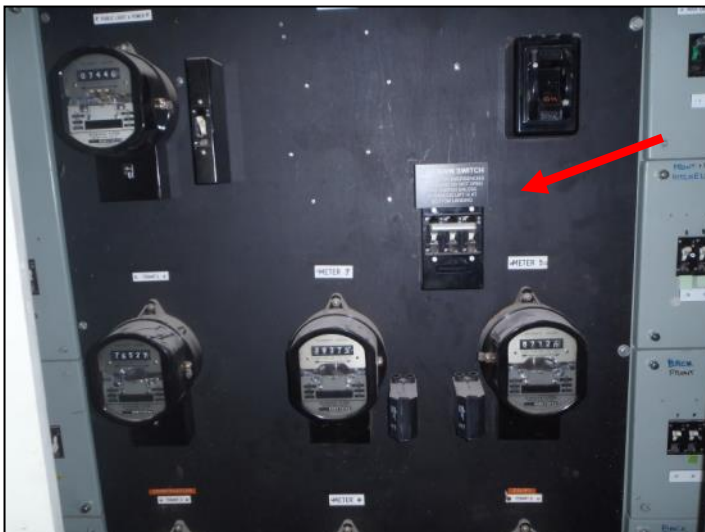
**Photograph 11**

Backing board to electrical meter panel inside main entry foyer, ground floor
(asbestos containing).

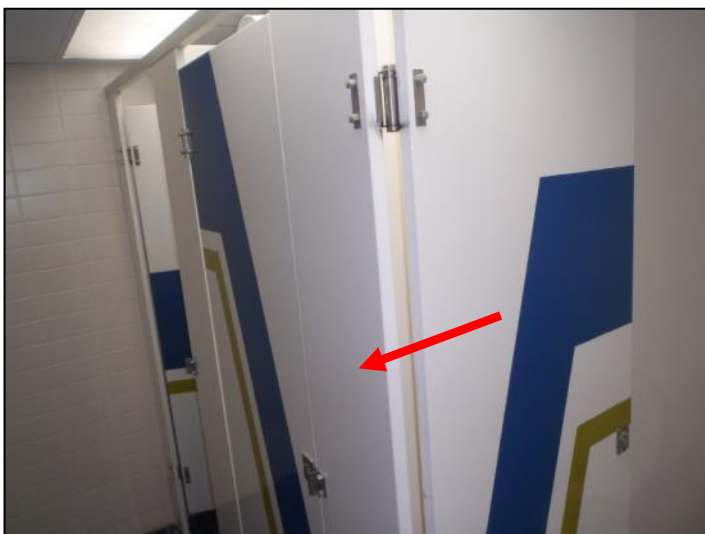
**Photograph 12**

Ground Floor, CCS partition walls and doors to male and female toilets	680.10035.00000/06	12	50m ²	Non-friable	1	0	0	1	2 – Very Low	C1, C2, C3, C4, C12	Material requires labelling

Compressed cement partition walls and doors to male and female toilets, Internal, ground floor
(asbestos containing).

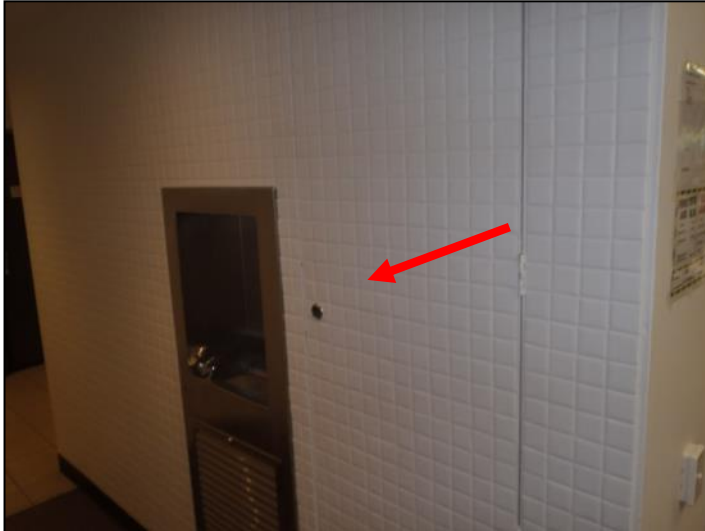
Photograph 13

No access to lift motor room, panel in hall beside water-cooler, ground floor
(assumed asbestos containing).

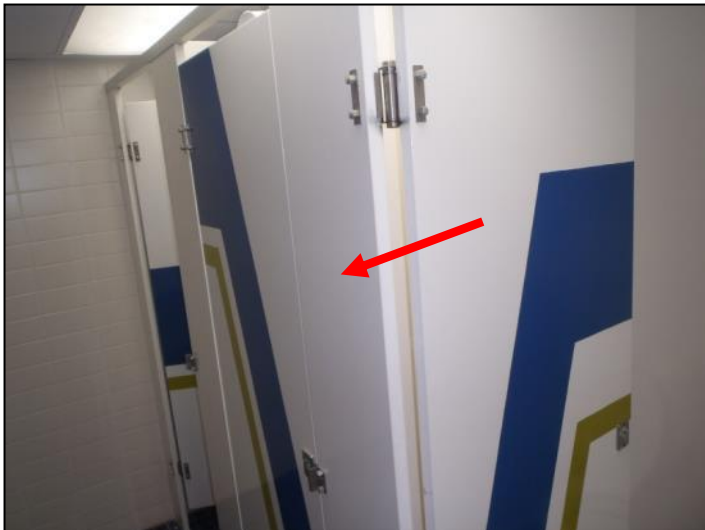
Photograph 14

Compressed cement partition walls and doors to male and female toilets, Internal, first floor
(assumed asbestos containing).
