Asbestos Register & Management Plan

City of Palmerston – Civic Centre

1 Chung Wah Tce, Palmerston NT 0830

Inspection By:	Paul Felvus
Report By:	Paul Felvus
Inspection Date:	03/05/2024
Report Date:	11/05/2024
Review Date:	03/05/2029
Project No:	A763.1
Status:	Released
Version:	1.0

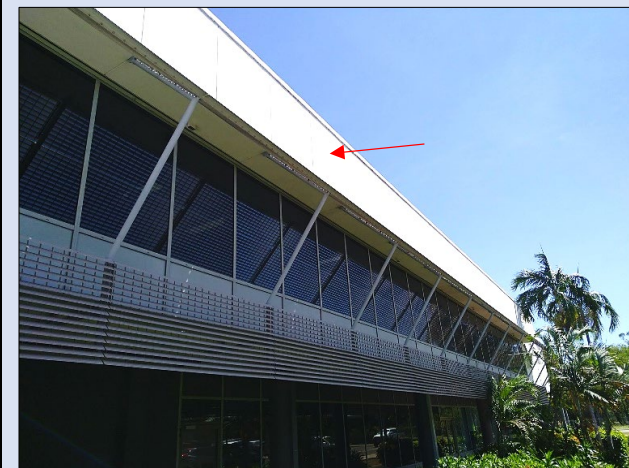
Sequence No:	1	Elevation:	Roof Level
Area:	External	Friability	
Location:	Front of building and roof	Condition:	
Position	Fascia panels/barge capping	Sealed:	
Material Type:	Fibre cement sheet	Traffic:	
Quantity:	300	Risk Likelihood:	
	Sq. M		
Sample No:	178949-001	Risk Consequence:	
Result:	No Asbestos Detected (NAD)	Risk Rating:

Fascia panel to northern, eastern and western elevations of the building. Sample 178949-001 collected on 03/05/2024.

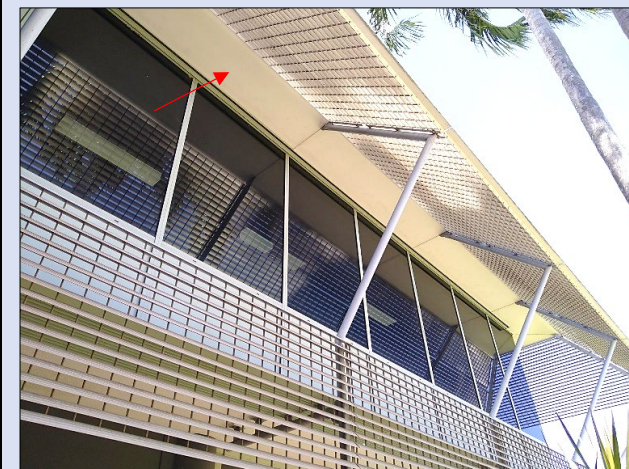
Sequence No:	2	Elevation:	Roof Level
Area:	External	Friability	
Location:	Front of building	Condition:	
Position	Eaves linings	Sealed:	
Material Type:	Fibre cement sheet	Traffic:	
Quantity:	100	Risk Likelihood:	
	Sq. M		
Sample No:	Same as 178949-001	Risk Consequence:	
Result:	No Asbestos Detected (NAD)	Risk Rating:

Eaves linings to northern, eastern and western elevations of the building, same as material in Sample 178949-001 collected on 03/05/2024.

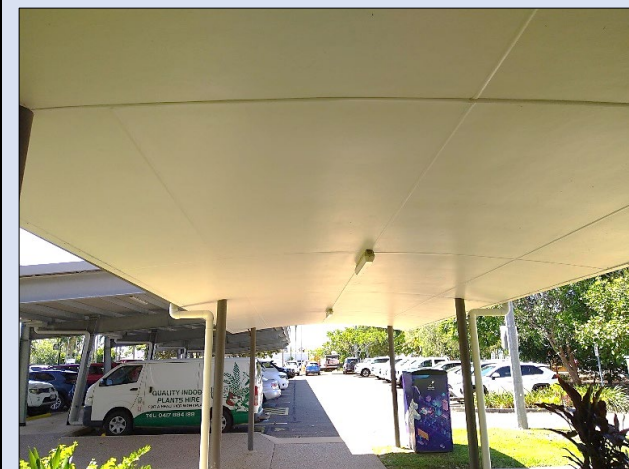
Sequence No:	3	Elevation:	Ground Floor
Area:	External	Friability	
Location:	Front and carpark entrances	Condition:	
Position	Soffit lining to covered walkways	Sealed:	
Material Type:	Fibre cement sheet	Traffic:	
Quantity:	60	Risk Likelihood:	
	Sq. M	Risk Consequence:	
Sample No:	NT0674-2	Risk Rating:	
Result:	No Asbestos Detected (NAD)

Sample collected on 10/09/2014.

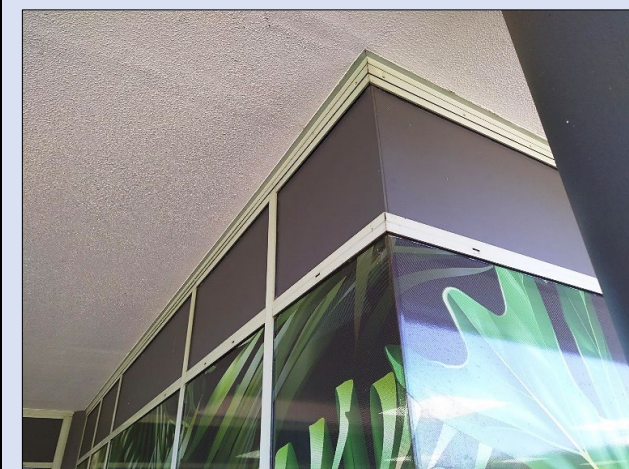
Sequence No:	4	Elevation:	Ground Floor
Area:	External	Friability	
Location:	Above windows	Condition:	
Position	Infill panels	Sealed:	
Material Type:	Fibre cement sheet	Traffic:	
Quantity:	120	Risk Likelihood:	
	Sq. M	Risk Consequence:	
Sample No:	NT0974-3	Risk Rating:	
Result:	No Asbestos Detected (NAD)

Above windows on northern, eastern and western elevations of the building. Sample collected on 10/09/2014

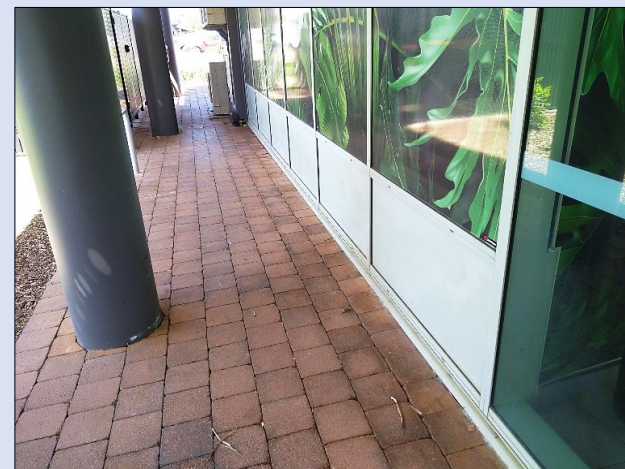
Below windows on northern, eastern and western elevations of the building. Same as sample for infill panels above windows collected on 10/09/2014.

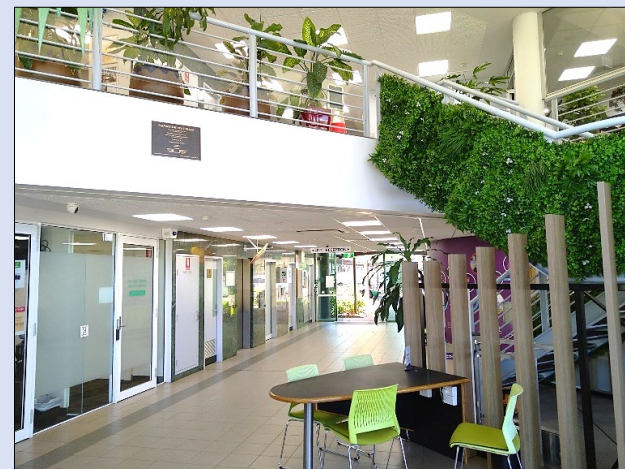
Sequence No:	6	Elevation:	Ground Floor
Area:	Internal	Friability	
Location:	Atrium	Condition:	
Position	Throughout	Enclosed	
Material Type:	No Suspect Materials Detected	Traffic:	
Quantity:	N/A	Risk Likelihood:	
	Sq. M		
Sample No:	N/A	Risk Consequence:	
Result:	No Suspect Materials Detected	Risk Rating:

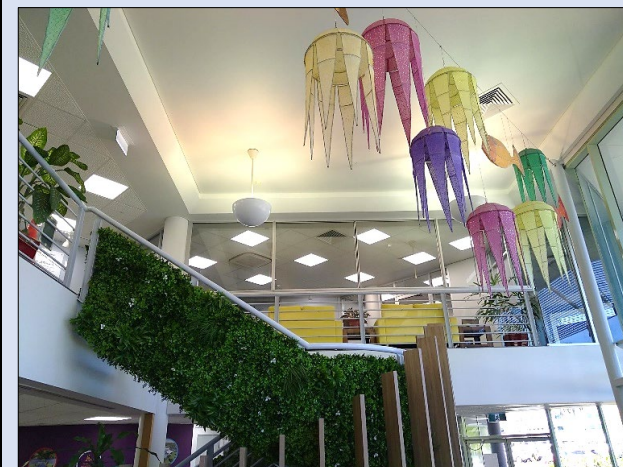
Sequence No:	7		Elevation:	Level 1
Area:	Internal		Friability	
Location:	Atrium		Condition:	
Position	Throughout		Sealed:	
Material Type:	No Suspect Materials Detected		Traffic:	
Quantity:	N/A	Sq. M	Risk Likelihood:	
Sample No:	N/A		Risk Consequence:	
Result:	No Suspect Materials Detected		Risk Rating:	
Comments:

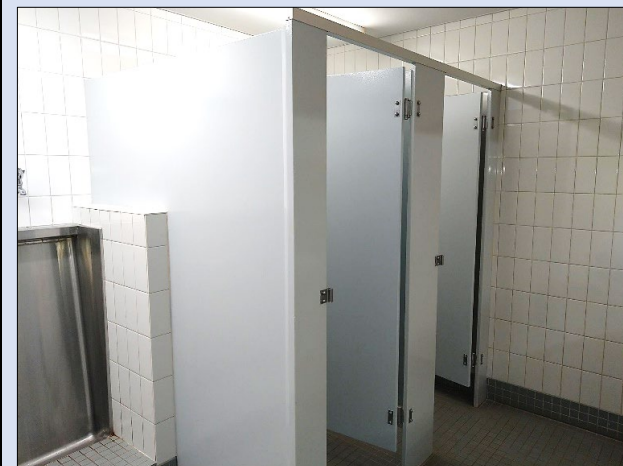
Sequence No:	8		Elevation:	Ground Floor
Area:	Internal		Friability	
Location:	Male and Female Ablutions		Condition:	
Position	Cubicle partitions		Enclosed	
Material Type:	Fibre cement sheet		Traffic:	
Quantity:	20	Sq. M	Risk Likelihood:	
Sample No:	NT0674-1		Risk Consequence:	
Result:	No Asbestos Detected (NAD)		Risk Rating:	
Comments:				
Sample collected on 10/09/2014

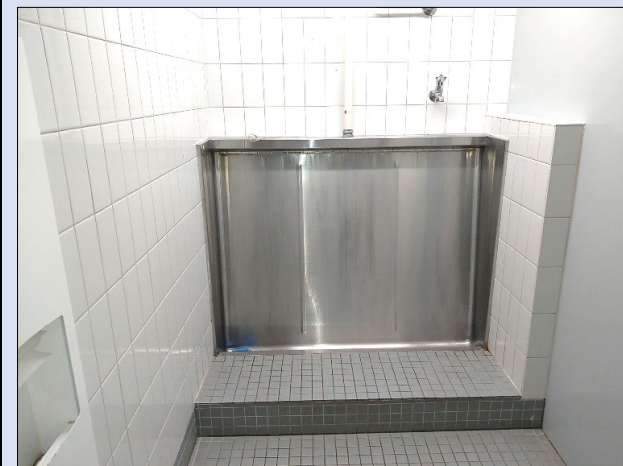
Older urinals are known to have a bituminastic sound deadening paint containing asbestos, and fibre cement sheet bracing panels at the rear that may also contain asbestos. It is unknown whether this urinal contains either and a sample cannot be collected without causing permanent damage to the facility. It should be presumed that asbestos is present and a more detailed inspection undertaken if major renovations that will disturb the urinal are planned.

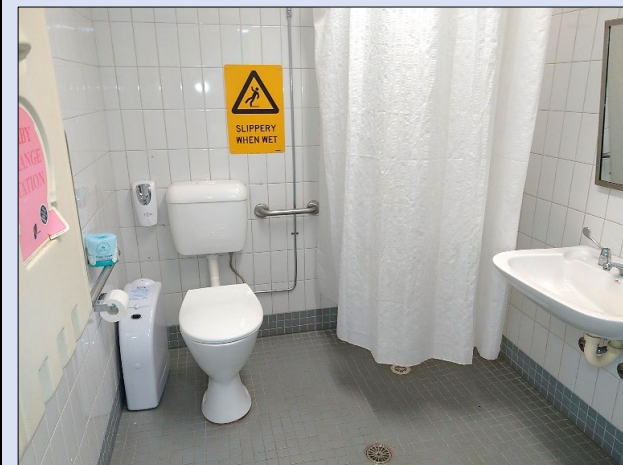
Sequence No:	10	Elevation:	Ground Floor
Area:	Internal	Friability	
Location:	Disabled access ablutions	Condition:	
Position	Ceilings and walls	Enclosed	
Material Type:	Concrete block walls & plasterboard ceiling	Traffic:	
Quantity:	N/A	Risk Likelihood:	
	Sq. M		
Sample No:	N/A	Risk Consequence:	
Result:	No Suspect Materials Detected	Risk Rating:

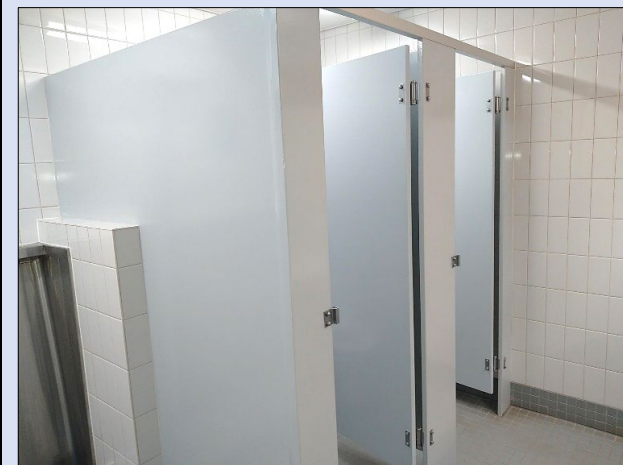
Sample collected on 10/09/2014

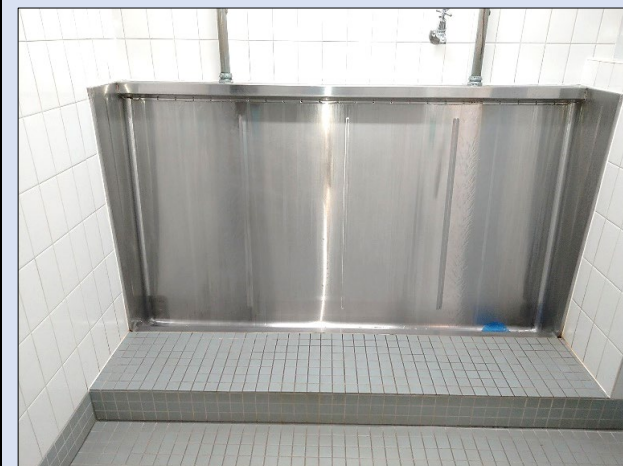
Sequence No:	24	Elevation:	Level 1
Area:	Internal	Friability	Unknown
Location:	Male ablutions	Condition:	Unknown
Position	Sound deadener and/or bracing to urinal	Enclosed	Yes
Material Type:	Bituminastic paint and/or fibre cement sheet	Traffic:	Medium
Quantity:	3	Risk Likelihood:	Unknown
	Sq. M		
Sample No:	N/A	Risk Consequence:	Unknown
Result:	Presumed	Risk Rating:	Unknown

Older urinals are known to have a bituminastic sound deadening paint containing asbestos, and fibre cement sheet bracing panels at the rear that may also contain asbestos. It is unknown whether this urinal contains either and a sample cannot be collected without causing permanent damage to the facility. It should be presumed that asbestos is present and a more detailed inspection undertaken if major renovations that will disturb the urinal are planned.
