# ASBESTOS REGISTER

**Saret Super Fund**

Barkley House 99 Paterson Street  
Tennant Creek NT

Date: 17 Feb 2015  
Register No: NT0702  
Register Version: NT0702/01  
Our Ref: J131287

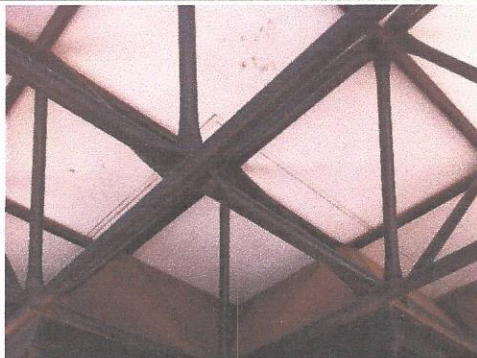
1. North eastern corner eaves.  <i>*Height restricted for sampling</i>	Area not accessed and not sampled. Based on findings in similar areas, it is highly likely fibre cement sheet material contains asbestos.		
Recommendation and Action			
Refer to Section 7.0: Policies & Management Procedures			
Situational Asbestos Risk Assessment:			
Friability	Condition	Signage	Risk Rating
Non Friable	Good	Install 4 small warning signs	Low

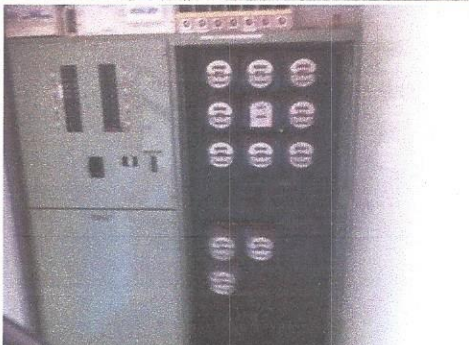
2. Electrical Backing board in main foyer.  <i>*not sampled due to Electrical hazard</i>	Area accessed but not sampled. Based on findings in similar areas, it is highly likely to contain asbestos.		
<b>Recommendation and Action</b>			
Refer to Section 7.0: Policies & Management Procedures			
<b>Situational Asbestos Risk Assessment:</b>			
Friability	Condition	Signage	Risk Rating
Non Friable	Good	Warning signs in place	Low
