ASBESTOS REGISTER

NO. NT0686d

RCG House, 83-85 Smith St, Darwin

December 2014

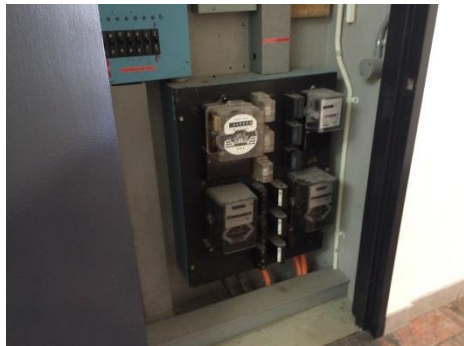
1. Electrical switchboard cupboard: backing board (1m ²)	Area accessed but not sampled. Based on findings in similar areas, it is highly likely to contain asbestos.		
Recommendation and Action			
Refer to Section 7.0: Policies & Management Procedures			
Situational Asbestos Risk Assessment:			
Friability	Condition	Signage	Risk Rating
Non-friable	Stable	Installed 1 small warning signs	Low

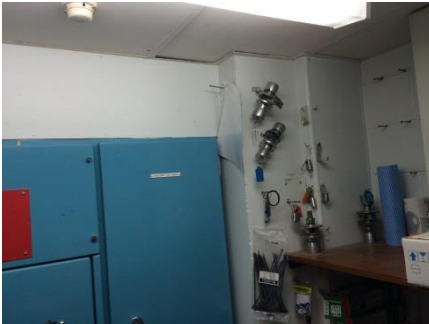
2. Lining to maintenance cupboard	Fibre cement sheet material containing white (Chrysotile) asbestos (sample no.1)		
Recommendation and Action			
Refer to Section 7.0: Policies & Management Procedures			
Situational Asbestos Risk Assessment:			
Friability	Condition	Signage	Risk Rating
Non-friable	Stable	Installed 1 small warning signs	Low

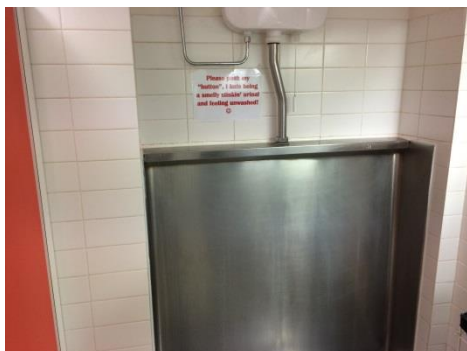
3. Sealant to urinal in male toilet (1.5m ²)	Area not accessed or sampled. Based on past experience in similar areas, asbestos in some form may exist. It is recommended that if work is contemplated in this area, due care and diligence should be exercised.		
Recommendation and Action			
Refer to Section 7.0: Policies & Management Procedures			
Situational Asbestos Risk Assessment:			
Friability	Condition	Signage	Risk Rating
Non-friable	Stable	Installed 1 small warning signs	Low

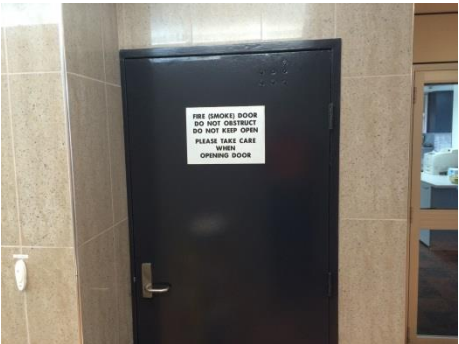
4. Fire door	Fibre cement sheet material containing white (Chrysotile) and grey/brown (Amosite) asbestos (sample no.2)		
Recommendation and Action			
Refer to Section 7.0: Policies & Management Procedures			
Situational Asbestos Risk Assessment:			
Friability	Condition	Signage	Risk Rating
Friable when exposed	Stable	Installed 1 small warning signs	Medium

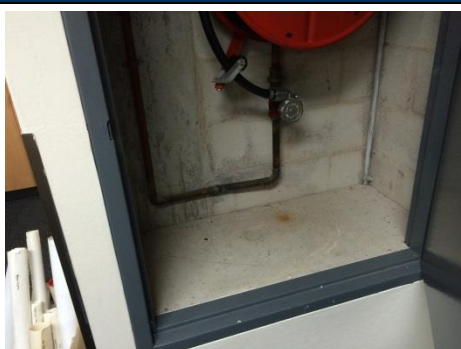
5. Lining to base of fire door cupboard	Fibre cement sheet material containing white (Chrysotile) asbestos (sample no. 4)		
Recommendation and Action			
Refer to Section 7.0: Policies & Management Procedures			
Situational Asbestos Risk Assessment:			
Friability	Condition	Signage	Risk Rating
Non-friable	Stable	Installed 1 small warning signs	Low

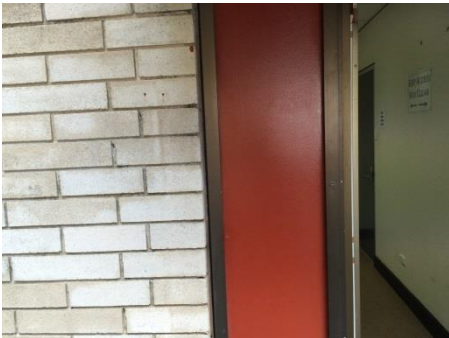
6. Vertical infill panel, south side (painted red) (x4)	Fibre cement sheet material containing white (Chrysotile) asbestos (sample no.5)		
Recommendation and Action			
Refer to Section 7.0: Policies & Management Procedures			
Situational Asbestos Risk Assessment:			
Friability	Condition	Signage	Risk Rating
Non-friable	Stable	Installed 4 small warning signs	Low

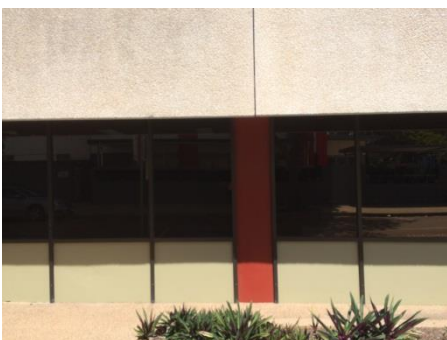
7. Vertical infill panels east side (painted red) (x5)	Fibre cement sheet material containing white (Chrysotile) asbestos (per sample no.5)		
Recommendation and Action			
Refer to Section 7.0: Policies & Management Procedures			
Situational Asbestos Risk Assessment:			
Friability	Condition	Signage	Risk Rating
Non-friable	Stable	Installed 5 small warning signs	Low

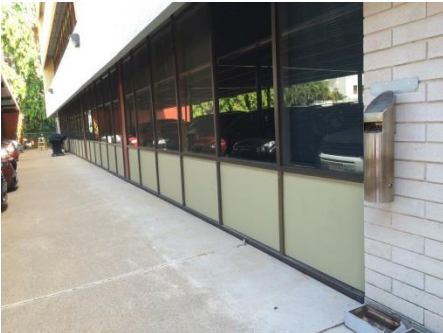
8. Infill panels above and below windows on south side	Fibre cement sheet material containing white (Chrysotile) asbestos (sample no.6)		
Recommendation and Action			
Refer to Section 7.0: Policies & Management Procedures			
Situational Asbestos Risk Assessment:			
Friability	Condition	Signage	Risk Rating
Non-friable	Stable	Installed 10 small plastic warning signs	Low

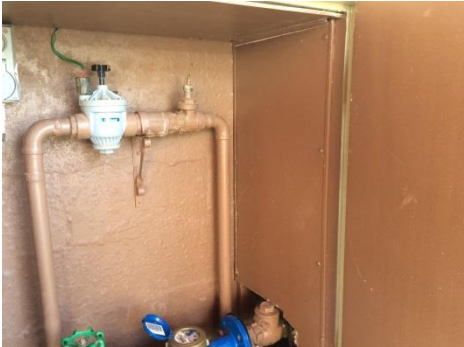
9. Lining to water metre cupboard south side of building	Fibre cement sheet material containing white (Chrysotile) asbestos (sample no.7)		
Recommendation and Action			
Refer to Section 7.0: Policies & Management Procedures			
Situational Asbestos Risk Assessment:			
Friability	Condition	Signage	Risk Rating
Non-friable	Stable	Installed 1 small warning signs	Low

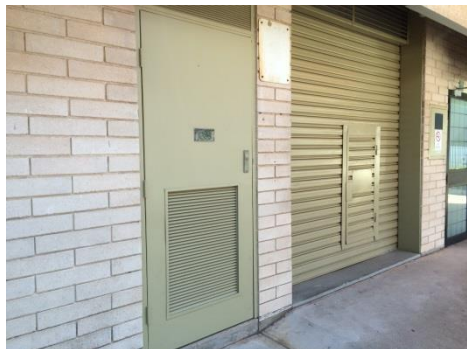
10. PAWA Transformer room	Area not accessed and not sampled. Based on findings in similar areas, it is highly likely to contain asbestos.		
Recommendation and Action			
Refer to Section 7.0: Policies & Management Procedures			
Situational Asbestos Risk Assessment:			
Friability	Condition	Signage	Risk Rating
Non-friable	Unknown	Installed 1 small warning signs	Low

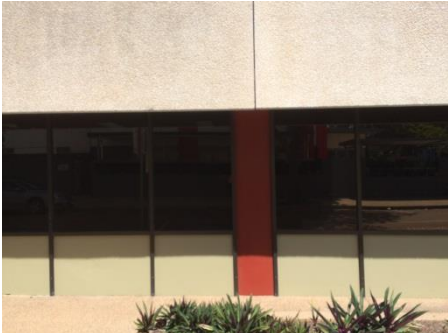
11. Vertical infill panels east side (painted red) (x5)	Fibre cement sheet material containing white (Chrysotile) asbestos (per sample no.5)		
Recommendation and Action			
Refer to Section 7.0: Policies & Management Procedures			
Situational Asbestos Risk Assessment:			
Friability	Condition	Signage	Risk Rating
Non-friable	Stable	Installed 5 small plastic warning signs	Low

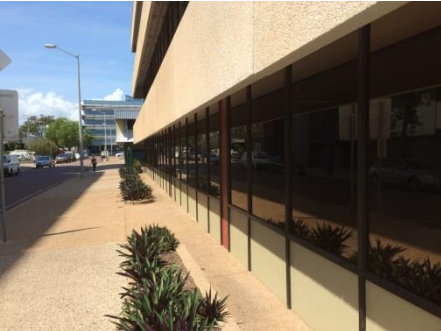
12. Infill panels above and below east side (28m ²)	Fibre cement sheet material containing white (Chrysotile) asbestos (sample no.6)		
Recommendation and Action			
Refer to Section 7.0: Policies & Management Procedures			
Situational Asbestos Risk Assessment:			
Friability	Condition	Signage	Risk Rating
Non-friable	Stable	Installed 10 small plastic warning signs	Low

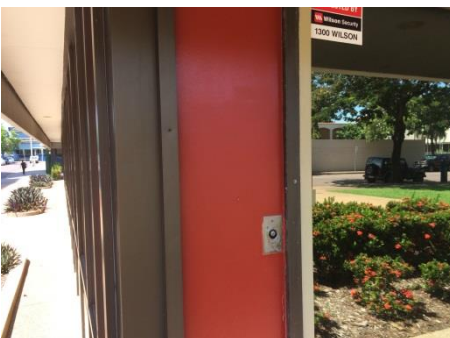
13. Vertical infill panel north side (painted red) (x6)	Fibre cement sheet material containing white (Chrysotile) asbestos (sample no.5)		
Recommendation and Action			
Refer to Section 7.0: Policies & Management Procedures			
Situational Asbestos Risk Assessment:			
Friability	Condition	Signage	Risk Rating
Non-friable	Stable	Installed 6 small plastic warning signs	Low

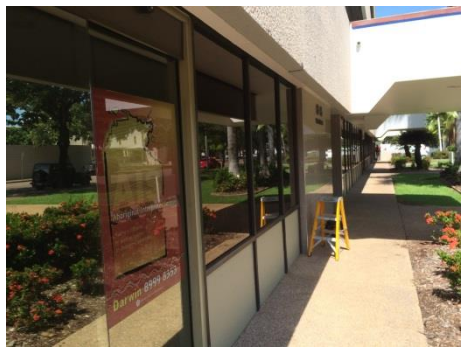
14. Infill panels above and below windows north side (29m ²)	Fibre cement sheet material containing white (Chrysotile) asbestos (per sample no.6)		
Recommendation and Action			
Refer to Section 7.0: Policies & Management Procedures			
Situational Asbestos Risk Assessment:			
Friability	Condition	Signage	Risk Rating
Non-friable	Stable	Installed 10 small plastic warning signs	Low

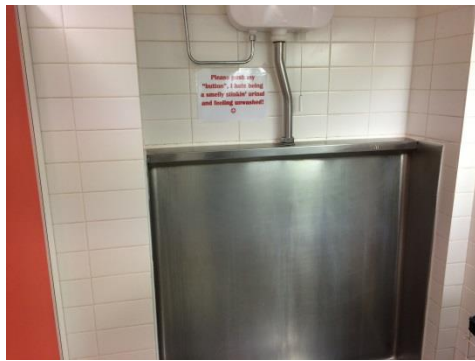
15. Sealant to urinal in male toilet (1.5m ²)	Area not accessed or sampled. Based on past experience in similar areas, asbestos in some form may exist. It is recommended that if work is contemplated in this area, due care and diligence should be exercised.		
Recommendation and Action			
Refer to Section 7.0: Policies & Management Procedures			
Situational Asbestos Risk Assessment:			
Friability	Condition	Signage	Risk Rating
Non-friable	Stable	Installed 1 small warning signs	Low

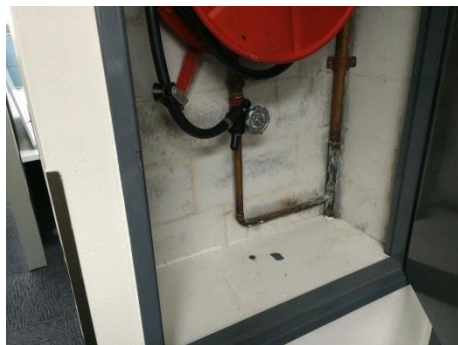
LEVEL 1, INTERNAL (Cont.)			
Location		Type of Material	
18. Lining to base of fire door cupboard		Fibre cement sheet material containing white (Chrysotile) asbestos (per sample no. 4)	
Recommendation and Action			
Refer to Section 7.0: Policies & Management Procedures

Situational Asbestos Risk Assessment:			
Friability	Condition	Signage	Risk Rating
Non-friable	Stable	Installed 6 small plastic warning signs	Low

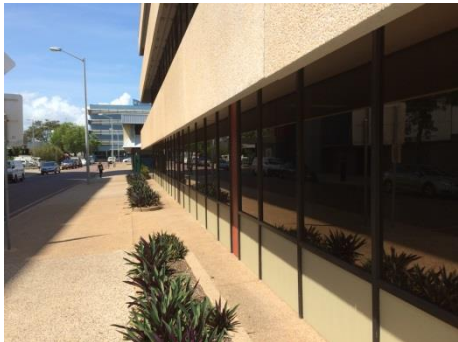
LEVEL 1, EXTERNAL			
Location		Type of Material	
19. Infill panels above and below, east side (28m ²)		Fibre cement sheet material containing white (Chrysotile) asbestos (per sample no.6)	
Recommendation and Action			
Refer to Section 7.0: Policies & Management Procedures

Situational Asbestos Risk Assessment:			
Friability	Condition	Signage	Risk Rating
Non-friable	Stable	Installed 10 small plastic warning signs	Low

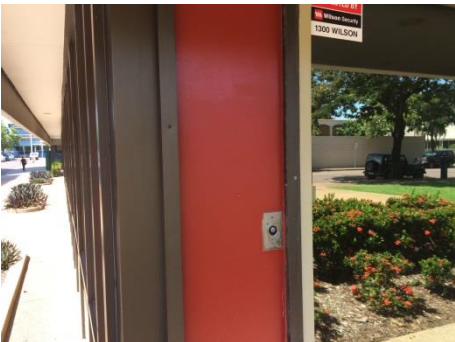
20. Vertical infill panel, north side (painted red) (x6)	Fibre cement sheet material containing white (Chrysotile) asbestos (per sample no. 5)		
Recommendation and Action			
Refer to Section 7.0: Policies & Management Procedures			
Situational Asbestos Risk Assessment:			
Friability	Condition	Signage	Risk Rating
Non-friable	Stable	Installed 6 small plastic warning signs	Low

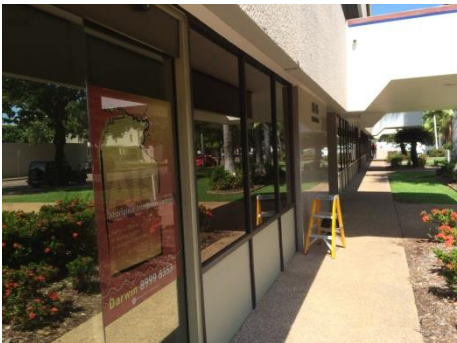
21. Infill panels above and below windows north side (35m ²)	Fibre cement sheet material containing white (Chrysotile) asbestos (per sample no.6)		
Recommendation and Action			
Refer to Section 7.0: Policies & Management Procedures			
Situational Asbestos Risk Assessment:			
Friability	Condition	Signage	Risk Rating
Non-friable	Stable	Installed 10 small plastic warning signs	Low

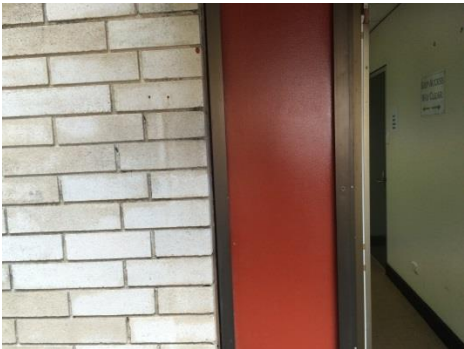
22. Vertical infill panels south side (painted red) (x4)	Fibre cement sheet material containing white (Chrysotile) asbestos (per sample no.5)		
Recommendation and Action			
Refer to Section 7.0: Policies & Management Procedures			
Situational Asbestos Risk Assessment:			
Friability	Condition	Signage	Risk Rating
Non-friable	Stable	Installed 4 small plastic warning signs	Low

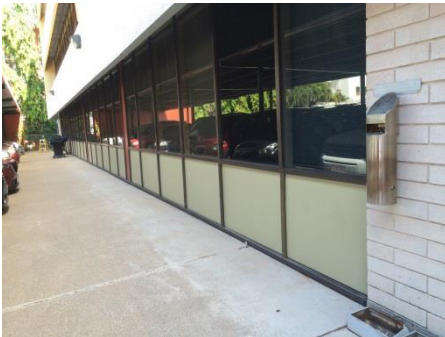
23. Infill panels above and below windows on south side	Fibre cement sheet material containing white (Chrysotile) asbestos (per sample no.6)		
Recommendation and Action			
Refer to Section 7.0: Policies & Management Procedures			
Situational Asbestos Risk Assessment:			
Friability	Condition	Signage	Risk Rating
Non-friable	Stable	Installed 2 small plastic warning signs	Low

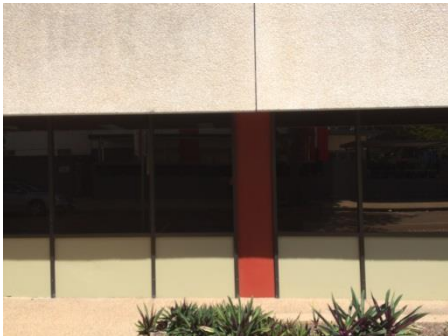
LEVEL 1, EXTERNAL (Cont.)			
Location		Type of Material	
24. Vertical infill panels east side (painted red) (x5)		Fibre cement sheet material containing white (Chrysotile) asbestos (per sample no.5)	
Recommendation and Action			
Refer to Section 7.0: Policies & Management Procedures

Situational Asbestos Risk Assessment:			
Friability	Condition	Signage	Risk Rating
Non-friable	Stable	Installed 5 small plastic warning signs	Low

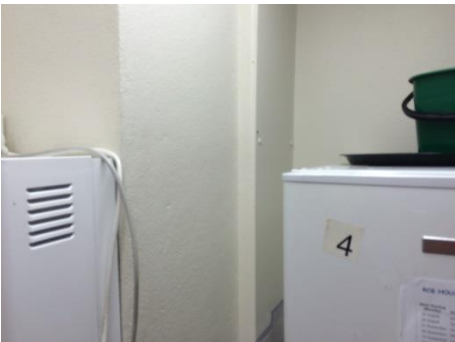
26. Infill panels in kitchen (1m ²)	Fibre cement sheet material containing white (Chrysotile) asbestos (per sample no.1)		
Recommendation and Action			
Refer to Section 7.0: Policies & Management Procedures			
Situational Asbestos Risk Assessment:			
Friability	Condition	Signage	Risk Rating
Non-friable	Stable	Installed 2 small warning signs	Low
