## ASBESTOS REGISTER No. NT0578

**ANANGU HOUSE  
44 BATH STREET  
ALICE SPRINGS NT**

Date: August 2013  
Register No: NT0578  
Register Version: V01  
Our Ref: DK/sk

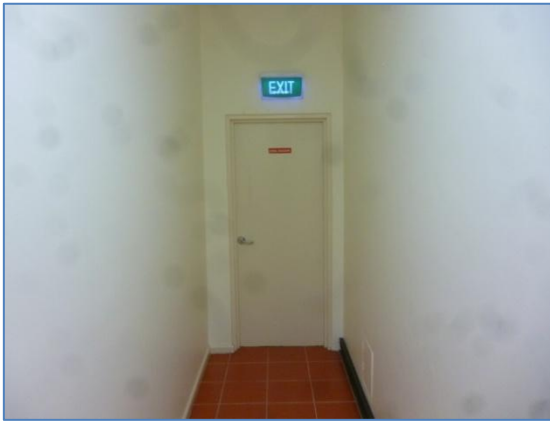
Location	Type of Material		
1. G6 – Rear Fire Escape door. Tagged “Fire Control” 198? (2m <sup>2</sup> )	Not accessed or sampled. Based on past experiences in similar areas, asbestos in some form may exist. It is recommended that if work is contemplated in this area, due care & diligence should be exercised

<b>Recommendation and Action</b>			
Refer to Asbestos Management Plan & Section 7.0: Policies and Recommendations			
<b>Situational Asbestos Risk Assessment:</b>			
Friability	Condition	Signage	Risk Rating
Friable when exposed	Stable	Install 2 small warning signs	Low

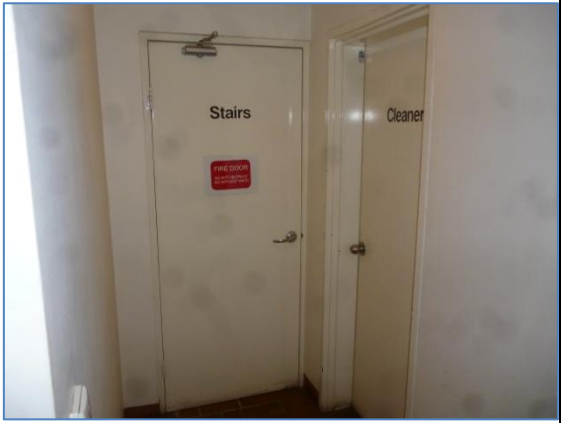
<b>GROUND FLOOR – Internal (cont'd)</b>			
<b>Location</b>	<b>Type of Material</b>		
2. Fire door in Common area (1m <sup>2</sup> )	Not accessed or sampled. Based on past experiences in similar areas, asbestos in some form may exist. It is recommended that if work is contemplated in this area, due care & diligence should be exercised

<b>Recommendation and Action</b>			
Refer to Asbestos Management Plan & Section 7.0: Policies and Recommendations			
<b>Situational Asbestos Risk Assessment:</b>			
<b>Friability</b>	<b>Condition</b>	<b>Signage</b>	<b>Risk Rating</b>
Friable when exposed	Stable	Install 2 small warning signs	Low

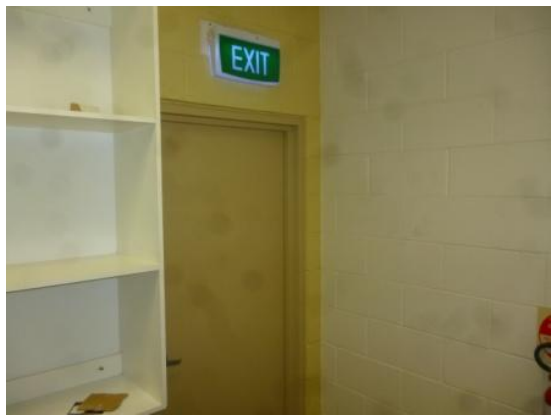
4. Fire escape door – Carpark access “Fire Control 198?” (1m <sup>2</sup> )	Not accessed or sampled. Based on past experiences in similar areas, asbestos in some form may exist. It is recommended that if work is contemplated in this area, due care & diligence should be exercised		
<b>Recommendation and Action</b>			
Refer to Asbestos Management Plan & Section 7.0: Policies and Recommendations			
<b>Situational Asbestos Risk Assessment:</b>			
<b>Friability</b>	<b>Condition</b>	<b>Signage</b>	<b>Risk Rating</b>
Non friable	Stable	Install 2 small warning signs	Low

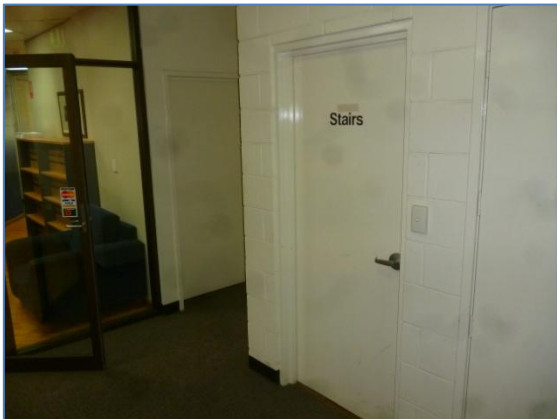
5. Fire door adjacent lift (1m <sup>2</sup> )	Not accessed or sampled. Based on past experiences in similar areas, asbestos in some form may exist. It is recommended that if work is contemplated in this area, due care & diligence should be exercised		
<b>Recommendation and Action</b>			
Refer to Asbestos Management Plan & Section 7.0: Policies and Recommendations			
<b>Situational Asbestos Risk Assessment:</b>			
<b>Friability</b>	<b>Condition</b>	<b>Signage</b>	<b>Risk Rating</b>
Friable when exposed	Stable	Install 2 small warning signs	Low

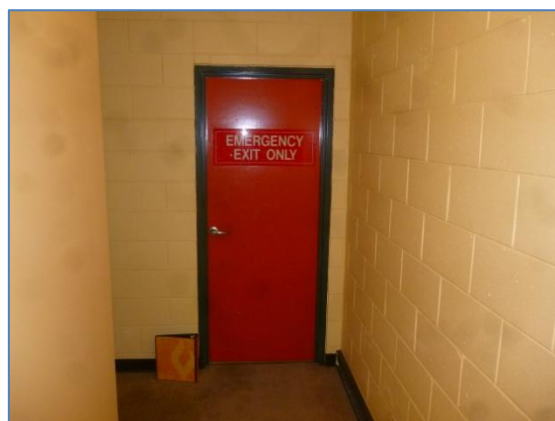
<b>INTERNAL</b>			
<b>Location</b>		<b>Type of Material</b>	
6. Health & Ageing – Fire door – Carpark access “Fire Control 198?” (1m <sup>2</sup> )		Not accessed or sampled. Based on past experiences in similar areas, asbestos in some form may exist. It is recommended that if work is contemplated in this area, due care & diligence should be exercised	
<b>Recommendation and Action</b>			
Refer to Asbestos Management Plan & Section 7.0: Policies and Recommendations			
<b>Situational Asbestos Risk Assessment:</b>			
<b>Friability</b>	<b>Condition</b>	<b>Signage</b>	<b>Risk Rating</b>
Friable when exposed	Stable	Install 2 small warning signs	Low

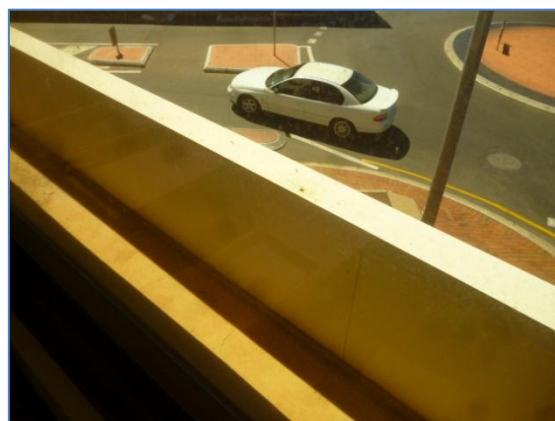
<b>EXTERNAL &amp; SECOND FLOOR</b>			
<b>Location</b>		<b>Type of Material</b>	
7. 1 <sup>st</sup> Floor – Balcony railing cladding (extent unknown)		Not accessed or sampled. Based on past experiences in similar areas, asbestos in some form may exist. It is recommended that if work is contemplated in this area, due care & diligence should be exercised	
<b>Recommendation and Action</b>			
Refer to Asbestos Management Plan & Section 7.0: Policies and Recommendations			
<b>Situational Asbestos Risk Assessment:</b>			
<b>Friability</b>	<b>Condition</b>	<b>Signage</b>	<b>Risk Rating</b>
Non friable	Stable	Install “General Awareness” warning signs	Low

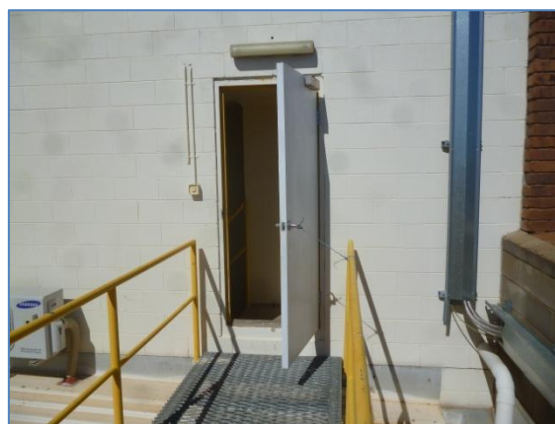
<b>EXTERNAL &amp; SECOND FLOOR (cont'd)</b>			
<b>Location</b>		<b>Type of Material</b>	
8. Roof – Fire door at top of stairs. Tagged “Fire Control”		Not accessed or sampled. Based on past experiences in similar areas, asbestos in some form may exist. It is recommended that if work is contemplated in this area, due care & diligence should be exercised	
<b>Recommendation and Action</b>			
Refer to Asbestos Management Plan & Section 7.0: Policies and Recommendations			
<b>Situational Asbestos Risk Assessment:</b>			
<b>Friability</b>	<b>Condition</b>	<b>Signage</b>	<b>Risk Rating</b>
Friable when exposed	Stable	Install 2 small warning signs	Low
