ASBESTOS CONTAINING BUILDING MATERIALS SURVEY REPORT

133 Mitchell Street
Larrakeyah NT 0820

Report Number 680.10041.00000.02 ASR 20130724

24 July 2013

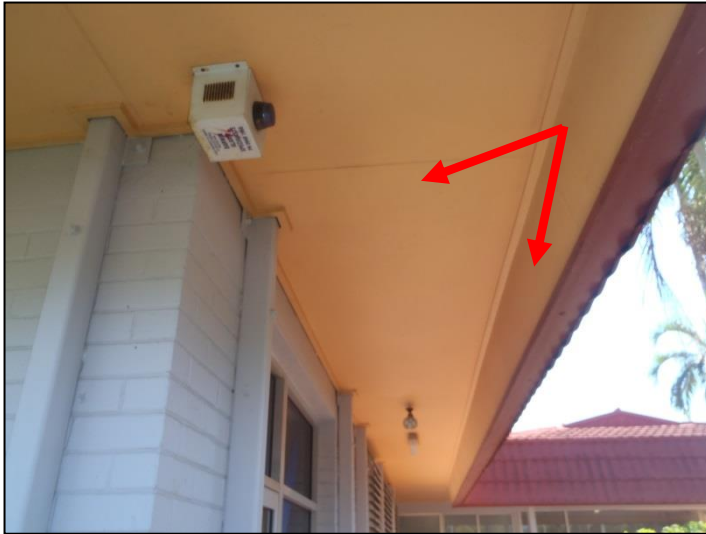
Photograph 1

Ground Floor, FCS Soffit linings including inside of fascia overhangs to all elevations (**asbestos containing**).

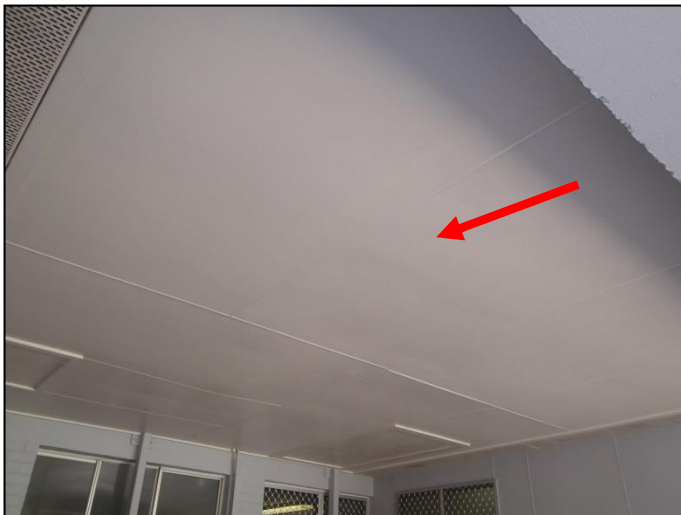
Photograph 2

Ground Floor, Ceiling Lining to garage to south of building (**assumed asbestos containing**).

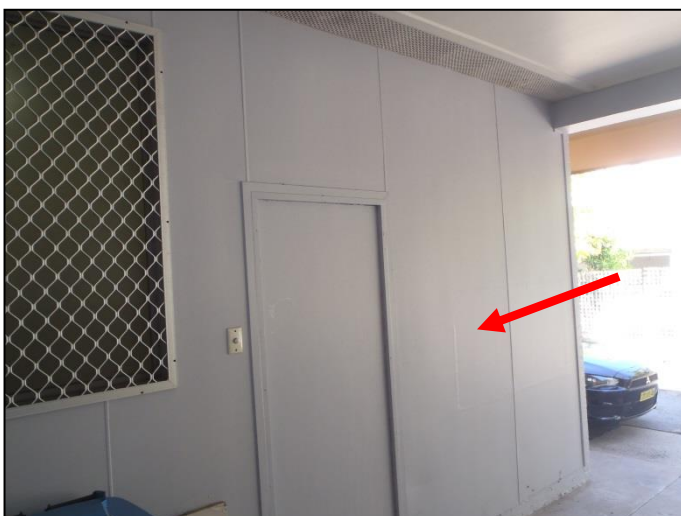
Photograph 3

Ground Floor, wall linings to east wall of garage alcove (**assumed asbestos containing**).

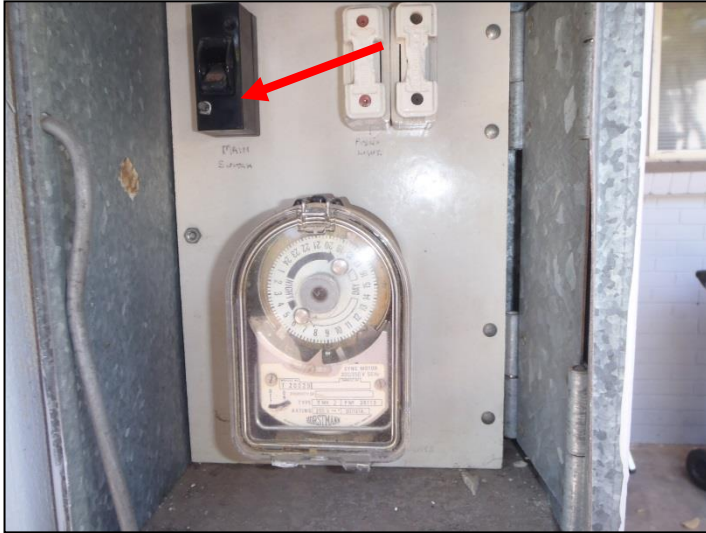
Photograph 4

Ground Floor, Assumed 'Bakelite' switches to timer switch to south elevation, west side of building	Assumed asbestos containing	4	<0.5 m ²	Non-friable	1	0	0	3	4-Very Low	C1, C2, C3, C4, C5, C12	Material requires labelling
Ground Floor, Assumed backing board to switchboard to south elevation, west side of building	Assumed asbestos containing	5	0.5 m ²	Non-friable	1	0	0	3	4-Very Low	C1, C2, C3, C4, C5, C12	Material requires labelling

Ground Floor, Assumed 'Bakelite' switches to timer switch to south elevation, west side of building (**assumed asbestos containing**).

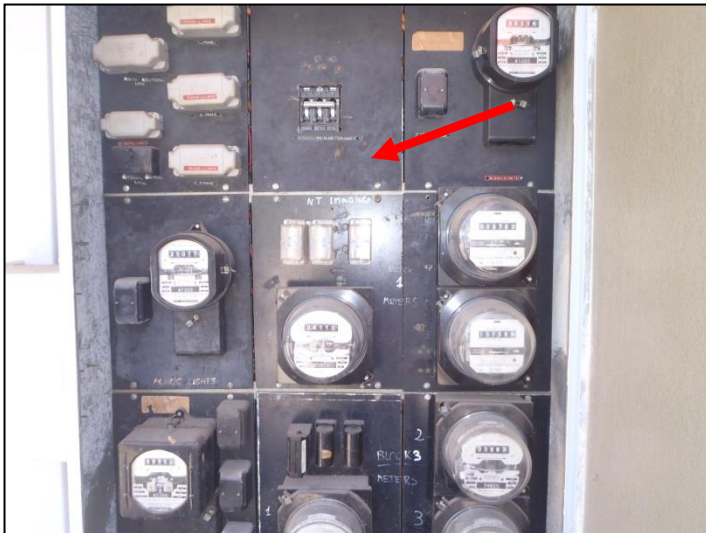
Photograph 5

Ground Floor, Assumed backing board to switchboard to south elevation, west side of building (**assumed asbestos containing**).
