ASBESTOS REGISTER

NO. NT0686b

Darwin Plaza, 41 The Mall, Smith Street,
Darwin

December 2014
J130279

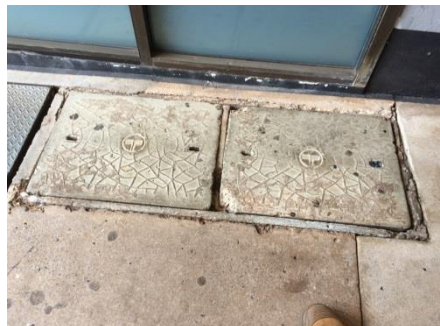
1. Lining to Telstra pit outside rear entrance to building	Area accessed but not sampled. Based on findings in similar areas, it is highly likely to contain asbestos.		
Recommendation and Action			
Refer to Section 7.0: Policies & Management Procedures			
Situational Asbestos Risk Assessment:			
Friability	Condition	Signage	Risk Rating
Non-friable	Some damage	Installed 1 small plastic warning sign	Low

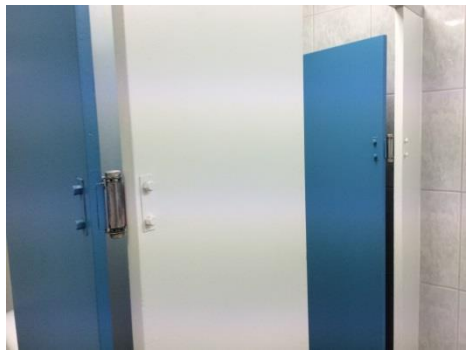
2. Cubicle partitions to male toilets in common area	Fibre cement sheet material containing White(Chrysotile) asbestos (sample no. 2-2)		
Recommendation and Action			
Refer to Section 7.0: Policies & Management Procedures			
Situational Asbestos Risk Assessment:			
Friability	Condition	Signage	Risk Rating
Non-friable	Stable	Installed 1 small warning signs	Low

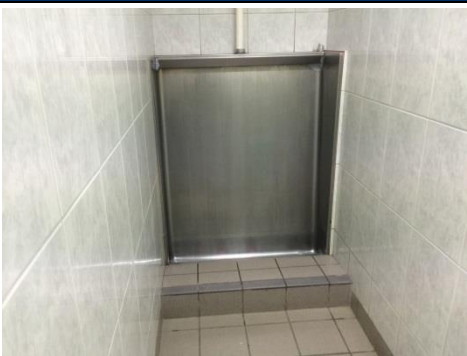
3. Sound dampener to male toilet urinal	Area accessed but not sampled. Based on findings in similar areas, it is highly likely to contain asbestos.	
Recommendation and Action		
Refer to Section 7.0: Policies & Management Procedures

Friability	Condition	Signage	Risk Rating
Non-friable	Stable	nil	Low

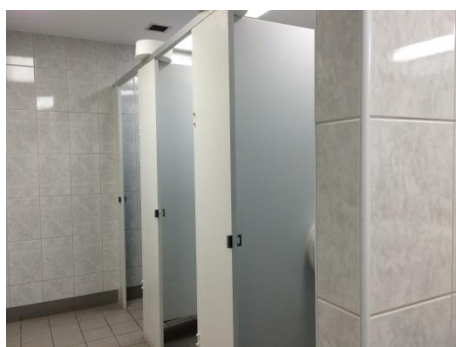
4. Cubicle partitions to female toilets in common area	Fibre cement sheet material containing White(Chrysotile) asbestos (per sample no. 2-2)	
Recommendation and Action		
Refer to Section 7.0: Policies & Management Procedures

Friability	Condition	Signage	Risk Rating
Non-friable	Stable	Installed 1 small warning signs	Low

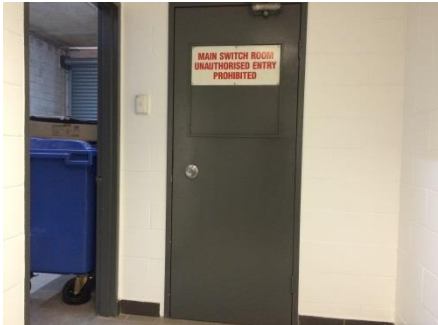
Location	Type of Material
5. Electrical switchboard in Main switch room <i>*No access this inspection</i>	Area not accessed or sampled. Based on past experience in similar areas, asbestos in some form may exist. It is recommended that if work is contemplated in this area, due care and diligence should be exercised.
Recommendation and Action	
Refer to Section 7.0: Policies & Management Procedures

Friability	Condition	Signage	Risk Rating
Non-friable	Stable	nil	Low

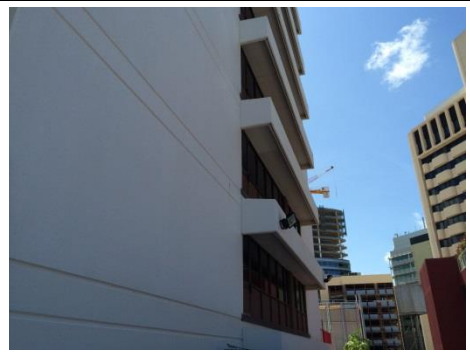
Location		Type of Material	
7. Eave lining to south side (10m ²)		Fibre cement sheet material containing White(Chrysotile) asbestos (per sample no. 1)	
Recommendation and Action			
Refer to Section 7.0: Policies & Management Procedures			
Situational Asbestos Risk Assessment:			
Friability	Condition	Signage	Risk Rating
Non-friable	Stable	Installed 6 small plastic warning signs	Low

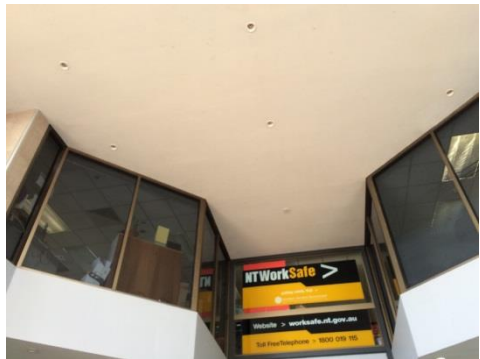
9. Ceiling and eave lining to front portico (30m ²)	Area not accessed or sampled. Based on past experience in similar areas, asbestos in some form may exist. It is recommended that if work is contemplated in this area, due care and diligence should be exercised.		
Recommendation and Action			
Refer to Section 7.0: Policies & Management Procedures			
Situational Asbestos Risk Assessment:			
Friability	Condition	Signage	Risk Rating
Non-friable	Stable	No access	Low

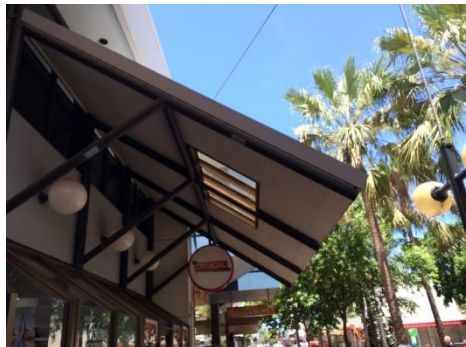
10. Front awnings to left and right elevations (30m ²)	Area not accessed or sampled. Based on past experience in similar areas, asbestos in some form may exist. It is recommended that if work is contemplated in this area, due care and diligence should be exercised.		
Recommendation and Action			
Refer to Section 7.0: Policies & Management Procedures			
Situational Asbestos Risk Assessment:			
Friability	Condition	Signage	Risk Rating
Non-friable	Stable	No access	Low

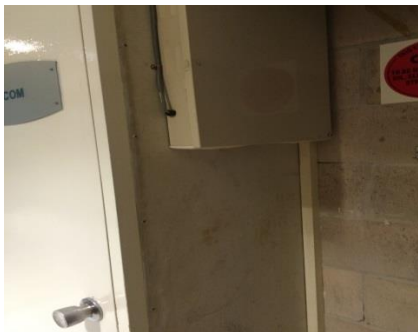
11. Lining to fire hose reel in front of elevators (1m ²)	Fibre cement sheet material containing White(Chrysotile) asbestos (sample no. 3a)		
Recommendation and Action			
Refer to Section 7.0: Policies & Management Procedures			
Situational Asbestos Risk Assessment:			
Friability	Condition	Signage	Risk Rating
Non-friable	Stable	Installed 1 small warning signs	Low
Location	Type of Material

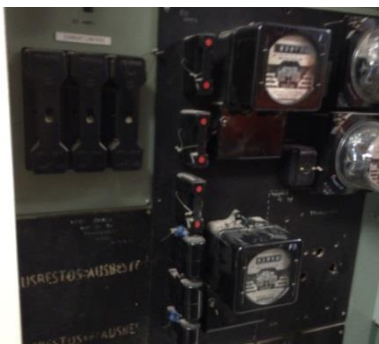
12. Electrical distribution boards in cupboard next to toilets: backing board (1.5m ²)	Area accessed but not sampled. Based on findings in similar areas, it is highly likely to contain asbestos.		
Recommendation and Action			
Refer to Section 7.0: Policies & Management Procedures			
Situational Asbestos Risk Assessment:			
Friability	Condition	Signage	Risk Rating
Non-friable	Stable	Installed 3 small warning signs	Low
Location	Type of Material

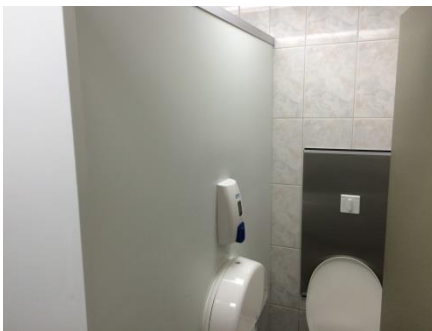
13. Partitions to male toilets (4.5m ²)	Fibre cement sheet material containing White(Chrysotile) asbestos (sample no. 4)		
Recommendation and Action			
Refer to Section 7.0: Policies & Management Procedures			
Situational Asbestos Risk Assessment:			
Friability	Condition	Signage	Risk Rating
Non-friable	Stable	Installed 3 small warning signs	Low

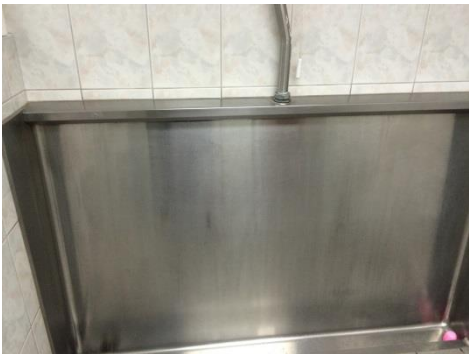
14. Sound dampener to male toilet urinal (2m ²)	Area not accessed or sampled. Based on past experience in similar areas, asbestos in some form may exist. It is recommended that if work is contemplated in this area, due care and diligence should be exercised.		
Recommendation and Action			
Refer to Section 7.0: Policies & Management Procedures			
Situational Asbestos Risk Assessment:			
Friability	Condition	Signage	Risk Rating
Non-friable	Stable	nil	Low

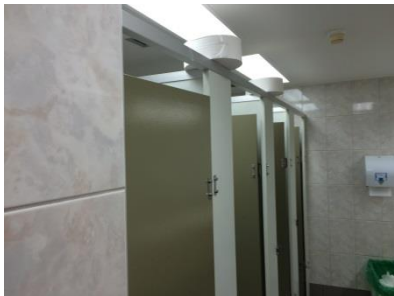
15. Partitions to female toilets (4.5m ²)	Fibre cement sheet material containing White(Chrysotile) asbestos (per sample no. 4)		
Recommendation and Action			
Refer to Section 7.0: Policies & Management Procedures			
Situational Asbestos Risk Assessment:			
Friability	Condition	Signage	Risk Rating
Non-friable	Stable	Installed 6 small warning signs	Low

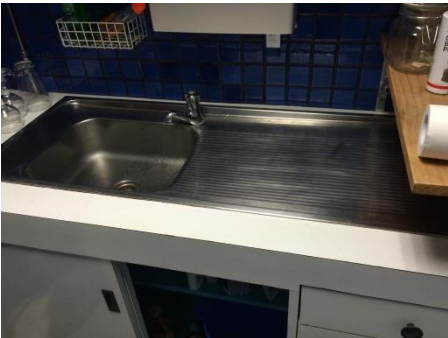
16. Sound dampener to small kitchen north eastern end, WorkSafe office	Insulation material containing White(Chrysotile) asbestos (sample no. 2)		
Recommendation and Action			
Refer to Section 7.0: Policies & Management Procedures			
Situational Asbestos Risk Assessment:			
Friability	Condition	Signage	Risk Rating
Non-friable	Stable	nil	Low

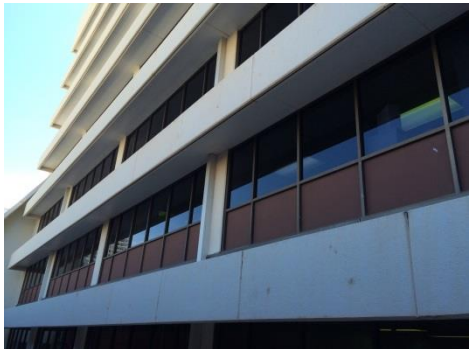
17. Eave lining to west side (40m ²)	Fibre cement sheet material containing White(Chrysotile) asbestos (per sample no. 1)		
Recommendation and Action			
Refer to Section 7.0: Policies & Management Procedures			
Situational Asbestos Risk Assessment:			
Friability	Condition	Signage	Risk Rating
Non-friable	Stable	No access	Low

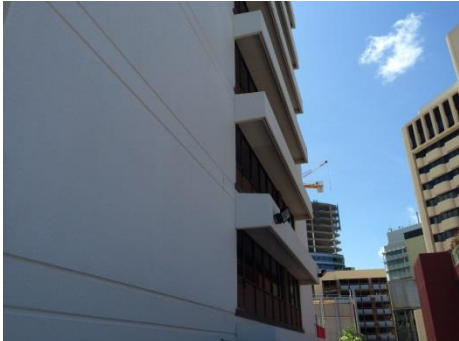
18. Eave lining to south side (10m ²)	Fibre cement sheet material containing White(Chrysotile) asbestos (per sample no. 1)		
Recommendation and Action			
Refer to Section 7.0: Policies & Management Procedures			
Situational Asbestos Risk Assessment:			
Friability	Condition	Signage	Risk Rating
Non-friable	Stable	No access	Low

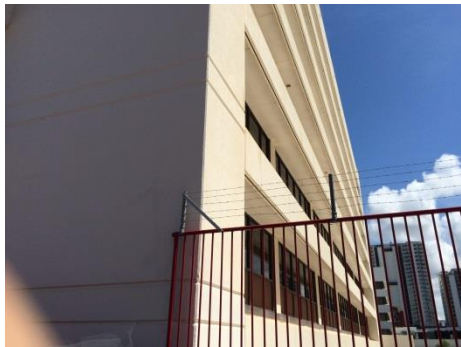
19. Eave lining to east side (10m ²)	Fibre cement sheet material containing White(Chrysotile) asbestos (per sample no. 1)		
Recommendation and Action			
Refer to Section 7.0: Policies & Management Procedures			
Situational Asbestos Risk Assessment:			
Friability	Condition	Signage	Risk Rating
Non-friable	Stable	No access	Low

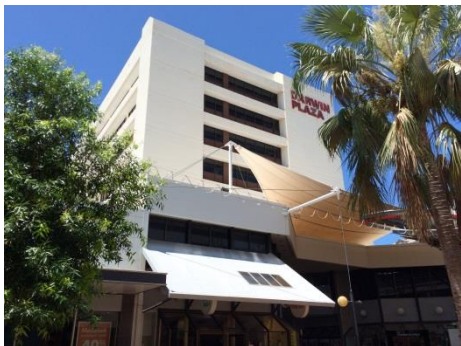
LEVEL 2, EXTERNAL			
Location		Type of Material	
20. Eave lining to north side (10m ²)		Fibre cement sheet material containing White(Chrysotile) asbestos (per sample no. 1)	
Recommendation and Action			
Refer to Section 7.0: Policies & Management Procedures

Situational Asbestos Risk Assessment:			
Friability	Condition	Signage	Risk Rating
Non-friable	Stable	No access	Low

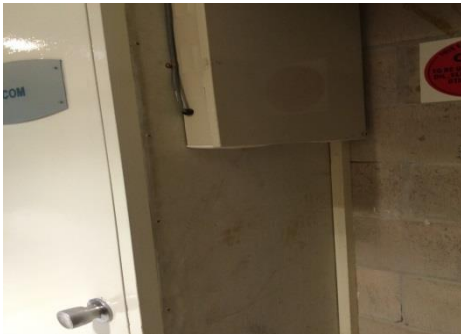
21. Lining to fire hose reel in front of elevators (1m ²)	Fibre cement sheet material containing White(Chrysotile) asbestos (per sample no. 3a)		
Recommendation and Action			
Refer to Section 7.0: Policies & Management Procedures			
Situational Asbestos Risk Assessment:			
Friability	Condition	Signage	Risk Rating
Non-friable	Stable	Installed 1 small warning signs	Low

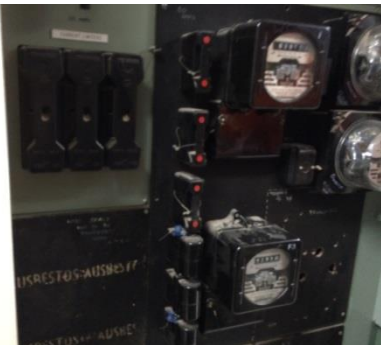
22. Electrical distribution boards in cupboard next to toilets (1.5m ²)	Area accessed but not sampled. Based on findings in similar areas, it is highly likely to contain asbestos.		
Recommendation and Action			
Refer to Section 7.0: Policies & Management Procedures			
Situational Asbestos Risk Assessment:			
Friability	Condition	Signage	Risk Rating
Non-friable	Stable	Installed 3 small warning signs	Low

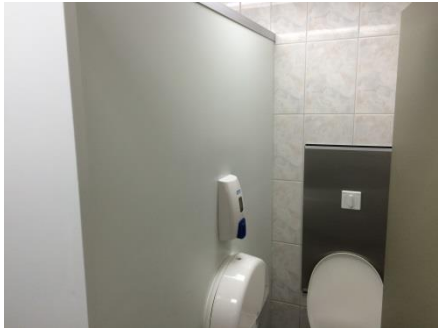
23. Partitions to male toilets (4.5m ²)	Fibre cement sheet material containing White(Chrysotile) asbestos (per sample no. 4)		
Recommendation and Action			
Refer to Section 7.0: Policies & Management Procedures			
Situational Asbestos Risk Assessment:			
Friability	Condition	Signage	Risk Rating
Non-friable	Stable	Installed 3 small warning signs	Low

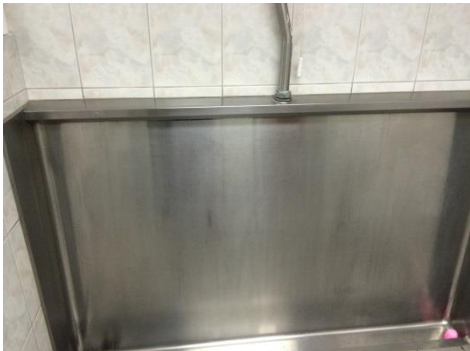
24. Sound dampener to male toilet urinal (2m ²)	Area not accessed or sampled. Based on past experience in similar areas, asbestos in some form may exist. It is recommended that if work is contemplated in this area, due care and diligence should be exercised.		
Recommendation and Action			
Refer to Section 7.0: Policies & Management Procedures			
Situational Asbestos Risk Assessment:			
Friability	Condition	Signage	Risk Rating
Non-friable	Stable	nil	Low

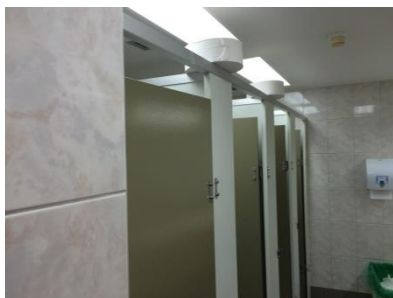
25. Partitions to female toilets (9m ²)	Fibre cement sheet material containing White(Chrysotile) asbestos (per sample no. 4)		
Recommendation and Action			
Refer to Section 7.0: Policies & Management Procedures			
Situational Asbestos Risk Assessment:			
Friability	Condition	Signage	Risk Rating
Non-friable	Stable	Installed 6 small warning signs	Low
LEVEL 2, INTERNAL (Cont.)			
Location	Type of Material

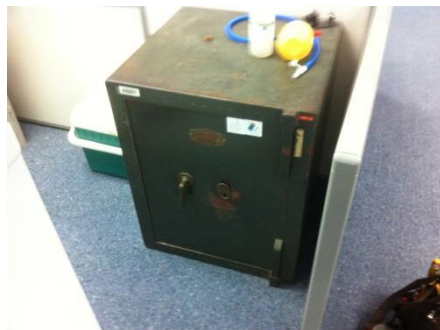
26. Insulation material to floor safe, 'JG Kelly'	Area not accessed or sampled. Based on past experience in similar areas, asbestos in some form may exist. It is recommended that if work is contemplated in this area, due care and diligence should be exercised.		
Recommendation and Action			
Refer to Section 7.0: Policies & Management Procedures			
Situational Asbestos Risk Assessment:			
Friability	Condition	Signage	Risk Rating
Friable when exposed	Stable	nil	Medium

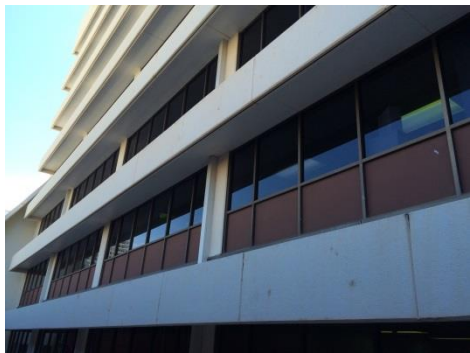
LEVEL 3, EXTERNAL			
Location		Type of Material	
27. Eave lining to west side (40m ²)		Fibre cement sheet material containing White(Chrysotile) asbestos (per sample no. 1)	
Recommendation and Action			
Refer to Section 7.0: Policies & Management Procedures			
Situational Asbestos Risk Assessment:			
Friability	Condition	Signage	Risk Rating
Non-friable	Stable	No access	Low

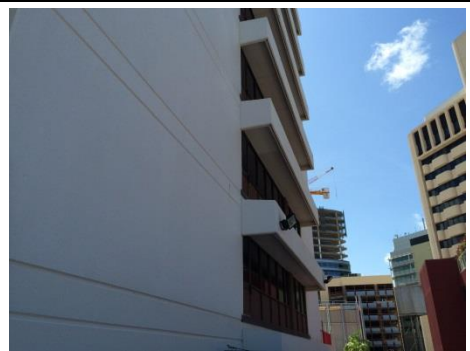
Location		Type of Material	
28. Eave lining to south side (10m ²)		Fibre cement sheet material containing White(Chrysotile) asbestos (per sample no. 1)	
Recommendation and Action			
Refer to Section 7.0: Policies & Management Procedures			
Situational Asbestos Risk Assessment:			
Friability	Condition	Signage	Risk Rating
Non-friable	Stable	No access	Low

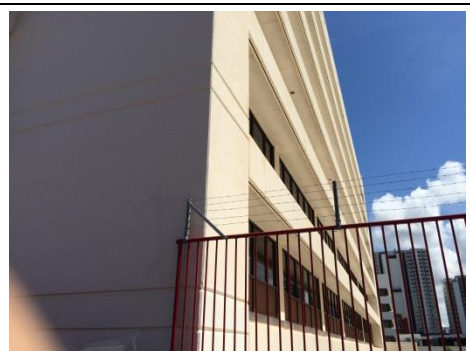
Location		Type of Material	
29. Eave lining to east side (10m ²)		Fibre cement sheet material containing White(Chrysotile) asbestos (per sample no. 1)	
Recommendation and Action			
Refer to Section 7.0: Policies & Management Procedures			
Situational Asbestos Risk Assessment:			
Friability	Condition	Signage	Risk Rating
Non-friable	Stable	No access	Low

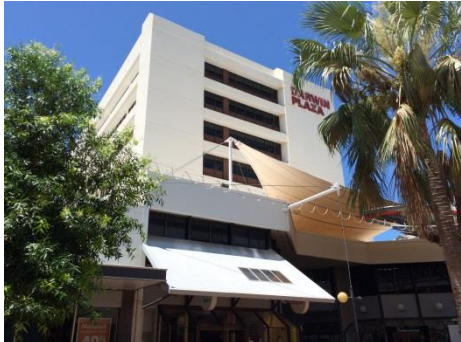
LEVEL 3, EXTERNAL (Cont.)			
Location		Type of Material	
30. Eave lining to north side (10m ²)		Fibre cement sheet material containing White(Chrysotile) asbestos (per sample no. 1)	
Recommendation and Action			
Refer to Section 7.0: Policies & Management Procedures

Situational Asbestos Risk Assessment:			
Friability	Condition	Signage	Risk Rating
Non-friable	Stable	No access	Low

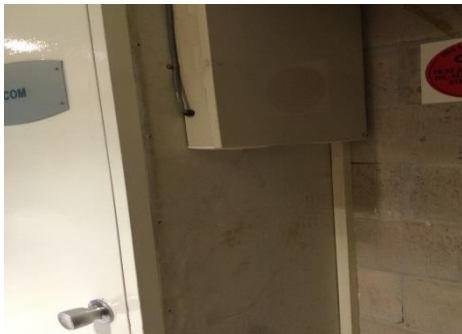
LEVEL 3, INTERNAL			
Location		Type of Material	
31. Lining to fire hose reel in front of elevators (1m ²)		Fibre cement sheet material containing White(Chrysotile) asbestos (per sample no. 3a)	
Recommendation and Action			
Refer to Section 7.0: Policies & Management Procedures

Situational Asbestos Risk Assessment:			
Friability	Condition	Signage	Risk Rating
Non-friable	Stable	Installed 2 small warning signs	Low

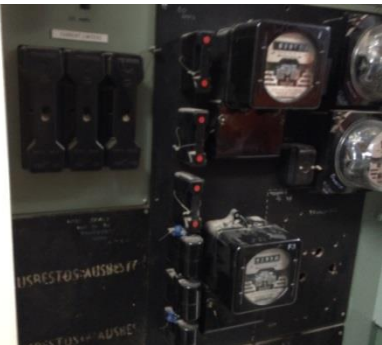
32. Electrical distribution boards in cupboard next to toilets (1.5m ²)	Area accessed but not sampled. Based on findings in similar areas, it is highly likely to contain asbestos.		
Recommendation and Action			
Refer to Section 7.0: Policies & Management Procedures			
Situational Asbestos Risk Assessment:			
Friability	Condition	Signage	Risk Rating
Non-friable	Stable	Installed 3 small warning signs	Low

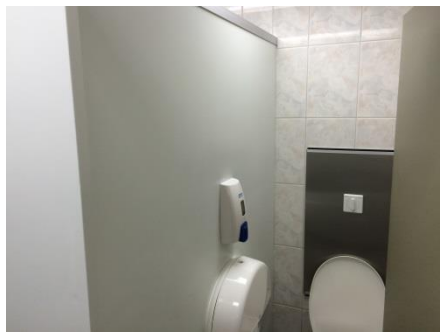
33. Partitions to male toilets (4.5m ²)	Fibre cement sheet material containing White(Chrysotile) asbestos (per sample no. 4)		
Recommendation and Action			
Refer to Section 7.0: Policies & Management Procedures			
Situational Asbestos Risk Assessment:			
Friability	Condition	Signage	Risk Rating
Non-friable	Stable	Installed 3 small warning signs	Low

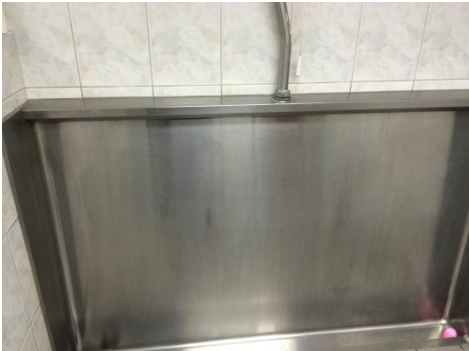
34. Sound dampener to male toilet urinal (2m ²)	Area not accessed or sampled. Based on past experience in similar areas, asbestos in some form may exist. It is recommended that if work is contemplated in this area, due care and diligence should be exercised.		
Recommendation and Action			
Refer to Section 7.0: Policies & Management Procedures			
Situational Asbestos Risk Assessment:			
Friability	Condition	Signage	Risk Rating
Non-friable	Stable	nil	Low

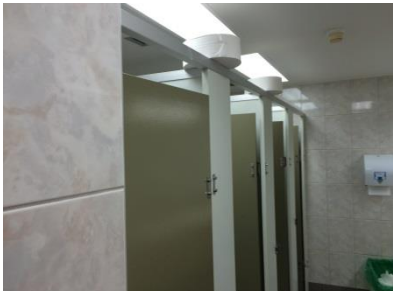
35. Partitions to female toilets (9m ²)	Fibre cement sheet material containing White(Chrysotile) asbestos (per sample no. 4)		
Recommendation and Action			
Refer to Section 7.0: Policies & Management Procedures			
Situational Asbestos Risk Assessment:			
Friability	Condition	Signage	Risk Rating
Non-friable	Stable	Installed 6 small warning signs	Low

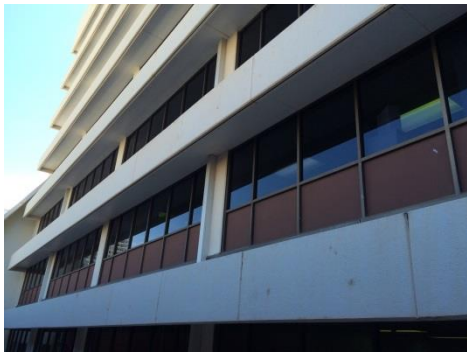
LEVEL 4, EXTERNAL			
Location		Type of Material	
36. Eave lining to west side (40m ²)		Fibre cement sheet material containing White(Chrysotile) asbestos (per sample no. 1)	
Recommendation and Action			
Refer to Section 7.0: Policies & Management Procedures			
Situational Asbestos Risk Assessment:			
Friability	Condition	Signage	Risk Rating
Non-friable	Stable	No access	Low

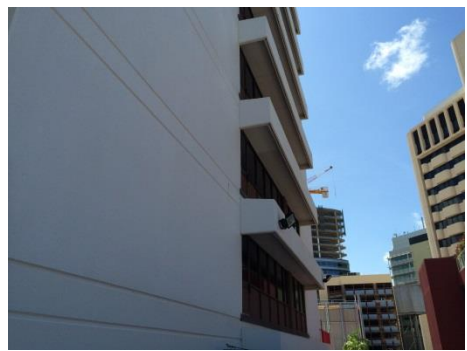
Location		Type of Material	
37. Eave lining to south side (10m ²)		Fibre cement sheet material containing White(Chrysotile) asbestos (per sample no. 1)	
Recommendation and Action			
Refer to Section 7.0: Policies & Management Procedures			
Situational Asbestos Risk Assessment:			
Friability	Condition	Signage	Risk Rating
Non-friable	Stable	No access	Low

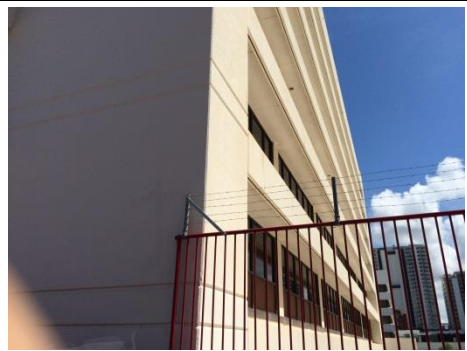
Location		Type of Material	
38. Eave lining to east side (10m ²)		Fibre cement sheet material containing White(Chrysotile) asbestos (per sample no. 1)	
Recommendation and Action			
Refer to Section 7.0: Policies & Management Procedures			
Situational Asbestos Risk Assessment:			
Friability	Condition	Signage	Risk Rating
Non-friable	Stable	No access	Low

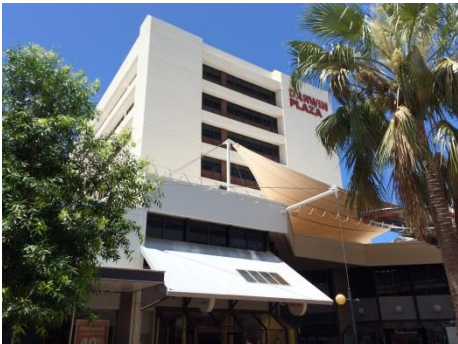
LEVEL 4, EXTERNAL (Cont.)			
Location		Type of Material	
39. Eave lining to north side (10m ²)		Fibre cement sheet material containing White(Chrysotile) asbestos (per sample no. 1)	
Recommendation and Action			
Refer to Section 7.0: Policies & Management Procedures			
Situational Asbestos Risk Assessment:			
Friability	Condition	Signage	Risk Rating
Non-friable	Stable	No access	Low

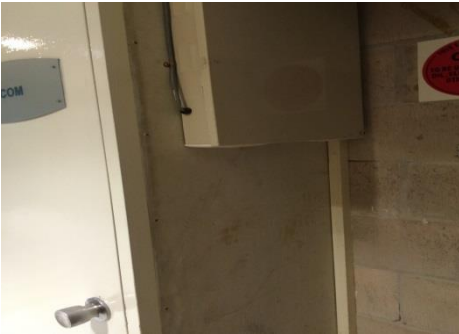
LEVEL 4, INTERNAL			
Location		Type of Material	
40. Lining to fire hose reel in front of elevators (1m ²)		Fibre cement sheet material containing White(Chrysotile) asbestos (per sample no. 3a)	
Recommendation and Action			
Refer to Section 7.0: Policies & Management Procedures

Situational Asbestos Risk Assessment:			
Friability	Condition	Signage	Risk Rating
Non-friable	Stable	Installed 2 small warning signs	Low

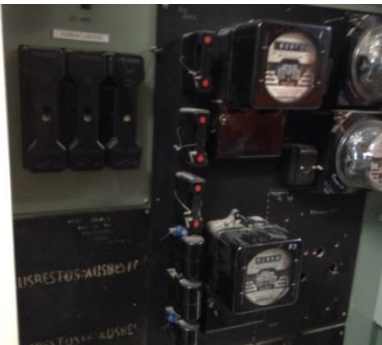
41. Electrical distribution boards in cupboard next to toilets (1.5m ²)	Area accessed but not sampled. Based on findings in similar areas, it is highly likely to contain asbestos.		
Recommendation and Action			
Refer to Section 7.0: Policies & Management Procedures			
Situational Asbestos Risk Assessment:			
Friability	Condition	Signage	Risk Rating
Non-friable	Stable	Installed 3 small warning signs	Low

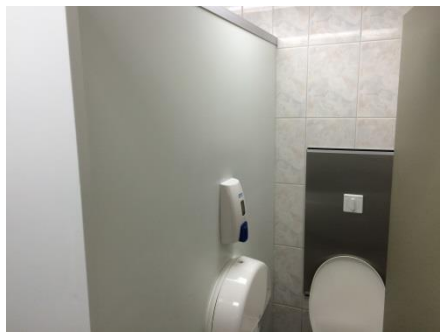
42. Partitions to male toilets (4.5m ²)	Fibre cement sheet material containing White(Chrysotile) asbestos (per sample no. 4)		
Recommendation and Action			
Refer to Section 7.0: Policies & Management Procedures			
Situational Asbestos Risk Assessment:			
Friability	Condition	Signage	Risk Rating
Non-friable	Stable	Installed 3 small warning signs	Low

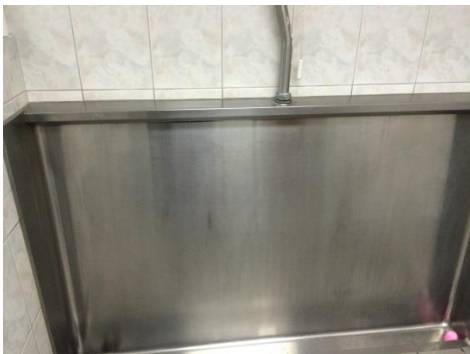
43. Sound dampener to male toilet urinal (2m ²)	Area not accessed or sampled. Based on past experience in similar areas, asbestos in some form may exist. It is recommended that if work is contemplated in this area, due care and diligence should be exercised.		
Recommendation and Action			
Refer to Section 7.0: Policies & Management Procedures			
Situational Asbestos Risk Assessment:			
Friability	Condition	Signage	Risk Rating
Non-friable	Stable	nil	Low

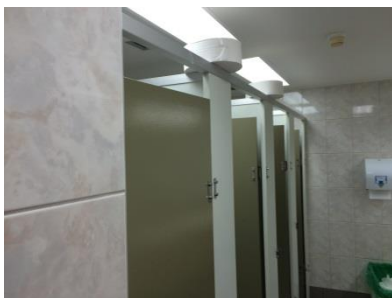
44. Partitions to female toilets (9m ²)	Fibre cement sheet material containing White(Chrysotile) asbestos (per sample no. 4)		
Recommendation and Action			
Refer to Section 7.0: Policies & Management Procedures			
Situational Asbestos Risk Assessment:			
Friability	Condition	Signage	Risk Rating
Non-friable	Stable	Installed 6 small warning signs	Low

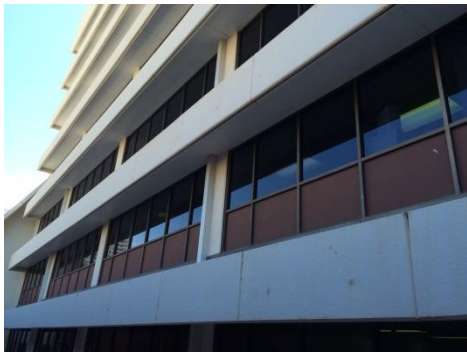
45. Eave lining to west side (40m ²)	Fibre cement sheet material containing White(Chrysotile) asbestos (per sample no. 1)		
Recommendation and Action			
Refer to Section 7.0: Policies & Management Procedures			
Situational Asbestos Risk Assessment:			
Friability	Condition	Signage	Risk Rating
Non-friable	Stable	No access	Low

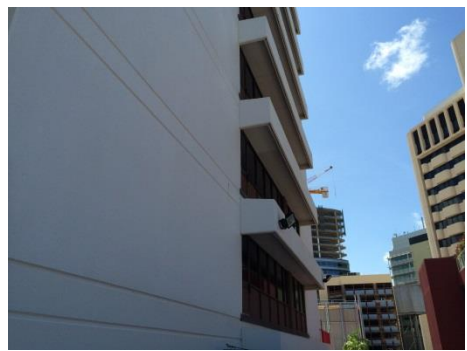
46. Eave lining to south side (10m ²)	Fibre cement sheet material containing White(Chrysotile) asbestos (per sample no. 1)		
Recommendation and Action			
Refer to Section 7.0: Policies & Management Procedures			
Situational Asbestos Risk Assessment:			
Friability	Condition	Signage	Risk Rating
Non-friable	Stable	No access	Low

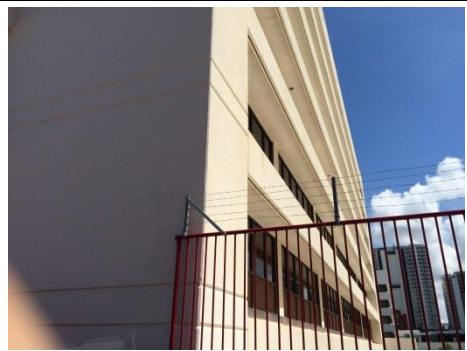
47. Eave lining to east side (10m ²)	Fibre cement sheet material containing White(Chrysotile) asbestos (per sample no. 1)		
Recommendation and Action			
Refer to Section 7.0: Policies & Management Procedures			
Situational Asbestos Risk Assessment:			
Friability	Condition	Signage	Risk Rating
Non-friable	Stable	No access	Low

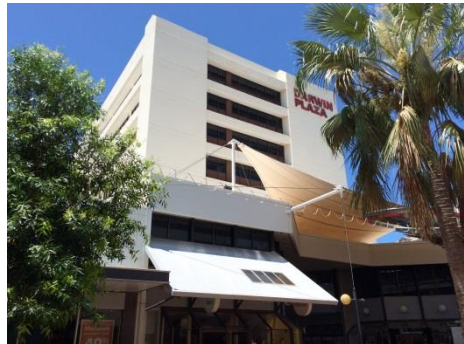
48. Eave lining to north side (10m ²)	Fibre cement sheet material containing White(Chrysotile) asbestos (per sample no. 1)		
Recommendation and Action			
Refer to Section 7.0: Policies & Management Procedures			
Situational Asbestos Risk Assessment:			
Friability	Condition	Signage	Risk Rating
Non-friable	Stable	No access	Low

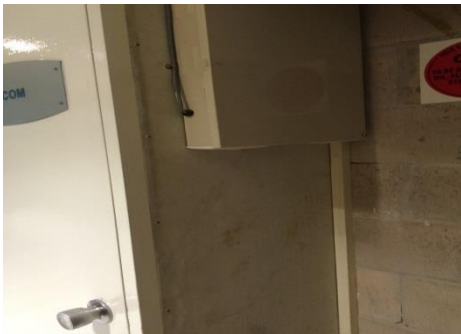
Recommendation and Action
Refer to Section 7.0: Policies & Management Procedures				
Situational Asbestos Risk Assessment:				
Friability		Condition	Signage	Risk Rating
Non-friable		Stable	Installed 2 small warning signs	Low

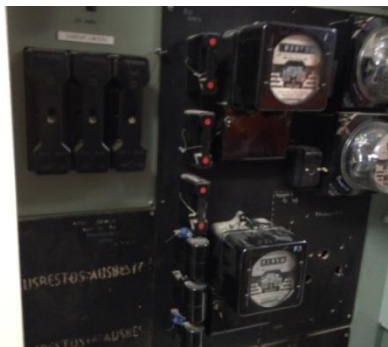
50. Electrical distribution boards in cupboard next to toilets (1.5m ²)	Area accessed but not sampled. Based on findings in similar areas, it is highly likely to contain asbestos.		
Recommendation and Action			
Refer to Section 7.0: Policies & Management Procedures			
Situational Asbestos Risk Assessment:			
Friability	Condition	Signage	Risk Rating
Non-friable	Stable	Installed 3 small warning signs	Low

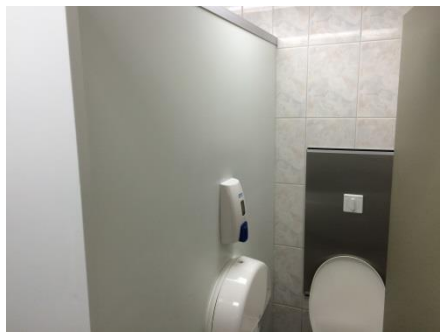
51. Partitions to male toilets (4.5m ²)	Fibre cement sheet material containing White(Chrysotile) asbestos (per sample no. 4)		
Recommendation and Action			
Refer to Section 7.0: Policies & Management Procedures			
Situational Asbestos Risk Assessment:			
Friability	Condition	Signage	Risk Rating
Non-friable	Stable	Installed 3 small warning signs	Low

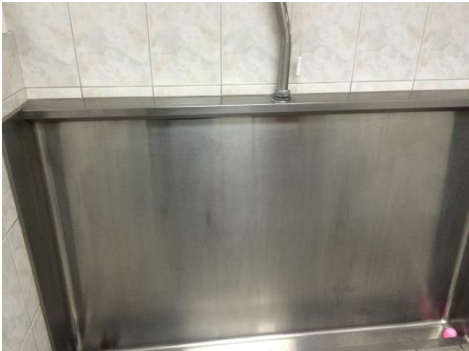
52. Sound dampener to male toilet urinal (2m ²)	Area not accessed or sampled. Based on past experience in similar areas, asbestos in some form may exist. It is recommended that if work is contemplated in this area, due care and diligence should be exercised.		
Recommendation and Action			
Refer to Section 7.0: Policies & Management Procedures			
Situational Asbestos Risk Assessment:			
Friability	Condition	Signage	Risk Rating
Non-friable	Stable	nil	Low

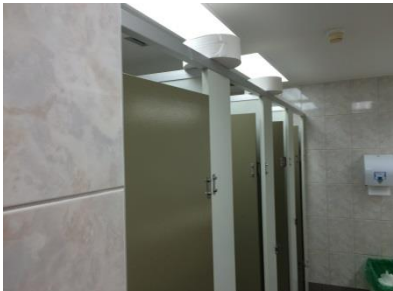
53. Partitions to female toilets (9m ²)	Fibre cement sheet material containing White(Chrysotile) asbestos (per sample no. 4)		
Recommendation and Action			
Refer to Section 7.0: Policies & Management Procedures			
Situational Asbestos Risk Assessment:			
Friability	Condition	Signage	Risk Rating
Non-friable	Stable	Installed 6 small warning signs	Low

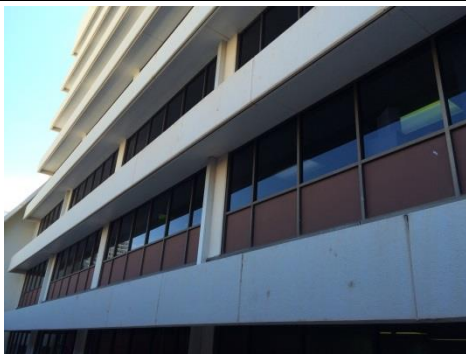
LEVEL 6, EXTERNAL			
Location		Type of Material	
54. Eave lining to west side (40m ²)		Fibre cement sheet material containing White(Chrysotile) asbestos (per sample no. 1)	
Recommendation and Action			
Refer to Section 7.0: Policies & Management Procedures			
Situational Asbestos Risk Assessment:			
Friability	Condition	Signage	Risk Rating
Non-friable	Stable	No access	Low

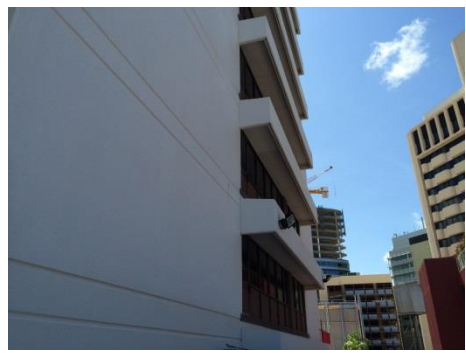
Location		Type of Material	
55. Eave lining to south side (10m ²)		Fibre cement sheet material containing White(Chrysotile) asbestos (per sample no. 1)	
Recommendation and Action			
Refer to Section 7.0: Policies & Management Procedures			
Situational Asbestos Risk Assessment:			
Friability	Condition	Signage	Risk Rating
Non-friable	Stable	No access	Low

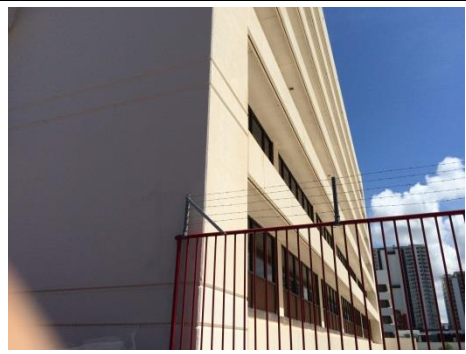
Location		Type of Material	
56. Eave lining to east side (10m ²)		Fibre cement sheet material containing White(Chrysotile) asbestos (per sample no. 1)	
Recommendation and Action			
Refer to Section 7.0: Policies & Management Procedures			
Situational Asbestos Risk Assessment:			
Friability	Condition	Signage	Risk Rating
Non-friable	Stable	No access	Low

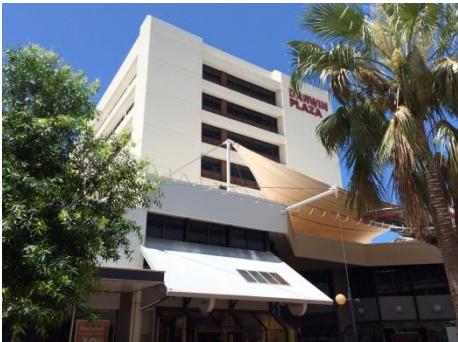
LEVEL 6, EXTERNAL (Cont.)			
Location		Type of Material	
57. Eave lining to north side (10m ²)		Fibre cement sheet material containing White(Chrysotile) asbestos (per sample no. 1)	
Recommendation and Action			
Refer to Section 7.0: Policies & Management Procedures			
Situational Asbestos Risk Assessment:			
Friability	Condition	Signage	Risk Rating
Non-friable	Stable	No access	Low

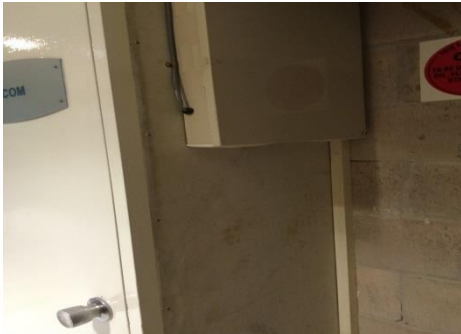
LEVEL 6, INTERNAL			
Location		Type of Material	
58. Lining to fire hose reel in front of elevators (1m ²)		Fibre cement sheet material containing White(Chrysotile) asbestos (per sample no. 3a)	
Recommendation and Action			
Refer to Section 7.0: Policies & Management Procedures

Situational Asbestos Risk Assessment:			
Friability	Condition	Signage	Risk Rating
Non-friable	Stable	Installed 2 small warning signs	Low

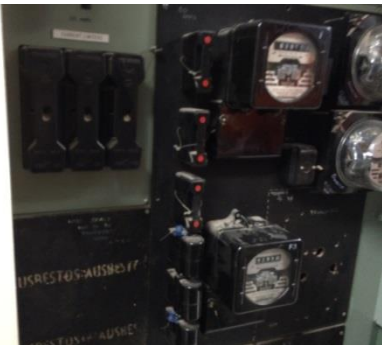
59. Electrical distribution boards in cupboard next to toilets (1.5m ²)	Area accessed but not sampled. Based on findings in similar areas, it is highly likely to contain asbestos.		
Recommendation and Action			
Refer to Section 7.0: Policies & Management Procedures			
Situational Asbestos Risk Assessment:			
Friability	Condition	Signage	Risk Rating
Non-friable	Stable	Installed 3 small warning signs	Low

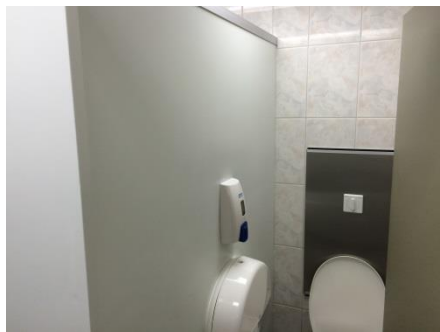
60. Partitions to male toilets (4.5m ²)	Fibre cement sheet material containing White(Chrysotile) asbestos (per sample no. 4)		
Recommendation and Action			
Refer to Section 7.0: Policies & Management Procedures			
Situational Asbestos Risk Assessment:			
Friability	Condition	Signage	Risk Rating
Non-friable	Stable	Installed 3 small warning signs	Low

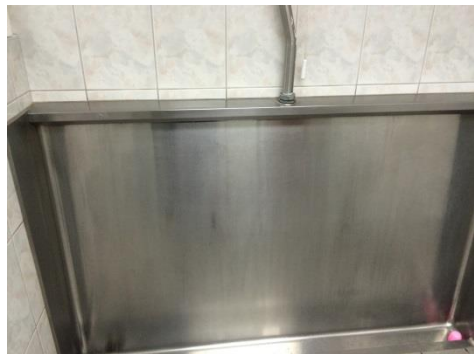
61. Sound dampener to male toilet urinal (2m ²)	Area not accessed or sampled. Based on past experience in similar areas, asbestos in some form may exist. It is recommended that if work is contemplated in this area, due care and diligence should be exercised.		
Recommendation and Action			
Refer to Section 7.0: Policies & Management Procedures			
Situational Asbestos Risk Assessment:			
Friability	Condition	Signage	Risk Rating
Non-friable	Stable	nil	Low

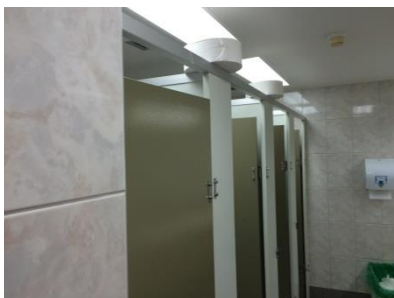
62. Partitions to female toilets (9m ²)	Fibre cement sheet material containing White(Chrysotile) asbestos (per sample no. 4)		
Recommendation and Action			
Refer to Section 7.0: Policies & Management Procedures			
Situational Asbestos Risk Assessment:			
Friability	Condition	Signage	Risk Rating
Non-friable	Stable	Installed 6 small warning signs	Low
