<b>Audit Number:</b>	00004169	<b>Client Name:</b>	Paspalis	<b>Client Contact:</b>	Darran Lum
<b>Version:</b>	1.0	<b>Site Name / Address:</b>	1/48-50 Smith St. Darwin

Site Name	
Paspalis Centrepoint Building Darwin	
Site Inspection Details	
<b>Asbestos Assessor:</b>	Adam Tucker
<b>Inspection Date:</b>	30/08/2016
<b>Re-inspection date:</b>	30/08/2019
Site Details	
<b>Number of Building / Structures:</b>	1
<b>Approximate Age of Buildings / Structures:</b>	1981

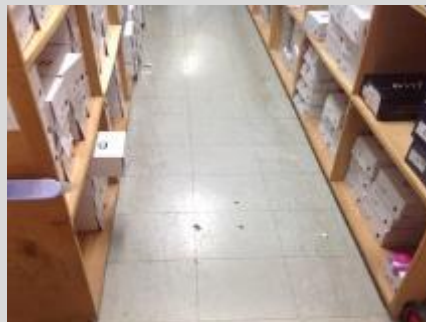
Location Details		Material Details		Results / Management Details		Photographs
Building ID:	Betts	Material Type:	Vinyl Tile	Status:	Not Present (Tested)

Elevation:	Ground Floor	Quantity:	60 - m2	Sample #:	37260	
Position Installed:	Floor Finish / Covering	Condition:	-	Sample Result:	No Asbestos Detected	
Primary Location:	Internal	Friability:	-	Risk Rating:	-	
Secondary Location:	Rear stock room	Surface Treatment:	-	Recommendation:	-	
Comments:	Grey vinyl floor tiles to rear stock room - Possibly extending throughout tenancy beneath ceramic tiles to shop area					Urgent Action Required?
						No

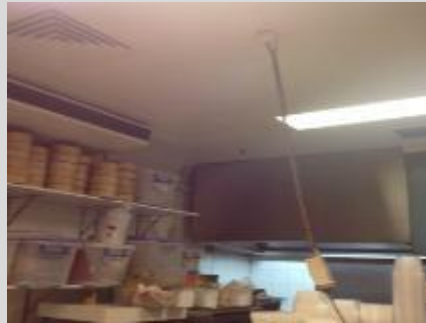
Elevation:	Ground Floor	Quantity:	40 - m2	Sample #:	-	
Position Installed:	Ceiling	Condition:	Good	Sample Result:	-	
Primary Location:	Internal	Friability:	Non-friable	Risk Rating:	5 - Moderate	
Secondary Location:	Throughout	Surface Treatment:	Sealed	Recommendation:	Manage & Review	
Comments:	Ceiling to Ruby Kitchen – Unable to access due to height					Urgent Action Required?
						No

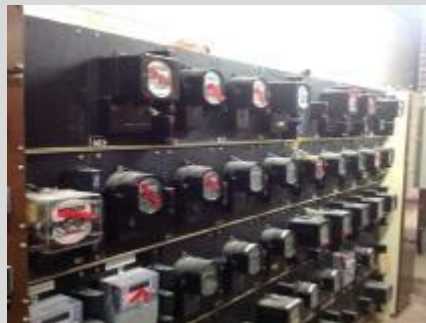
<b>Elevation:</b>	Ground Floor	<b>Quantity:</b>	6 - m2	<b>Sample #:</b>	-	
<b>Position Installed:</b>	Plant, Equipment & Machinery	<b>Condition:</b>	Good	<b>Sample Result:</b>	-	
<b>Primary Location:</b>	Internal	<b>Friability:</b>	Non-friable	<b>Risk Rating:</b>	5 - Moderate	
<b>Secondary Location:</b>	Electrical equipment	<b>Surface Treatment:</b>	Unsealed	<b>Recommendation:</b>	Manage & Review	
<b>Comments:</b>	Resinous backing board to meter boards. Unable to sample due to electrical hazard.					<b>Urgent Action Required?</b> No

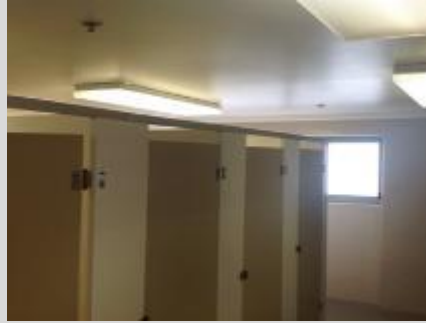
<b>Elevation:</b>	Level 1	<b>Quantity:</b>	20 - m2	<b>Sample #:</b>	-	
<b>Position Installed:</b>	Wall	<b>Condition:</b>	Good	<b>Sample Result:</b>	-	
<b>Primary Location:</b>	Internal	<b>Friability:</b>	Non-friable	<b>Risk Rating:</b>	6 - Moderate	
<b>Secondary Location:</b>	Behind tiles	<b>Surface Treatment:</b>	Sealed	<b>Recommendation:</b>	Manage & Review	
<b>Comments:</b>	Potentially cement based walls behind ceramic tile - all other internals are non-asbestos materials, plasterboard, concrete					<b>Urgent Action Required?</b> No

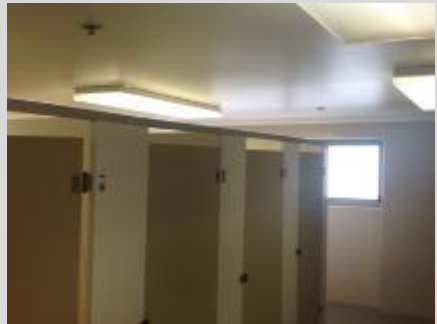
Elevation:	Level 1	Quantity:	20 - m2	Sample #:	-	
Position Installed:	Other – Refer to comments	Condition:	Good	Sample Result:	-	
Primary Location:	Internal	Friability:	Non-friable	Risk Rating:	6 - Moderate	
Secondary Location:	Toilet cubicles	Surface Treatment:	Sealed	Recommendation:	Manage & Review	
Comments:	Toilet cubicle partitions and doors to restroom internals					Urgent Action Required?
						No

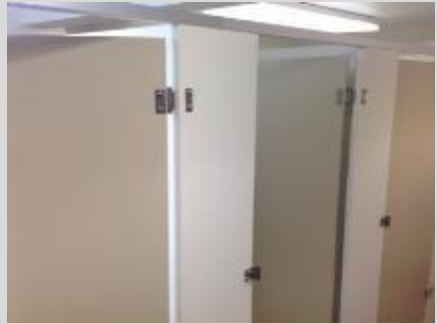
Elevation:	Level 1	Quantity:	20 - m2	Sample #:	-	
Position Installed:	Other – Refer to comments	Condition:	Good	Sample Result:	-	
Primary Location:	Internal	Friability:	Non-friable	Risk Rating:	6 - Moderate	
Secondary Location:	Toilet cubicles	Surface Treatment:	Sealed	Recommendation:	Manage & Review	
Comments:	Toilet cubicle partitions and doors to restroom internals					Urgent Action Required?
						No

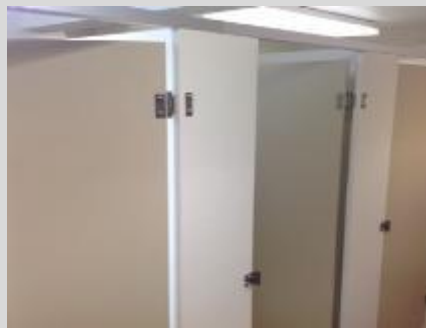
Elevation:	Level 1	Quantity:	20 - m2	Sample #:	-	
Position Installed:	Wall	Condition:	Good	Sample Result:	-	
Primary Location:	Internal	Friability:	Non-friable	Risk Rating:	6 - Moderate	
Secondary Location:	Toilet cubicles	Surface Treatment:	Sealed	Recommendation:	Manage & Review	
Comments:	Potentially cement based walls behind ceramic tile - all other internals are non-asbestos materials, plasterboard, concrete					Urgent Action Required?
						No

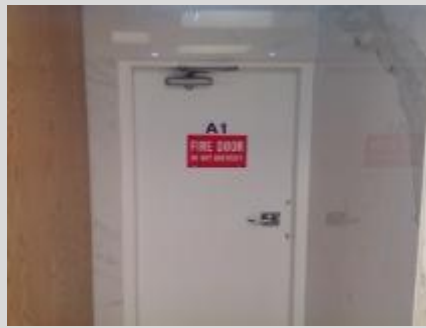
Elevation:	Level 1	Quantity:	2 - m2	Sample #:	-	
Position Installed:	Fire Door	Condition:	Good	Sample Result:	-	
Primary Location:	Internal	Friability:	Unknown	Risk Rating:	6 - Moderate	
Secondary Location:	A1	Surface Treatment:	Partially Sealed	Recommendation:	Manage & Review	
Comments:	Fire door A1					Urgent Action Required?
						No

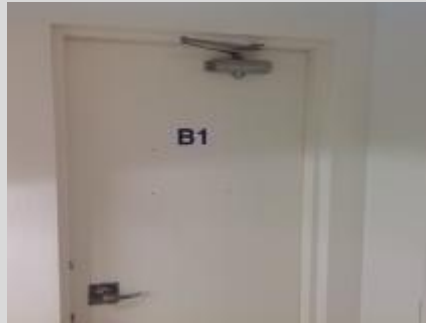
Elevation:	Level 1	Quantity:	2 - m2	Sample #:	-	
Position Installed:	Fire Door	Condition:	Good	Sample Result:	-	
Primary Location:	Internal	Friability:	Unknown	Risk Rating:	6 - Moderate	
Secondary Location:	B1	Surface Treatment:	Partially Sealed	Recommendation:	Manage & Review	
Comments:	Fire door B1					Urgent Action Required?
						No

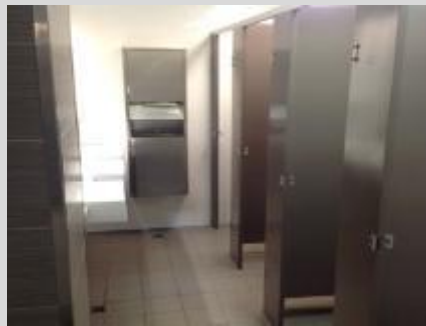
<b>Elevation:</b>	Level 2	<b>Quantity:</b>	20 - m2	<b>Sample #:</b>	-	
<b>Position Installed:</b>	Wall	<b>Condition:</b>	Good	<b>Sample Result:</b>	-	
<b>Primary Location:</b>	Internal	<b>Friability:</b>	Non-friable	<b>Risk Rating:</b>	6 - Moderate	
<b>Secondary Location:</b>	Toilet cubicles	<b>Surface Treatment:</b>	Sealed	<b>Recommendation:</b>	Manage & Review	
<b>Comments:</b>	Toilet cubicle partitions and doors to restroom internals (potentially cement based walls behind ceramic tile - all other internals are non-asbestos materials, plasterboard, concrete)					<b>Urgent Action Required?</b> No

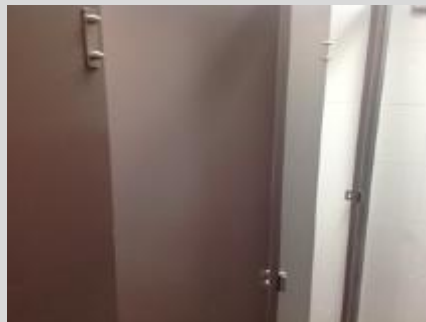
Elevation:	Level 2	Quantity:	20 - m2	Sample #:	-	
Position Installed:	Wall	Condition:	Good	Sample Result:	-	
Primary Location:	Internal	Friability:	Non-friable	Risk Rating:	6 - Moderate	
Secondary Location:	Toilet cubicles	Surface Treatment:	Sealed	Recommendation:	Manage & Review	
Comments:	Toilet cubicle partitions and doors to restroom internals (potentially cement based walls behind ceramic tile - all other internals are non-asbestos materials, plasterboard, concrete)					Urgent Action Required?
						No

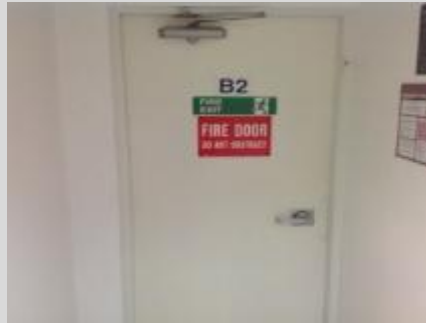
Elevation:	Level 2	Quantity:	2 - m2	Sample #:	-	
Position Installed:	Fire Door	Condition:	Good	Sample Result:	-	
Primary Location:	Internal	Friability:	Unknown	Risk Rating:	6 - Moderate	
Secondary Location:	B2	Surface Treatment:	Partially Sealed	Recommendation:	Manage & Review	
Comments:	Fire door B2					Urgent Action Required?
						No

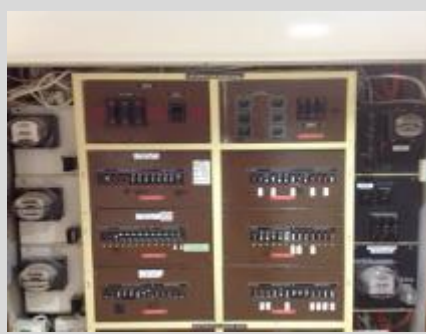
<b>Elevation:</b>	Level 2	<b>Quantity:</b>	1 - m2	<b>Sample #:</b>	-	
<b>Position Installed:</b>	Electrical Component Box	<b>Condition:</b>	Good	<b>Sample Result:</b>	-	
<b>Primary Location:</b>	Internal	<b>Friability:</b>	Non-friable	<b>Risk Rating:</b>	5 - Moderate	
<b>Secondary Location:</b>	Electrical equipment	<b>Surface Treatment:</b>	Unsealed	<b>Recommendation:</b>	Manage & Review	
<b>Comments:</b>	Resinous backing board to meter boards					<b>Urgent Action Required?</b> No

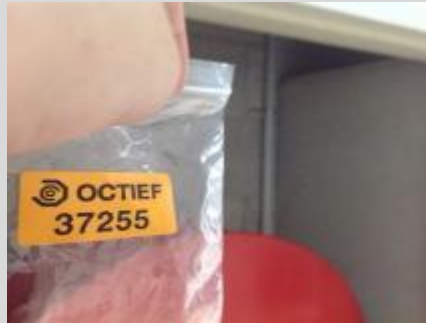
<b>Elevation:</b>	Level 2	<b>Quantity:</b>	2 - m2	<b>Sample #:</b>	37255	
<b>Position Installed:</b>	Wall	<b>Condition:</b>	Good	<b>Sample Result:</b>	Chrysotile	
<b>Primary Location:</b>	Internal	<b>Friability:</b>	Non-friable	<b>Risk Rating:</b>	6 - Moderate	
<b>Secondary Location:</b>	Between cupboards	<b>Surface Treatment:</b>	Partially Sealed	<b>Recommendation:</b>	Manage & Review	
<b>Comments:</b>	Internal wall sheets between fire cupboard/comms cupboard/riser cupboard to foyer					<b>Urgent Action Required?</b> No

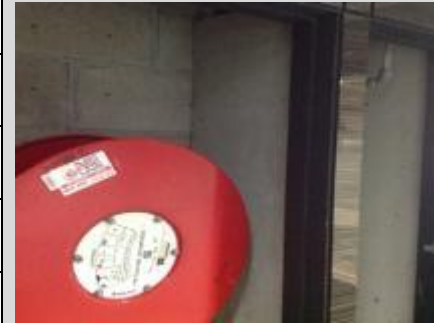
<b>Elevation:</b>	Level 3	<b>Quantity:</b>	2 - m2	<b>Sample #:</b>	Similar to 37255	
<b>Position Installed:</b>	Wall	<b>Condition:</b>	Good	<b>Sample Result:</b>	Chrysotile	
<b>Primary Location:</b>	Internal	<b>Friability:</b>	Non-friable	<b>Risk Rating:</b>	6 - Moderate	
<b>Secondary Location:</b>	Between cupboards	<b>Surface Treatment:</b>	Partially Sealed	<b>Recommendation:</b>	Manage & Review	
<b>Comments:</b>	Internal wall sheets between fire cupboard/comms cupboard/riser cupboard to foyer					<b>Urgent Action Required?</b> No

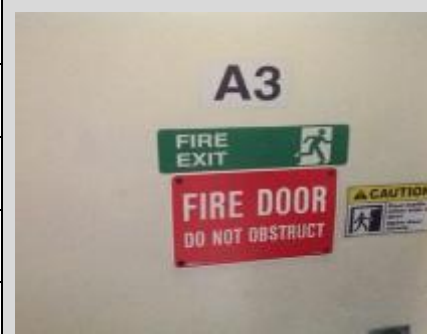
Elevation:	Level 3	Quantity:	2 - m2	Sample #:	-	
Position Installed:	Fire Door	Condition:	Good	Sample Result:	-	
Primary Location:	Internal	Friability:	Unknown	Risk Rating:	6 - Moderate	
Secondary Location:	A3	Surface Treatment:	Partially Sealed	Recommendation:	Manage & Review	
Comments:	Fire door A3					Urgent Action Required? No

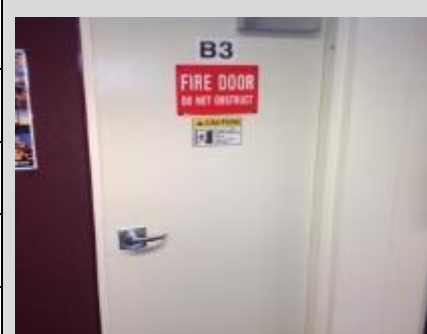
Elevation:	Level 3	Quantity:	2 - m2	Sample #:	-	
Position Installed:	Fire Door	Condition:	Good	Sample Result:	-	
Primary Location:	Internal	Friability:	Unknown	Risk Rating:	6 - Moderate	
Secondary Location:	B3	Surface Treatment:	Partially Sealed	Recommendation:	Manage & Review	
Comments:	Fire door B3					Urgent Action Required? No

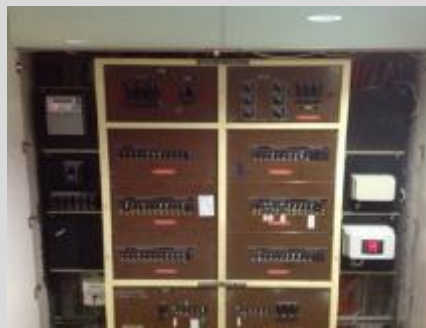
Elevation:	Level 4	Quantity:	1 - m2	Sample #:	-	
Position Installed:	Electrical Component Box	Condition:	Good	Sample Result:	-	
Primary Location:	Internal	Friability:	Non-friable	Risk Rating:	5 - Moderate	
Secondary Location:	Electrical equipment	Surface Treatment:	Unsealed	Recommendation:	Manage & Review	
Comments:	Resinous backing board to meter boards					Urgent Action Required?
						No

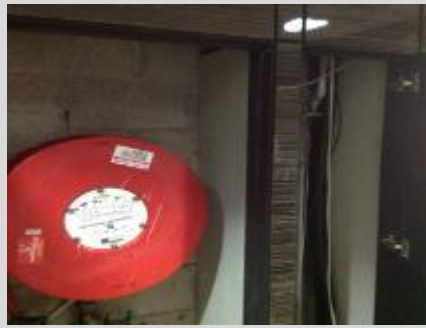
Elevation:	Level 4	Quantity:	2 - m2	Sample #:	Similar to 37255	
Position Installed:	Wall	Condition:	Good	Sample Result:	Chrysotile	
Primary Location:	Internal	Friability:	Non-friable	Risk Rating:	6 - Moderate	
Secondary Location:	Between cupboards	Surface Treatment:	Partially Sealed	Recommendation:	Manage & Review	
Comments:	Internal wall sheets between fire cupboard/comms cupboard/riser cupboard to foyer					Urgent Action Required?
						No

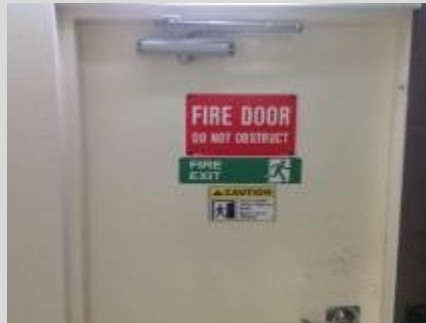
Elevation:	Level 4	Quantity:	2 - m2	Sample #:	-	
Position Installed:	Fire Door	Condition:	Good	Sample Result:	-	
Primary Location:	Internal	Friability:	Unknown	Risk Rating:	6 - Moderate	
Secondary Location:	A4	Surface Treatment:	Partially Sealed	Recommendation:	Manage & Review	
Comments:	Fire door A4					Urgent Action Required?
						No

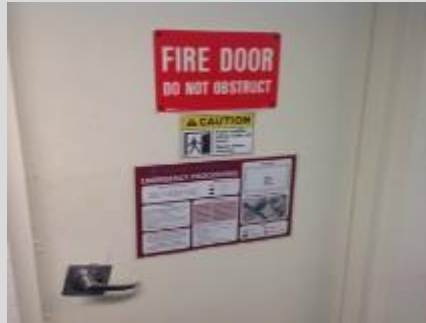
Elevation:	Level 4	Quantity:	2 - m2	Sample #:	-	
Position Installed:	Fire Door	Condition:	Good	Sample Result:	-	
Primary Location:	Internal	Friability:	Unknown	Risk Rating:	6 - Moderate	
Secondary Location:	B4	Surface Treatment:	Partially Sealed	Recommendation:	Manage & Review	
Comments:	Fire door B4					Urgent Action Required?
						No

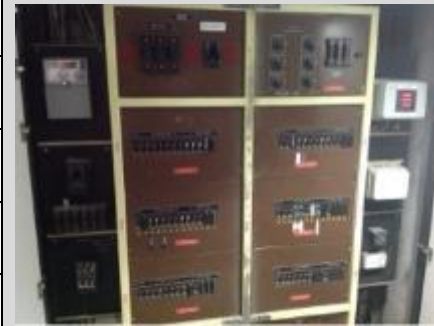
<b>Elevation:</b>	Level 5	<b>Quantity:</b>	1 - m2	<b>Sample #:</b>	-	
<b>Position Installed:</b>	Electrical Component Box	<b>Condition:</b>	Good	<b>Sample Result:</b>	-	
<b>Primary Location:</b>	Internal	<b>Friability:</b>	Non-friable	<b>Risk Rating:</b>	5 - Moderate	
<b>Secondary Location:</b>	Electrical equipment	<b>Surface Treatment:</b>	Unsealed	<b>Recommendation:</b>	Manage & Review	
<b>Comments:</b>	Resinous backing board to meter boards					<b>Urgent Action Required?</b> No

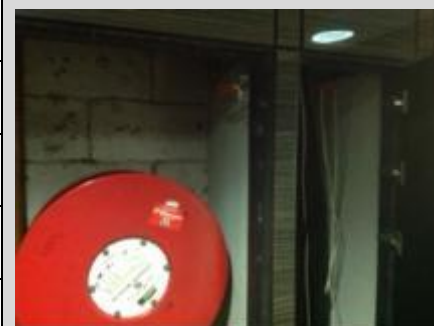
<b>Elevation:</b>	Level 5	<b>Quantity:</b>	2 - m2	<b>Sample #:</b>	Similar to 37255	
<b>Position Installed:</b>	Wall	<b>Condition:</b>	Good	<b>Sample Result:</b>	Chrysotile	
<b>Primary Location:</b>	Internal	<b>Friability:</b>	Non-friable	<b>Risk Rating:</b>	6 - Moderate	
<b>Secondary Location:</b>	Between cupboards	<b>Surface Treatment:</b>	Partially Sealed	<b>Recommendation:</b>	Manage & Review	
<b>Comments:</b>	Internal wall sheets between fire cupboard/comms cupboard/riser cupboard to foyer					<b>Urgent Action Required?</b> No

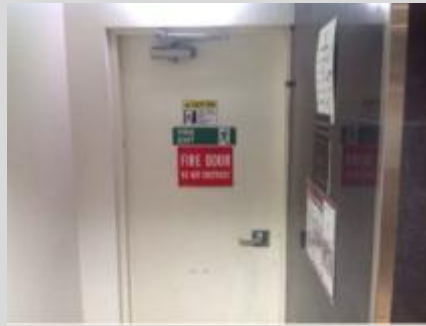
Elevation:	Level 5	Quantity:	2 - m2	Sample #:	37251	
Position Installed:	Fire Door	Condition:	Good	Sample Result:	No Asbestos Detected	
Primary Location:	Internal	Friability:	Unknown	Risk Rating:	6 - Moderate	
Secondary Location:	A5	Surface Treatment:	Partially Sealed	Recommendation:	Manage & Review	
Comments:	Fire door A5 - SAMPLED AT TOP ONLY, MAY STILL CONTAIN ASBESTOS INTERNALLY					Urgent Action Required?
						No

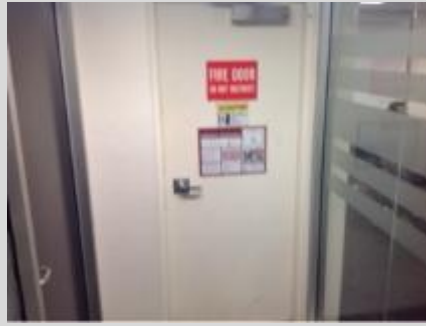
Elevation:	Level 5	Quantity:	2 - m2	Sample #:	-	
Position Installed:	Fire Door	Condition:	Good	Sample Result:	-	
Primary Location:	Internal	Friability:	Unknown	Risk Rating:	6 - Moderate	
Secondary Location:	B5	Surface Treatment:	Partially Sealed	Recommendation:	Manage & Review	
Comments:	Fire door B5					Urgent Action Required?
						No

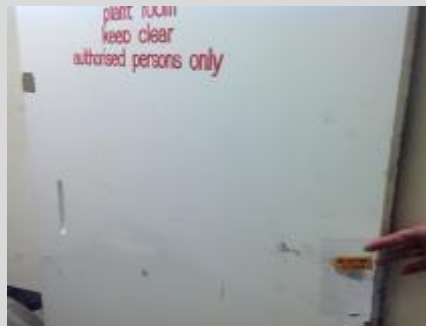
Elevation:	Level 5	Quantity:	2 - m2	Sample #:	37254	
Position Installed:	Fire Door	Condition:	Good	Sample Result:	Chrysotile	
Primary Location:	Internal	Friability:	Non-friable	Risk Rating:	6 - Moderate	
Secondary Location:	Fire Door	Surface Treatment:	Partially Sealed	Recommendation:	Manage & Review	
Comments:	Sliding door to stairwell to level 6 plantrooms					Urgent Action Required?
						No

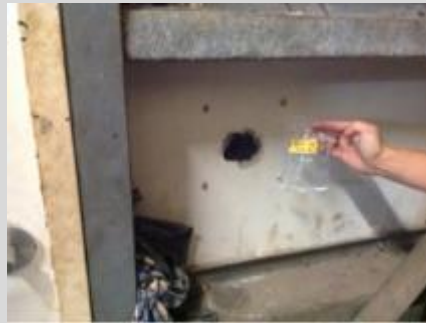
Elevation:	Level 6	Quantity:	200 - m2	Sample #:	37252	
Position Installed:	Wall	Condition:	Fair	Sample Result:	Chrysotile	
Primary Location:	Internal	Friability:	Non-friable	Risk Rating:	6 - Moderate	
Secondary Location:	All elevations	Surface Treatment:	Partially Sealed	Recommendation:	Manage & Review	
Comments:	Wall sheeting to all elevations to internals to level 6 plant and equipment areas - Floors and ceilings are concrete and metal					Urgent Action Required?
						No

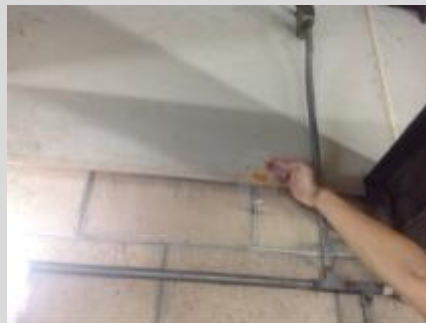
Elevation:	Level 6	Quantity:	7 - m2	Sample #:	37253	
Position Installed:	Wall	Condition:	Good	Sample Result:	Chrysotile, Amosite	
Primary Location:	Internal	Friability:	Non-friable	Risk Rating:	5 - Moderate	
Secondary Location:	All elevations	Surface Treatment:	Unsealed	Recommendation:	Manage & Review	
Comments:	Upper wall sheeting to all elevations to internals to level lift motor room - Floors and ceilings are concrete and metal					Urgent Action Required?
						No

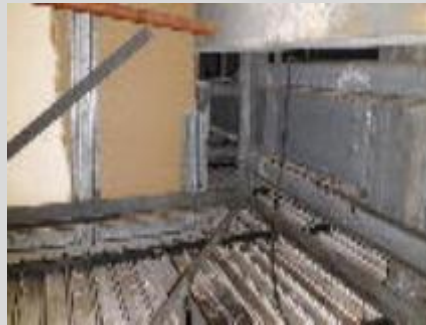
<b>Elevation:</b>	Ground Floor	<b>Quantity:</b>	Unknown	<b>Sample #:</b>	NT1608031242	
<b>Position Installed:</b>	Dust / Debris	<b>Condition:</b>	Poor	<b>Sample Result:</b>	Chrysotile	
<b>Primary Location:</b>	Internal	<b>Friability:</b>	Friable	<b>Risk Rating:</b>	7 - High	
<b>Secondary Location:</b>	Western awning bulkhead above Cotton On	<b>Surface Treatment:</b>	Unsealed	<b>Recommendation:</b>	Encapsulate / Seal	
<b>Comments:</b>	Interior of bulkhead after a prior removal showed pre-existing dust and debris on horizontal surfaces that was unable to be cleaned due to inaccessibility					<b>Urgent Action Required?</b> Yes
