**ASBESTOS REGISTER
No. NT0414**

**16 Bennett Street
Darwin
NORTHERN TERRITORY**

Date: May 2011
Register No: NT0414/01
Our Ref: PP/GP

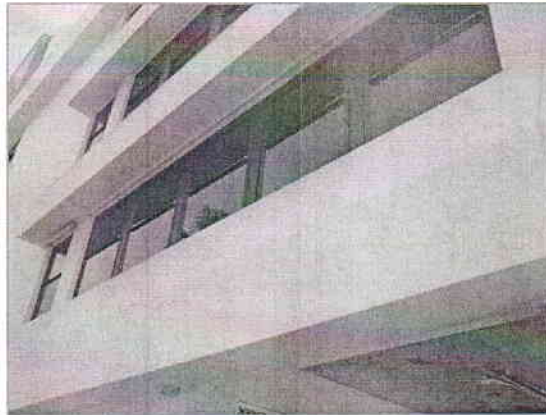
Photo 1, External wall cladding

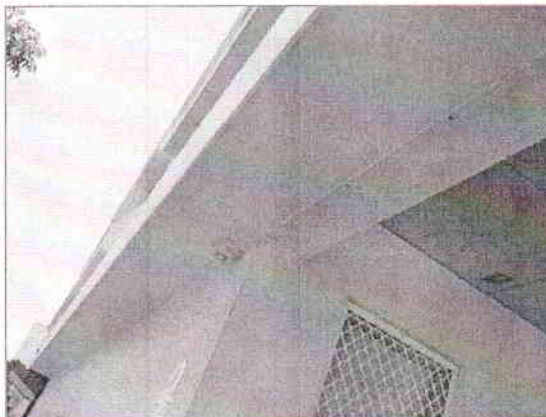
Lining to underside of cladding overhang levels 1 - 3 (90 ^{m2}) *Refer Photo 2	Fibre cement sheet material containing white (Chrysotile) asbestos (Per AEC sample no.2 in Report NT0336 – Sept 2009)	Stable	Warning signs 5 small plastic per level Refer Section 6.0: Management Procedure	
Ceiling lining to carport/driveway area at north east corner of building (125 ^{m2}) *Refer Photo 3	Fibre cement sheet material containing white (Chrysotile) asbestos (Refer to AEC sample no.3 in Report NT0336 – Sept 2009)	Stable	Warning signs 6 small plastic Refer Section 6.0: Management Procedure	
Internal				
Ground Level – No Asbestos Detected				
Level 1 - ABC Tenancy – No Asbestos Detected				
Level 2 - Indigenous Legal Services Tenancy				
HWS in kitchen, wire insulation (<1m ²) *Refer photo 4	Not accessed or sampled. Based on past experience in similar areas, asbestos in some form may exist. It is recommended that if work is contemplated in this area, due care and diligence should be exercised.	Friable when exposed.	Warning signs 1 small Refer Section 6.0: Management Procedures.

Photo 2, Lining to underside of cladding overhang

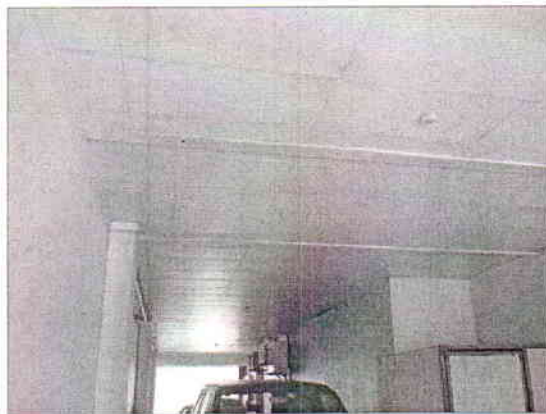
Photo 3, Ceiling lining to carport area

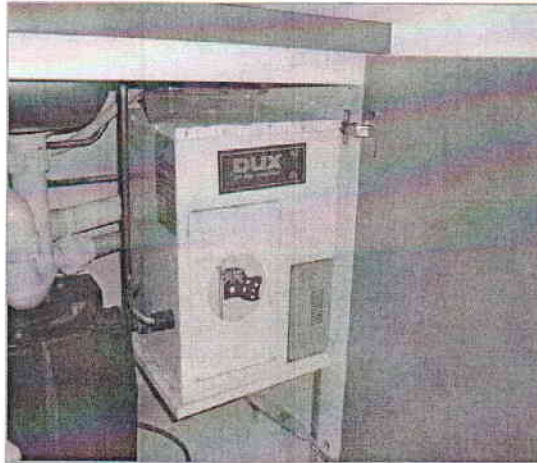
Photo 4. Wire insulation to HWS in kitchen

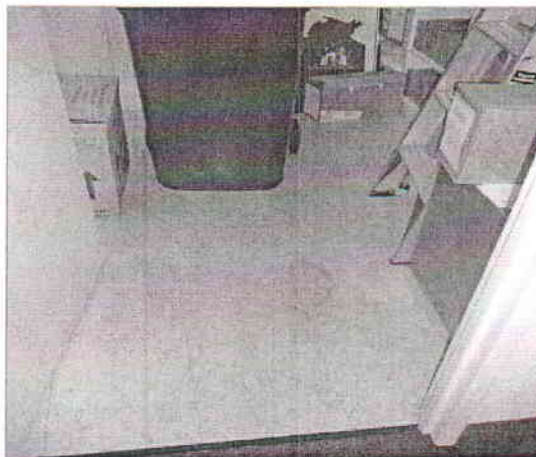
Photo 5. Vinyl floor tiles to store room

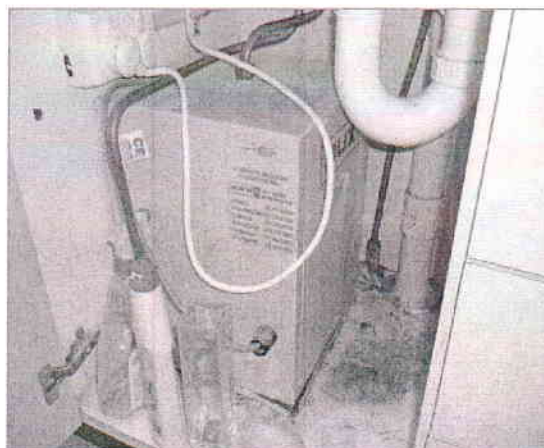
HWS below sink in lunchroom (<1 ^{m2}) <i>*Refer photo 6</i>	Not accessed or sampled. Based on past experience in similar areas, asbestos in some form may exist. It is recommended that if work is contemplated in this area, due care and diligence should be exercised.	Friable when exposed.	Warning signs 1 small Refer Section 6.0: Management Procedures.	
Plant Room				
Fire doors x 2 to plant room core material (2 ^{m2} per door) <i>*Refer photo 7</i>	Core material containing white (Chrysotile) and brown (Amosite) asbestos (Refer to AEC sample no.12 in Report NT0336 – Sept 2009)	Friable when exposed. Some damage exposed core material	Warning signs 2 small per door. Refer Section 6.0: Management Procedures.	Remove
Main Air-condition unit (Blue) <i>*Refer photo 8</i>	Gasket Material – brown mastic containing white (Chrysotile) asbestos (AEC sample no. 6)	Stable	Warning signs 8 small plastic Refer Section 6.0: Management Procedures.

Photo 6. Wire insulation to HWS in lunchroom

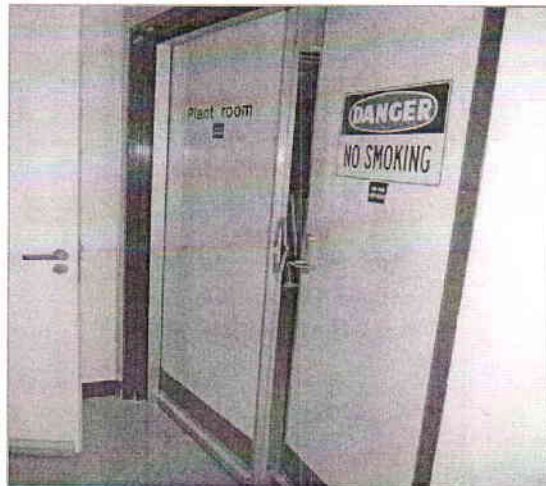
Photo 7. Fire doors to plant room

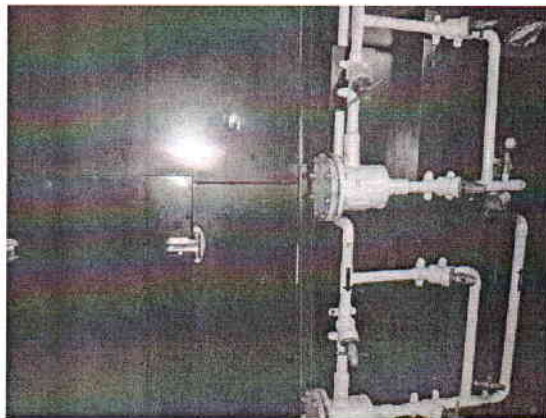
Photo 8. Main Air Conditioner unit (Blue) – Brown gasket material

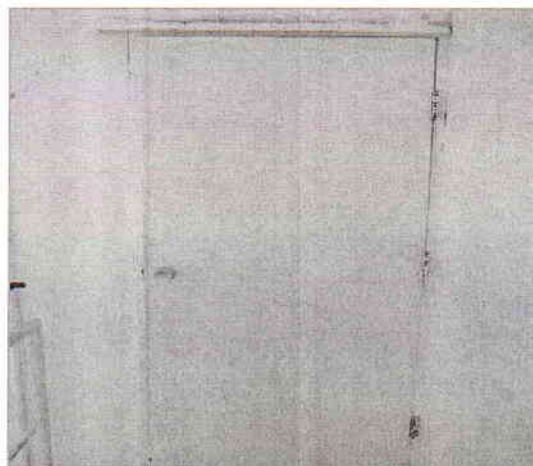
Roof				
Fire door to roof access stairwell core material (2 ^{m2}) <i>*Refer photo 9</i>	Not accessed or sampled. Based on past experience in similar areas, asbestos in some form may exist. It is recommended that if work is contemplated in this area, due care and diligence should be exercised.	Friable when exposed.	Warning signs 2 small plastic Refer Section 6.0: Management Procedures.	
Brake shoe linings to lift motor (<1 ^{m2}) <i>*Refer photo 10</i>	Not accessed or sampled. Based on past experience in similar areas, asbestos in some form may exist. It is recommended that if work is contemplated in this area, due care and diligence should be exercised.	Stable	Warning signs 1 small Plastic Refer Section 6.0: Management Procedure

Photo 9. Roof access fire door

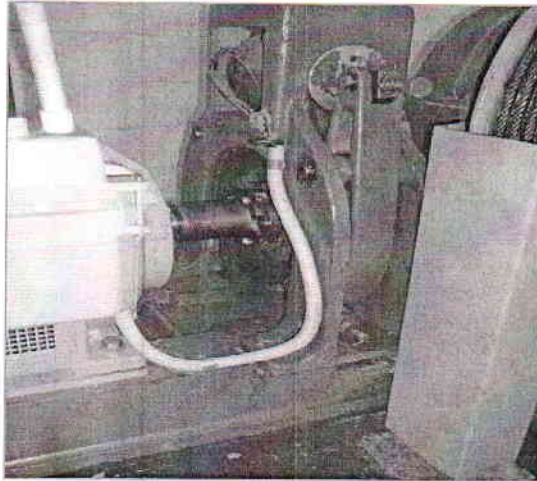
Photo 10. Brake shoes to lift motor
