ASBESTOS CONTAINING BUILDING MATERIALS SURVEY REPORT

TCG Building
80 Mitchell Street
Darwin NT 0800

Report Number 680.10035.00000.01 ASR R1 20130823

23 August 2013

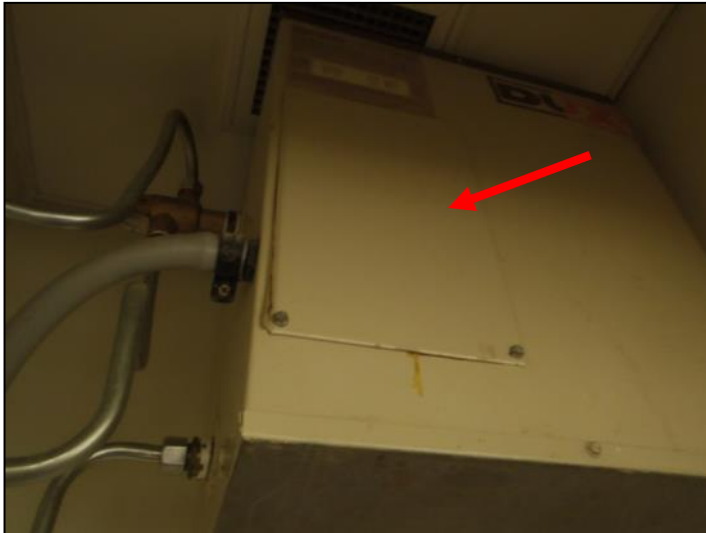
Photograph 1

'Dux' hot water system inside cleaners closets in male toilets to all floors except basement, level 5 and the roof level (**assumed asbestos containing**).

Following the request to clarify, SLR conducted an inspection of the hot water systems on Wednesday 31st July 2013 and found that the insulation in question does not contain asbestos.

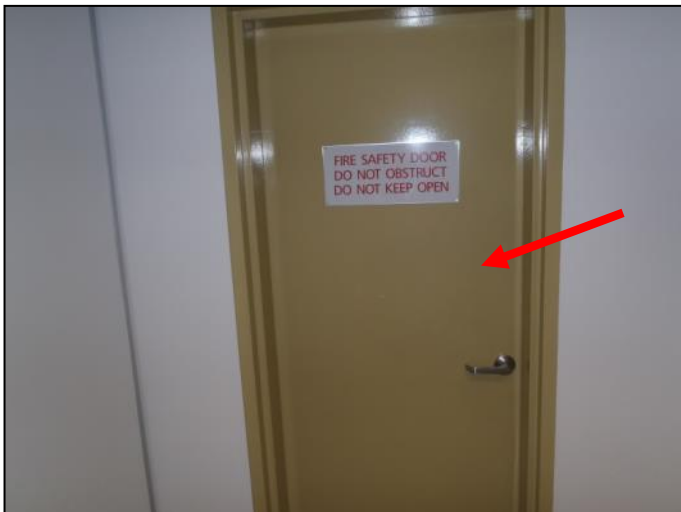
Photograph 2

Insulation material to cores of fire doors, north-east and northwest fire-escape entries to each floor	Assumed Asbestos Containing	2	N/A	N/A	N/A	N/A	N/A	N/A	N/A	C5	Material deemed free of asbestos (see Appendix D for details)
Building Interior – Roof level plant room											
Within the Scope and Limitations, no asbestos was detected or assumed present throughout the Roof Level Plant room											
Refer to related notes on Page 12 .

Insulated cores to fire doors to all fire escapes (**assumed asbestos containing**).
