ASBESTOS REGISTER

FOR THE PROPERTY AT: Katherine Central NT
Katherine Terrace / Savannah Way,
Katherine, NT

CLIENT: Centro Properties Group

DATE INSPECTED: 7th December, 2010

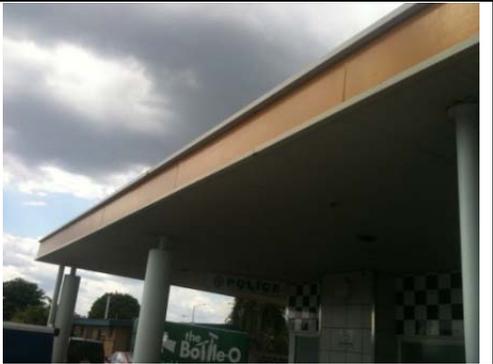
LOCATION - DESCRIPTION	EXTENT	ASBESTOS ASSESSMENT	CONDITION	SAMPLE NO VISUAL TEST	SIGNAGE STATUS
A. External, Front and side elevations, verandah perimeter façade lining – fibre cement sheeting. (strip painted yellow).	Approx 100m x 500mm	No asbestos detected	-	Sample no. 01/MA/071210	-
SURVEY FINDINGS and HAZARD MANAGEMENT RECOMMENDATIONS					
No asbestos detected upon laboratory analysis of sample.

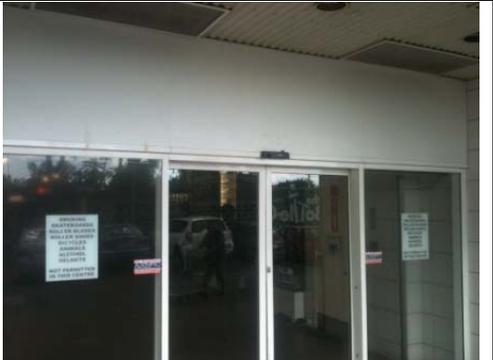
LOCATION - DESCRIPTION	EXTENT	ASBESTOS ASSESSMENT	CONDITION	SAMPLE NO VISUAL TEST	SIGNAGE STATUS
B. External, Mall / Plaza entries, infill lining above doors / sign panel - fibre cement sheeting. (strip painted yellow).	Approx 5m ² per entry x4.	No asbestos detected	-	Sample no. 03/MA/071210	-
SURVEY FINDINGS and HAZARD MANAGEMENT RECOMMENDATIONS					
No asbestos detected upon laboratory analysis of sample.

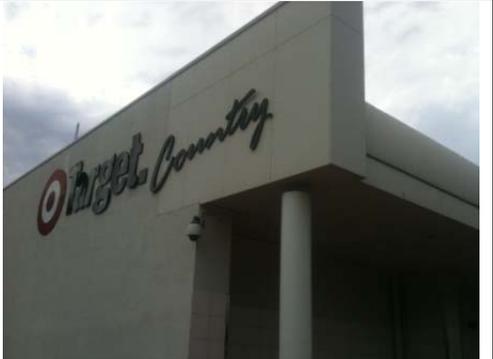
LOCATION - DESCRIPTION	EXTENT	ASBESTOS ASSESSMENT	CONDITION	SAMPLE NO VISUAL TEST	SIGNAGE STATUS
C. External, Target Country façade cladding and verandah end wall cladding on building corners – thicksheet, – fibre cement sheeting.	Approx 100m ²	No asbestos detected	-	Sample no. 04/MA/071210	-
SURVEY FINDINGS and HAZARD MANAGEMENT RECOMMENDATIONS					
No asbestos detected upon laboratory analysis of sample.

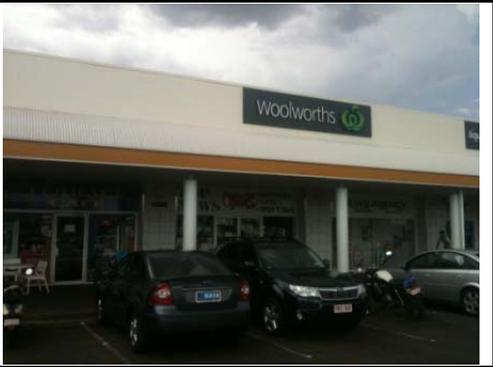
LOCATION - DESCRIPTION	EXTENT	ASBESTOS ASSESSMENT	CONDITION	SAMPLE NO VISUAL TEST	SIGNAGE STATUS	
D. External, Front elevation 'Woolworths' signage panel façade cladding above verandah-fibre cement sheeting.	Approx 30m ²	Presumed Non-Asbestos	-	Visual – similar to sample no. 01/MA/071210	-

SURVEY FINDINGS and HAZARD MANAGEMENT RECOMMENDATIONS						
No asbestos detected upon laboratory analysis of visually similar sample. Due to visually similar composition of material to sample number 01/MA/071210 and given the age of construction, presumed non-asbestos material.						
LOCATION - DESCRIPTION	EXTENT	ASBESTOS ASSESSMENT	CONDITION	SAMPLE NO VISUAL TEST	SIGNAGE STATUS

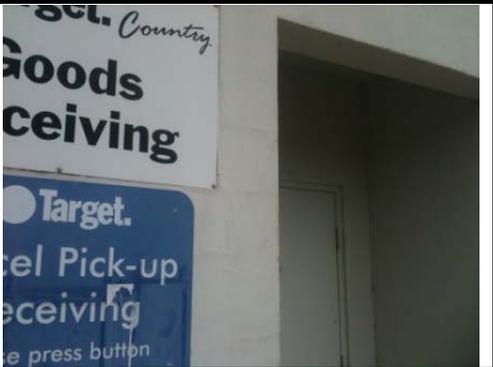
E. External, rear elevation 'Target Country - goods receiving' entry porch lining - fibre cement sheeting.	Approx 1m ²	Presumed Non-Asbestos	-	Visual – similar to sample no. 01/MA/071210	-

SURVEY FINDINGS and HAZARD MANAGEMENT RECOMMENDATIONS						
No asbestos detected upon laboratory analysis of visually similar sample. Due to visually similar composition of material to sample number 01/MA/071210 and given the age of construction, presumed non-asbestos material.						
LOCATION - DESCRIPTION	EXTENT	ASBESTOS ASSESSMENT	CONDITION	SAMPLE NO VISUAL TEST	SIGNAGE STATUS

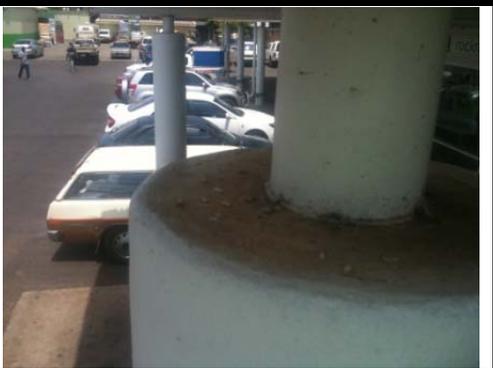
F. External, Front and side entry to mall / plaza, verandah columns – cement based circular column.	Columns, approx. 3m high, 400mm diameter	No asbestos visible	-	Visual	-

SURVEY FINDINGS and HAZARD MANAGEMENT RECOMMENDATIONS						
Inspection of column at front elevation mall plaza entry 2, solid column detected at top of column. Note it was common to use concrete filled fibre cement pipes for this purpose, hence inspected at top of column revealed no fibre cement, presumed this column typical of others.

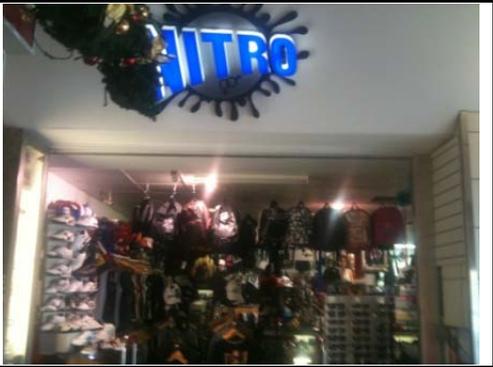
LOCATION - DESCRIPTION	EXTENT	ASBESTOS ASSESSMENT	CONDITION	SAMPLE NO VISUAL TEST	SIGNAGE STATUS	
1. Internal, Tenancy 1 'Nitro' construction and fit-out – No asbestos containing materials visible.	-	No asbestos visible	-	Visual	-

SURVEY FINDINGS and HAZARD MANAGEMENT RECOMMENDATIONS						
No asbestos visible upon inspection. Fit-out consisted of timber / plasterboard walls, (some over solid masonry, some on stud partition walls) 600mm square plasterboard ceiling tiles suspended in aluminium grid, concrete floor slab. No asbestos visible to sheet-metal electrical distribution board. Typical perimeter building construction is besser block walls, ceiling space inspections at random revealed non-insulated structural steel 'I' beams, steel 'z' roofing purlins, underside of glass fibre insulation blanket directly beneath sheet-metal roof, pvc downpipes. No inspection to ceiling space in this tenancy due to inaccessibility.

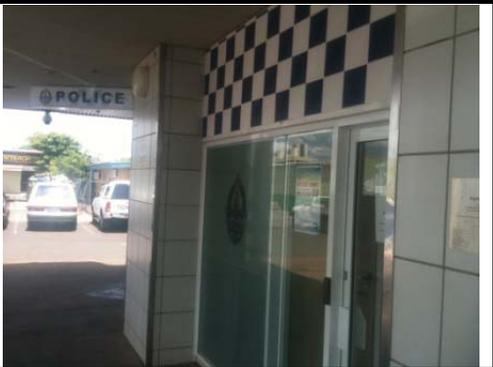
2. Internal, Tenancy 2 'NT Police' construction and fit-out – No asbestos containing materials visible.	-	No asbestos visible	-	Visual	-

SURVEY FINDINGS and HAZARD MANAGEMENT RECOMMENDATIONS						
No asbestos visible upon inspection. Fit-out consisted of plasterboard walls, 600mm square plasterboard ceiling tiles suspended in aluminium grid, carpet and lino on concrete floor slab. Typical perimeter building construction is besser block walls, ceiling space inspections at random revealed non-insulated structural steel 'I' beams, steel 'z' roofing purlins, underside of glass fibre insulation blanket directly beneath sheet-metal roof, pvc downpipes. No inspection to ceiling space in this tenancy due to inaccessibility.

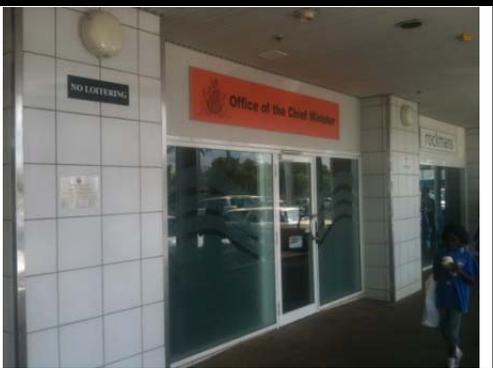
3. Internal, Tenancy 2a 'Office of the Chief Minister' construction and fit-out – No Access provided for inspection.	-	-	Inaccessible	Visual	-

SURVEY FINDINGS and HAZARD MANAGEMENT RECOMMENDATIONS						
No access provided for inspection, no tenant available during 6 th & 7 th December 2010. Based upon age of construction of other adjoining areas and sample results obtained, presumed no asbestos used in the construction / fit-out.

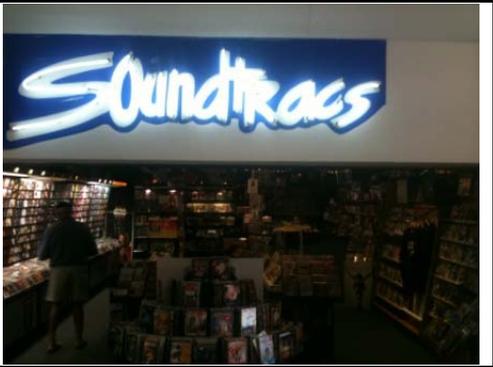
LOCATION - DESCRIPTION	EXTENT	ASBESTOS ASSESSMENT	CONDITION	SAMPLE NO VISUAL TEST	SIGNAGE STATUS	
4. Internal, Tenancy 3 'Soundtracks' construction and fit-out – No asbestos containing materials visible.	-	No asbestos visible	-	Visual	-

<p>SURVEY FINDINGS and HAZARD MANAGEMENT RECOMMENDATIONS</p> <p>No asbestos visible upon inspection. Fit-out consisted of plasterboard walls, 600mm square plasterboard ceiling tiles suspended in aluminium grid, carpet and ceramic tiles on concrete floor slab. Typical perimeter building construction is besser block walls, ceiling space inspections at random revealed non-insulated structural steel 'I' beams, steel 'z' roofing purlins, underside of glass fibre insulation blanket directly beneath sheet-metal roof, pvc downpipes, assumed typical throughout. No inspection to ceiling space in this tenancy due to inaccessibility.</p>

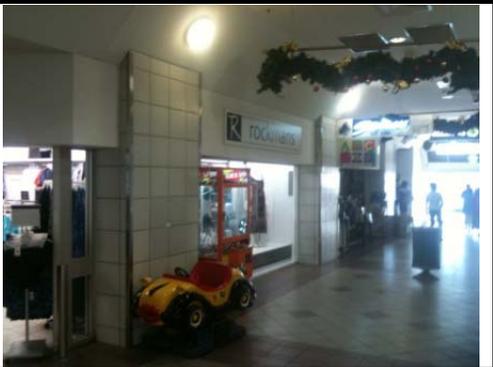
5. Internal, Tenancy 4 'Rockmans' construction and fit-out – No asbestos containing materials visible.	-	No asbestos visible	-	Visual	-

<p>SURVEY FINDINGS and HAZARD MANAGEMENT RECOMMENDATIONS</p> <p>No asbestos visible upon inspection. Fit-out consisted of mdf timber and plasterboard walls, 600mm square plasterboard ceiling tiles suspended in aluminium grid, carpet and ceramic tiles on concrete floor slab. Typical perimeter building construction is besser block walls, ceiling space inspections at random revealed non-insulated structural steel 'I' beams, steel 'z' roofing purlins, underside of glass fibre insulation blanket directly beneath sheet-metal roof, pvc downpipes, assumed typical throughout. No inspection to ceiling space in this tenancy due to inaccessibility.</p>

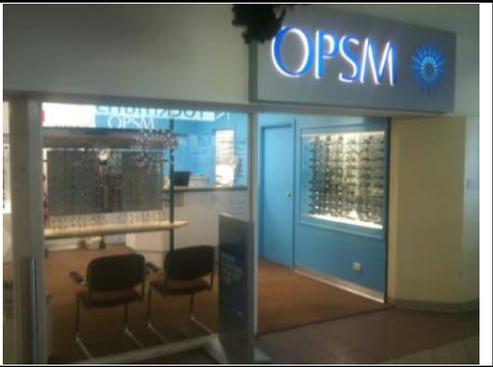
LOCATION - DESCRIPTION	EXTENT	ASBESTOS ASSESSMENT	CONDITION	SAMPLE NO VISUAL TEST	SIGNAGE STATUS	
7. Internal, Tenancy 6 'OPSM' construction and fit-out – No asbestos containing materials visible.	-	No asbestos visible	-	Visual	-

SURVEY FINDINGS and HAZARD MANAGEMENT RECOMMENDATIONS						
No asbestos visible upon inspection. Fit-out consisted of plasterboard walls, 600mm square plasterboard ceiling tiles suspended in aluminium grid, carpet and ceramic tiles on concrete floor slab. Typical perimeter building construction is besser block walls, ceiling space inspections at random revealed non-insulated structural steel 'I' beams, steel 'z' roofing purlins, underside of glass fibre insulation blanket directly beneath sheet-metal roof, pvc downpipes, assumed typical throughout. No inspection to ceiling space in this tenancy due to inaccessibility.						
LOCATION - DESCRIPTION	EXTENT	ASBESTOS ASSESSMENT	CONDITION	SAMPLE NO VISUAL TEST	SIGNAGE STATUS

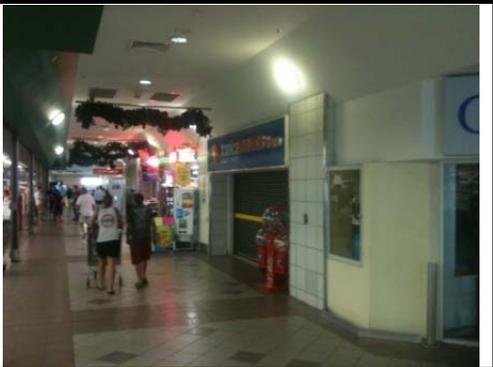
8. Internal, Tenancy 7 'Vacant' construction and fit-out – No asbestos containing materials visible.	-	No asbestos visible	-	Visual	-

SURVEY FINDINGS and HAZARD MANAGEMENT RECOMMENDATIONS						
Old photo shop. No asbestos visible upon inspection. Fit-out consisted of plasterboard walls, 600mm square plasterboard ceiling tiles suspended in aluminium grid, ceramic tiles on concrete floor slab. Typical perimeter building construction is besser block walls. As tenancy vacant ceiling inspection performed - ceiling space inspections revealed non-insulated structural steel 'I' beams, steel 'z' roofing purlins, underside of glass fibre insulation blanket directly beneath sheet-metal roof, pvc downpipes, assumed typical throughout.						
LOCATION - DESCRIPTION	EXTENT	ASBESTOS ASSESSMENT	CONDITION	SAMPLE NO VISUAL TEST	SIGNAGE STATUS

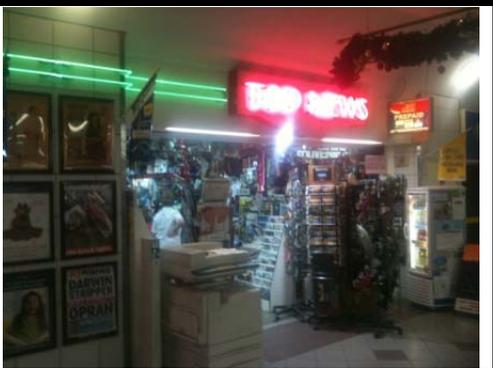
9. Internal, Tenancy 8/9 'Top News' construction and fit-out – No asbestos containing materials visible.	-	No asbestos visible	-	Visual	-

SURVEY FINDINGS and HAZARD MANAGEMENT RECOMMENDATIONS						
No asbestos visible upon inspection. Fit-out consisted of plasterboard walls, 600mm square plasterboard ceiling tiles suspended in aluminium grid, carpet and ceramic tiles on concrete floor slab. Typical perimeter building construction is besser block walls, ceiling space inspections at random revealed non-insulated structural steel 'I' beams, steel 'z' roofing purlins, underside of glass fibre insulation blanket directly beneath sheet-metal roof, pvc downpipes, assumed typical throughout. No inspection to ceiling space in this tenancy due to inaccessibility.

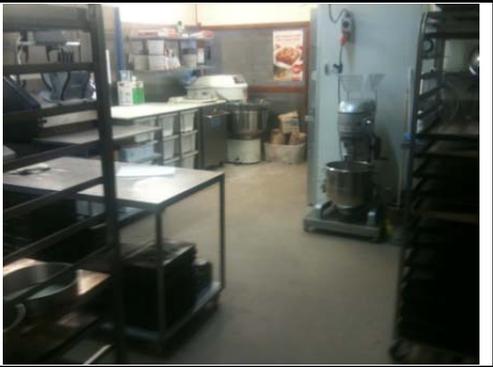
LOCATION - DESCRIPTION	EXTENT	ASBESTOS ASSESSMENT	CONDITION	SAMPLE NO VISUAL TEST	SIGNAGE STATUS	
10. Internal, Tenancy 10/10a – assumed to be part of tenancy 12 Brumby's – No asbestos visible.	-	No asbestos visible	-	Visual	-

SURVEY FINDINGS and HAZARD MANAGEMENT RECOMMENDATIONS						
No asbestos visible upon inspection. Fit-out consisted of sandwich panel cold rooms fitted out within plasterboard walls, 600mm square plasterboard ceiling tiles suspended in aluminium grid, vinyl and ceramic tiles on concrete floor slab. Typical perimeter building construction is besser block walls, ceiling space inspections at random revealed non-insulated structural steel 'I' beams, steel 'z' roofing purlins, underside of glass fibre insulation blanket directly beneath sheet-metal roof, pvc downpipes, assumed typical throughout. No inspection to ceiling space in this tenancy due to inaccessibility.

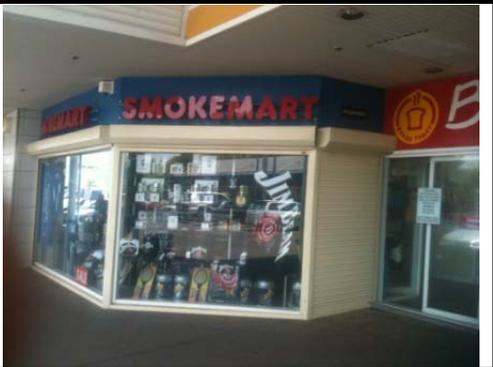
LOCATION - DESCRIPTION	EXTENT	ASBESTOS ASSESSMENT	CONDITION	SAMPLE NO VISUAL TEST	SIGNAGE STATUS	
11. Internal, Tenancy 11 'Smoke Mart' construction and fit-out – No asbestos containing materials visible.	-	No asbestos visible	-	Visual	-

SURVEY FINDINGS and HAZARD MANAGEMENT RECOMMENDATIONS						
No asbestos visible upon inspection. Fit-out consisted of plasterboard walls, 600mm square plasterboard ceiling tiles suspended in aluminium grid, carpet and ceramic tiles on concrete floor slab. Typical perimeter building construction is besser block walls, ceiling space inspections at random revealed non-insulated structural steel 'I' beams, steel 'z' roofing purlins, underside of glass fibre insulation blanket directly beneath sheet-metal roof, pvc downpipes, assumed typical throughout. No inspection to ceiling space in this tenancy due to inaccessibility.						
LOCATION - DESCRIPTION	EXTENT	ASBESTOS ASSESSMENT	CONDITION	SAMPLE NO VISUAL TEST	SIGNAGE STATUS

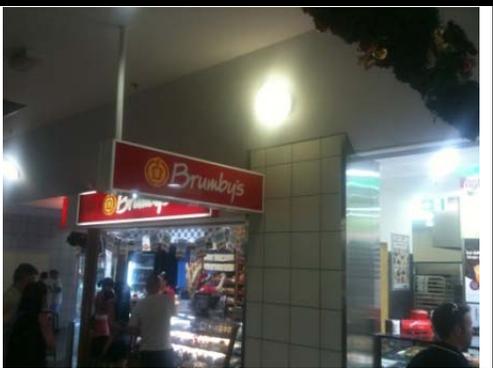
12. Internal, Tenancy 12 'Brumby's' construction and fit-out – No asbestos containing materials visible.	-	No asbestos visible	-	Visual	-

SURVEY FINDINGS and HAZARD MANAGEMENT RECOMMENDATIONS						
No asbestos visible upon inspection. Fit-out consisted of plasterboard walls, 600mm square plasterboard ceiling tiles suspended in aluminium grid, carpet and ceramic tiles on concrete floor slab. Typical perimeter building construction is besser block walls, ceiling space inspections at random revealed non-insulated structural steel 'I' beams, steel 'z' roofing purlins, underside of glass fibre insulation blanket directly beneath sheet-metal roof, pvc downpipes, assumed typical throughout. No inspection to ceiling space in this tenancy due to inaccessibility.

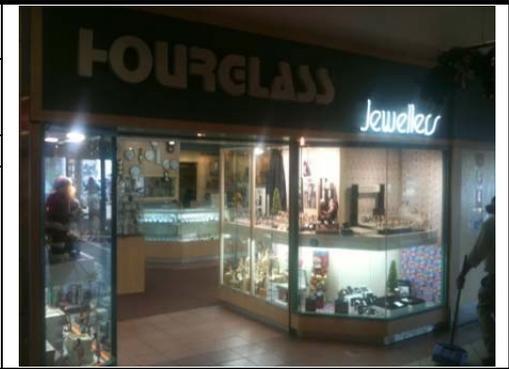
LOCATION - DESCRIPTION	EXTENT	ASBESTOS ASSESSMENT	CONDITION	SAMPLE NO VISUAL TEST	SIGNAGE STATUS
13. Internal, Tenancy 13/15 'Hourglass Jewellers' construction and fit-out – No asbestos containing materials visible.	-	No asbestos visible	-	Visual	-
SURVEY FINDINGS and HAZARD MANAGEMENT RECOMMENDATIONS					
No asbestos visible upon inspection. Fit-out consisted of plasterboard walls, 600mm square plasterboard ceiling tiles suspended in aluminium grid, carpet and ceramic tiles on concrete floor slab. Typical perimeter building construction is besser block walls, ceiling space inspections at random revealed non-insulated structural steel 'I' beams, steel 'z' roofing purlins, underside of glass fibre insulation blanket directly beneath sheet-metal roof, pvc downpipes, assumed typical throughout. No inspection to ceiling space in this tenancy due to inaccessibility.

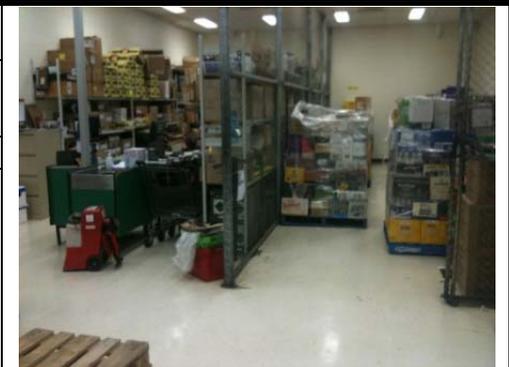
LOCATION - DESCRIPTION	EXTENT	ASBESTOS ASSESSMENT	CONDITION	SAMPLE NO VISUAL TEST	SIGNAGE STATUS
14. Internal, Tenancy 16 'Woolworths', liquor store floor coverings throughout shop – Vinyl Tiles (300mm square, off-white colour).	Approx 5m ² per entry x4.	No asbestos detected	-	Sample no. 09/MA/071210	-
SURVEY FINDINGS and HAZARD MANAGEMENT RECOMMENDATIONS					
Damage noted at coldroom doorway and fenced area. No asbestos detected upon laboratory analysis of sample.

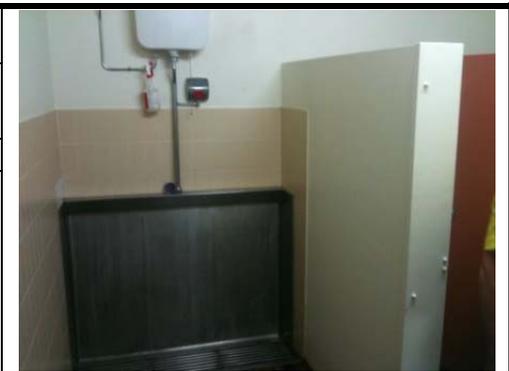
LOCATION - DESCRIPTION	EXTENT	ASBESTOS ASSESSMENT	CONDITION	SAMPLE NO VISUAL TEST	SIGNAGE STATUS
14. Internal, Tenancy 16 'Woolworths', staff amenities toilet partitions – fibre cement thicksheet.	Approx 20m ²	No asbestos detected	-	Sample no. 10/MA/071210	-
SURVEY FINDINGS and HAZARD MANAGEMENT RECOMMENDATIONS					
Damage noted at coldroom doorway and fenced area. No asbestos detected upon laboratory analysis of sample.

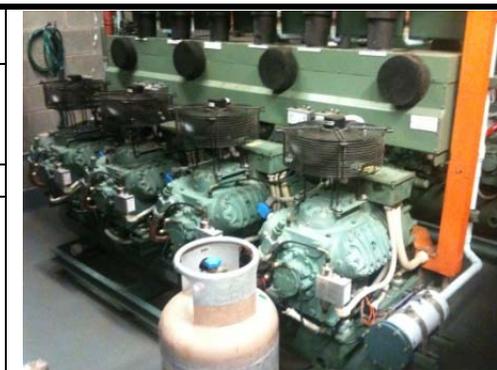
LOCATION - DESCRIPTION	EXTENT	ASBESTOS ASSESSMENT	CONDITION	SAMPLE NO VISUAL TEST	SIGNAGE STATUS
15. Internal, Tenancy 16 'Woolworths', mezzanine area main plantroom air-conditioning plant & equipment – gaskets, compressed fibre compound material.	-	Possible Asbestos Content	Inaccessible	Visual	-

SURVEY FINDINGS and HAZARD MANAGEMENT RECOMMENDATIONS
 Plant and equipment not dismantled for inspection. It is possible for asbestos gaskets to be integral as part of machinery (possible head gaskets etc), whilst none visible, access with caution if dismantling. Treat all gaskets (other than rubber or cork) as asbestos containing unless confirmed otherwise by sample analysis.
 Note non-asbestos containing fire doors detected to plantroom entry with tagged date of manufacture 2xxx.

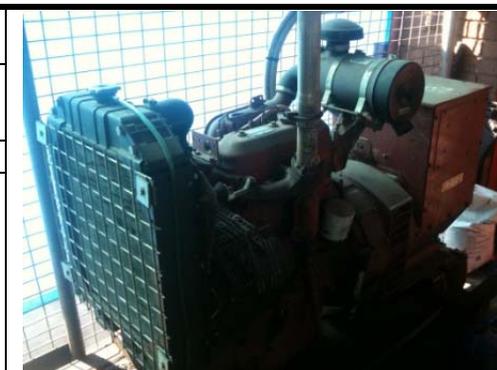
LOCATION - DESCRIPTION	EXTENT	ASBESTOS ASSESSMENT	CONDITION	SAMPLE NO VISUAL TEST	SIGNAGE STATUS
16. Internal, Tenancy 16 'Woolworths', loading dock generator plant & equipment – gaskets, compressed fibre compound material.	-	Possible Asbestos Content	Inaccessible	Visual	-

SURVEY FINDINGS and HAZARD MANAGEMENT RECOMMENDATIONS
 Plant and equipment not dismantled for inspection. It is possible for asbestos gaskets to be integral as part of machinery (possible head gaskets etc), whilst none visible, access with caution if dismantling. Treat all gaskets (other than rubber or cork) as asbestos containing unless confirmed otherwise by sample analysis.

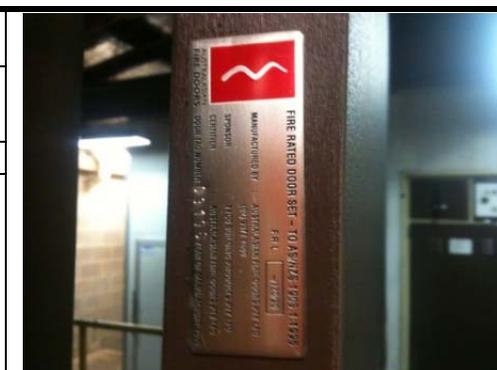
LOCATION - DESCRIPTION	EXTENT	ASBESTOS ASSESSMENT	CONDITION	SAMPLE NO VISUAL TEST	SIGNAGE STATUS
17. Internal, Tenancy 16 'Woolworths' mezzanine level plantroom entry fire rated doors – internal insulating core.	-	No asbestos visible	-	Visual	-

SURVEY FINDINGS and HAZARD MANAGEMENT RECOMMENDATIONS
 No asbestos visible upon inspection. Note non-asbestos containing fire doors detected to plantroom entry with tagged date of manufacture 2000.

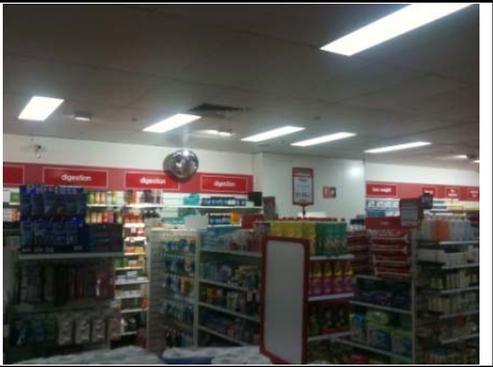
LOCATION - DESCRIPTION	EXTENT	ASBESTOS ASSESSMENT	CONDITION	SAMPLE NO VISUAL TEST	SIGNAGE STATUS	
18. Internal, Tenancy 17/18 'Chemist' construction and fit-out – No asbestos containing materials visible.	-	No asbestos visible	-	Visual	-

<p>SURVEY FINDINGS and HAZARD MANAGEMENT RECOMMENDATIONS</p> <p>No asbestos visible upon inspection. Fit-out consisted of mdf / plasterboard walls, 600mm square plasterboard ceiling tiles suspended in aluminium grid, vinyl and ceramic tiles on concrete floor slab. Typical perimeter building construction is besser block walls, ceiling space inspections at random revealed non-insulated structural steel 'I' beams, steel 'z' roofing purlins, underside of glass fibre insulation blanket directly beneath sheet-metal roof, pvc downpipes, assumed typical throughout. No inspection to ceiling space in this tenancy due to inaccessibility.</p>

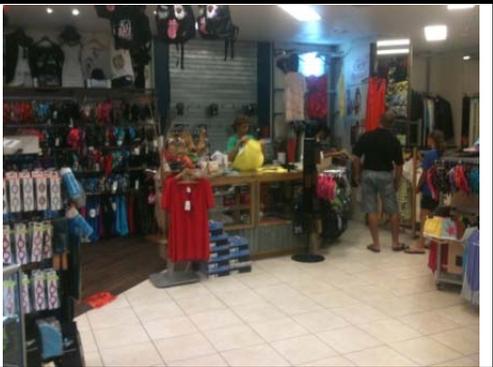
19. Internal, Tenancy 19 'Wild Child Surf Shop' construction and fit-out – No asbestos containing materials visible.	-	No asbestos visible	-	Visual	-

<p>SURVEY FINDINGS and HAZARD MANAGEMENT RECOMMENDATIONS</p> <p>No asbestos visible upon inspection. Fit-out consisted of plasterboard walls, 600mm square plasterboard ceiling tiles suspended in aluminium grid, carpet and ceramic tiles on concrete floor slab. Typical perimeter building construction is besser block walls, ceiling space inspections at random revealed non-insulated structural steel 'I' beams, steel 'z' roofing purlins, underside of glass fibre insulation blanket directly beneath sheet-metal roof, pvc downpipes, assumed typical throughout. No inspection to ceiling space in this tenancy due to inaccessibility.</p>

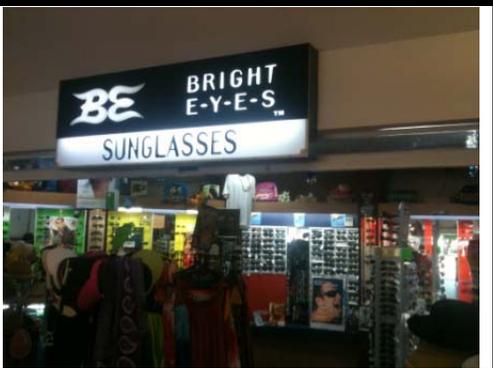
<p>SURVEY FINDINGS and HAZARD MANAGEMENT RECOMMENDATIONS</p> <p>No asbestos visible upon inspection. Fit-out consisted of plasterboard walls, 600mm square plasterboard ceiling tiles suspended in aluminium grid, carpet and ceramic tiles on concrete floor slab. Typical perimeter building construction is besser block walls, ceiling space inspections at random revealed non-insulated structural steel 'I' beams, steel 'z' roofing purlins, underside of glass fibre insulation blanket directly beneath sheet-metal roof, pvc downpipes, assumed typical throughout. No inspection to ceiling space in this tenancy due to inaccessibility.</p>

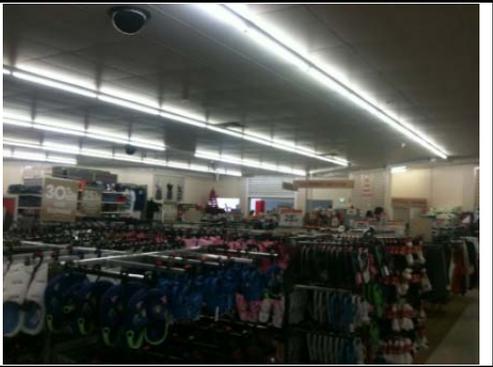
LOCATION - DESCRIPTION	EXTENT	ASBESTOS ASSESSMENT	CONDITION	SAMPLE NO VISUAL TEST	SIGNAGE STATUS	
21. Internal, Tenancy 21 'Target Country' construction and fit-out – No asbestos containing materials visible.	-	No asbestos visible	-	Visual	-

<p>SURVEY FINDINGS and HAZARD MANAGEMENT RECOMMENDATIONS</p> <p>No asbestos visible upon inspection. Fit-out consisted of plasterboard walls, 600mm square plasterboard ceiling tiles suspended in aluminium grid, carpet and ceramic tiles on concrete floor slab. Typical perimeter building construction is besser block walls, ceiling space inspections at random revealed non-insulated structural steel 'I' beams, steel 'z' roofing purlins, underside of glass fibre insulation blanket directly beneath sheet-metal roof, pvc downpipes, assumed typical throughout. No inspection to ceiling space in this tenancy due to inaccessibility.</p>

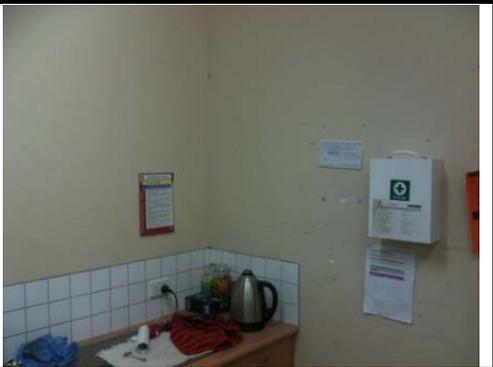
<p>SURVEY FINDINGS and HAZARD MANAGEMENT RECOMMENDATIONS</p> <p>Item was visually identified at top edge of stud wall from within ceiling space as 'villaboard' fibre cement sheet consistent with wall linings detected in cleaners storeroom, assumed to be similar material and age of construction. As no asbestos detected to this other sheeting it was presumed to be the same.</p>

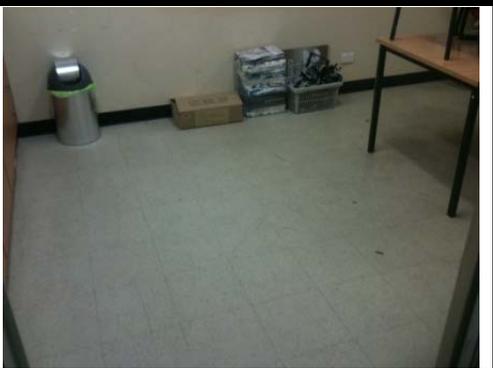
<p>SURVEY FINDINGS and HAZARD MANAGEMENT RECOMMENDATIONS</p> <p>No asbestos detected upon laboratory analysis of sample.</p>

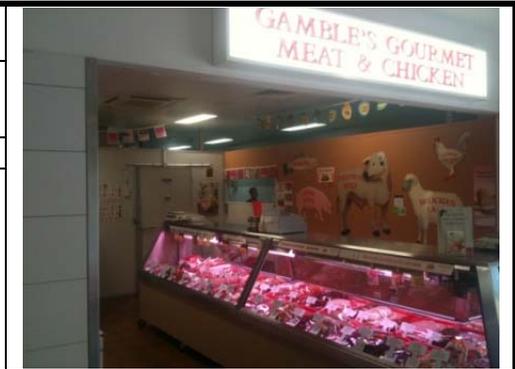
LOCATION - DESCRIPTION	EXTENT	ASBESTOS ASSESSMENT	CONDITION	SAMPLE NO VISUAL TEST	SIGNAGE STATUS
24. Internal, Tenancy 22 'Butchers' construction and fit-out – No asbestos containing materials visible.	-	No asbestos visible	-	Visual	-

SURVEY FINDINGS and HAZARD MANAGEMENT RECOMMENDATIONS
 No asbestos visible upon inspection. Fit-out consisted of plasterboard walls, 600mm square plasterboard ceiling tiles suspended in aluminium grid, carpet and ceramic tiles on concrete floor slab. Typical perimeter building construction is besser block walls, ceiling space inspections at random revealed non-insulated structural steel 'I' beams, steel 'z' roofing purlins, underside of glass fibre insulation blanket directly beneath sheet-metal roof, pvc downpipes, assumed typical throughout. No inspection to ceiling space in this tenancy due to inaccessibility.

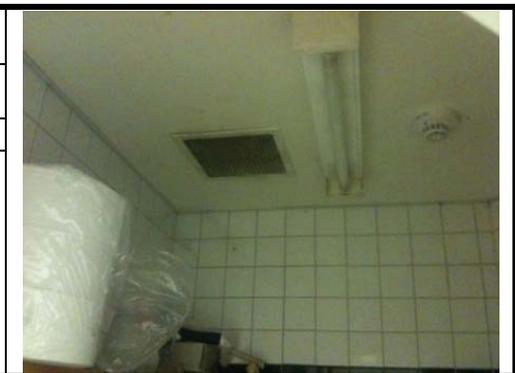
LOCATION - DESCRIPTION	EXTENT	ASBESTOS ASSESSMENT	CONDITION	SAMPLE NO VISUAL TEST	SIGNAGE STATUS
25. Internal, Amenities, cleaners store, and toilets ceiling linings – fibre cement sheeting.	Approx 50m ² visible	No asbestos detected	-	Sample no. 06/MA/071210	-

SURVEY FINDINGS and HAZARD MANAGEMENT RECOMMENDATIONS
 No asbestos detected upon laboratory analysis of sample.

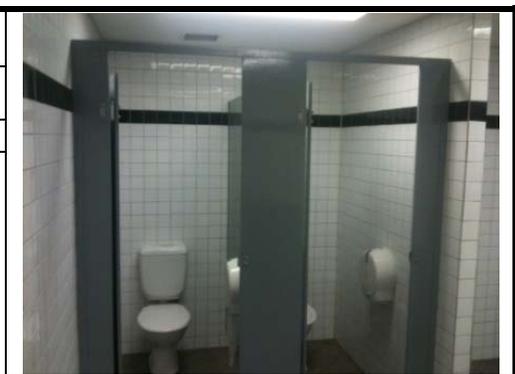
LOCATION - DESCRIPTION	EXTENT	ASBESTOS ASSESSMENT	CONDITION	SAMPLE NO VISUAL TEST	SIGNAGE STATUS
26. Internal, Amenities, male and female toilets dividing partitions – fibre cement thicksheet.	Approx 20m ² visible	No asbestos detected	-	Sample no. 07/MA/071210	-

SURVEY FINDINGS and HAZARD MANAGEMENT RECOMMENDATIONS
 No asbestos detected upon laboratory analysis of sample.

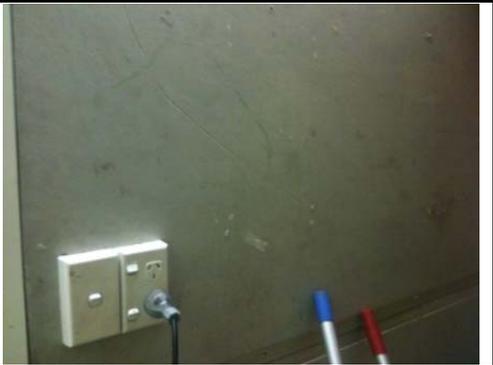
LOCATION - DESCRIPTION	EXTENT	ASBESTOS ASSESSMENT	CONDITION	SAMPLE NO VISUAL TEST	SIGNAGE STATUS
27. Internal, Mall / Plaza cleaners storeroom wall linings - fibre cement sheeting.	Approx 20m ² visible	No asbestos detected	-	Sample no. 08/MA/071210	-
SURVEY FINDINGS and HAZARD MANAGEMENT RECOMMENDATIONS					
No asbestos detected upon laboratory analysis of sample.

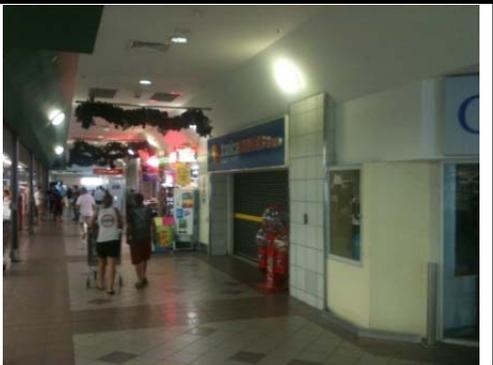
LOCATION - DESCRIPTION	EXTENT	ASBESTOS ASSESSMENT	CONDITION	SAMPLE NO VISUAL TEST	SIGNAGE STATUS
28. Internal, Mall / Plaza ceiling linings sampled from adjacent cleaners storeroom - fibre cement sheeting.	Approx 20m ² visible	No asbestos detected	-	Sample no. 05/MA/071210	-
SURVEY FINDINGS and HAZARD MANAGEMENT RECOMMENDATIONS					
No asbestos detected upon laboratory analysis of sample.

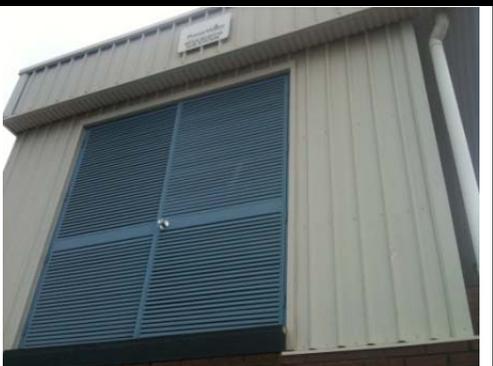
LOCATION - DESCRIPTION	EXTENT	ASBESTOS ASSESSMENT	CONDITION	SAMPLE NO VISUAL TEST	SIGNAGE STATUS
29. Internal / External of second storey electrical sub-station – no access for inspection.	Extent not able to be confirmed	-	Inaccessible	-	-
SURVEY FINDINGS and HAZARD MANAGEMENT RECOMMENDATIONS					
No access for inspection – access with caution.
