ASBESTOS REGISTER No. NT0580

**MINERALS HOUSE
58 HARTLEY STREET
ALICE SPRINGS NT**

Date: August 2013
Register No: NT0580
Register Version: V01
Our Ref: DK/sk

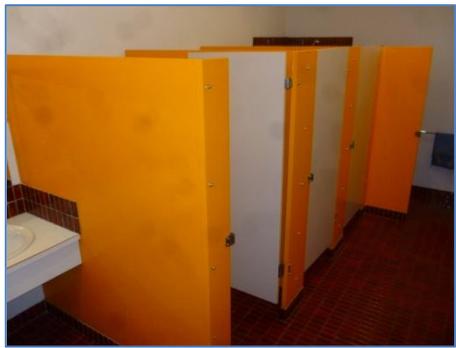
GROUND FLOOR – Internal			
Location	Type of Material		
1. Partitions in Male & Female toilets (30m ²)	Fibre cement sheet material containing white (Chrysotile) asbestos (sample no.1)

Recommendation and Action			
Refer to Asbestos Management Plan & Section 7.0: Policies and Recommendations			
Situational Asbestos Risk Assessment:			
Friability	Condition	Signage	Risk Rating
Non friable	Stable	Install 3 small warning signs	Low

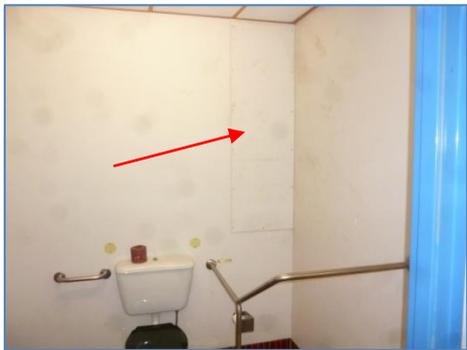
Location	Type of Material		
2. Infill panel on Northern elevation wall of Disabled toilets (1m ²)	Fibre cement sheet material containing white (Chrysotile) asbestos (sample no.2)

Recommendation and Action			
Refer to Asbestos Management Plan & Section 7.0: Policies and Recommendations			
Situational Asbestos Risk Assessment:			
Friability	Condition	Signage	Risk Rating
Non friable	Stable	Install 1 small warning sign	Low

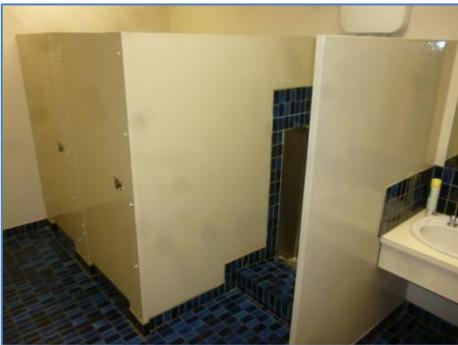
FIRST FLOOR - Internal			
Location		Type of Material	
3. Partitions in Male & Female toilets (30m ²)		Fibre cement sheet material containing white (Chrysotile) asbestos (per sample no.1)

Refer to Asbestos Management Plan & Section 7.0: Policies and Recommendations			
Situational Asbestos Risk Assessment:			
Friability	Condition	Signage	Risk Rating
Non friable	Stable	Install 2 small warning signs	Low

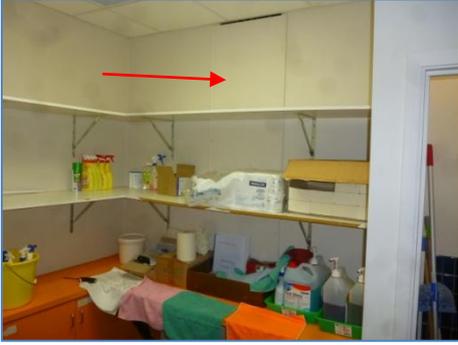
Location		Type of Material	
4. Infill panel in Cleaners room (1m ²)		Fibre cement sheet material containing white (Chrysotile) asbestos (sample no.4)

Refer to Asbestos Management Plan & Section 7.0: Policies and Recommendations			
Situational Asbestos Risk Assessment:			
Friability	Condition	Signage	Risk Rating
Non friable	Stable	Install 1 small warning sign	Low

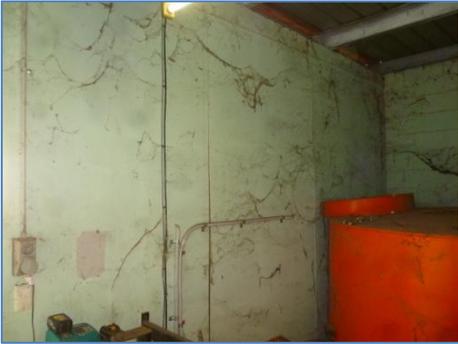
Location		Type of Material	
5. Wall lining in Plant room (20m ²)		Fibre cement sheet material containing white (Chrysotile) asbestos (sample no.5)

Refer to Asbestos Management Plan & Section 7.0: Policies and Recommendations			
Situational Asbestos Risk Assessment:			
Friability	Condition	Signage	Risk Rating
Non friable	Some damaged sections	Install 2 small warning signs	Low

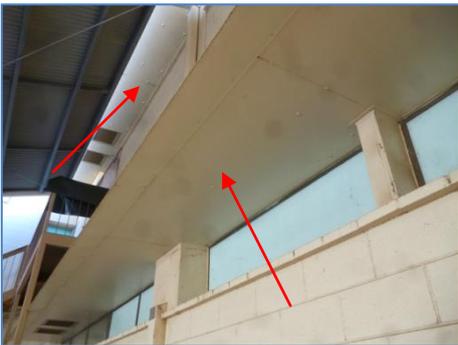
GROUND & FIRST FLOOR – External			
Location		Type of Material	
6. Awning cladding in rear Carpark (30m ²)		Fibre cement sheet material containing white (Chrysotile) asbestos (sample no.7)

Refer to Asbestos Management Plan & Section 7.0: Policies and Recommendations			
Situational Asbestos Risk Assessment:			
Friability	Condition	Signage	Risk Rating
Non friable	Stable	Install 2 small warning signs on each floor	Low
