**ASBESTOS CONTAINING MATERIALS
SURVEY REPORT**

270 Trower Road, Casuarina NT

Report Number 680.10358.00000-R01-ASR

27 April 2017

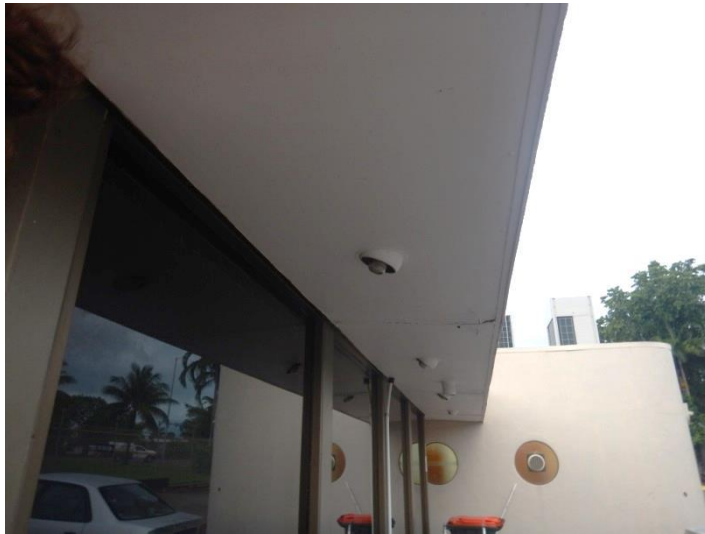
Photo 1

Non-ACM lining to external eaves, as confirmed by laboratory analysis (sample I.D. MVR1)

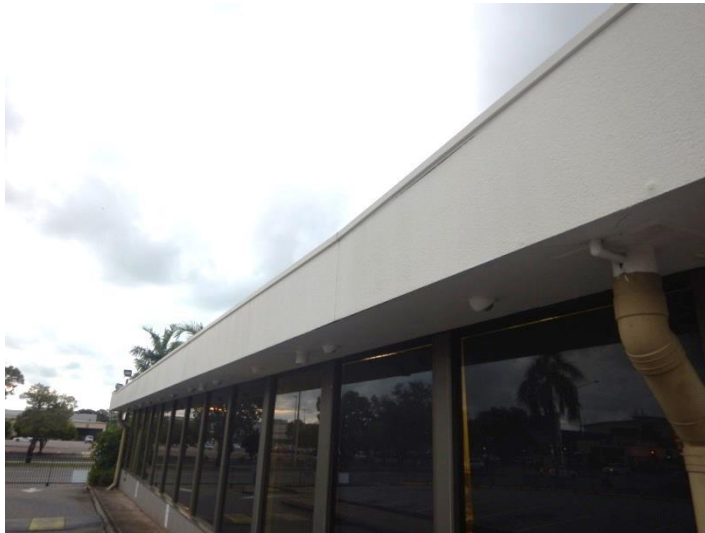
Photo 2

Non-ACM lining to external fascia, as confirmed by laboratory analysis (sample I.D. MVR2)

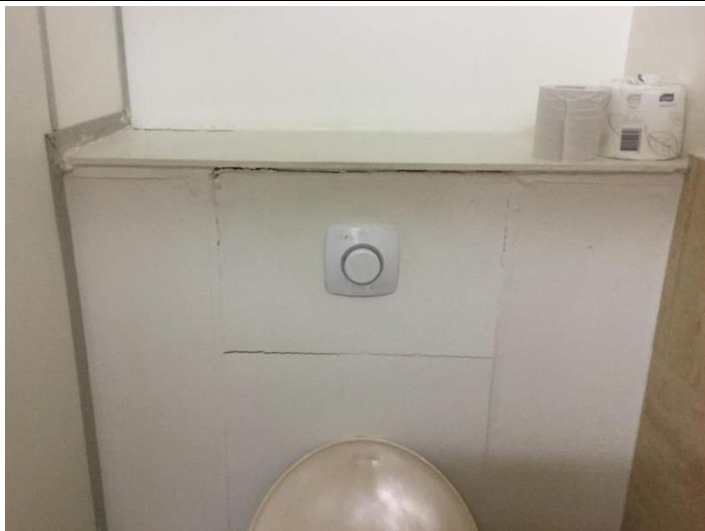
Photo 3

Non-ACM panel to ledge above toilet cisterns, as confirmed by laboratory analysis (sample I.D. MVR3)

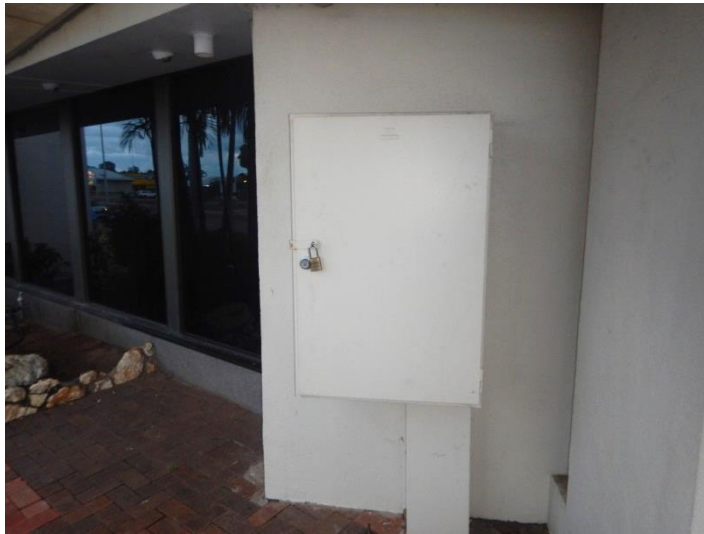
Photo 4

Inaccessible during site investigation and excluded from this survey:

Materials inside external electrical switchboard, adjacent to main entrance.

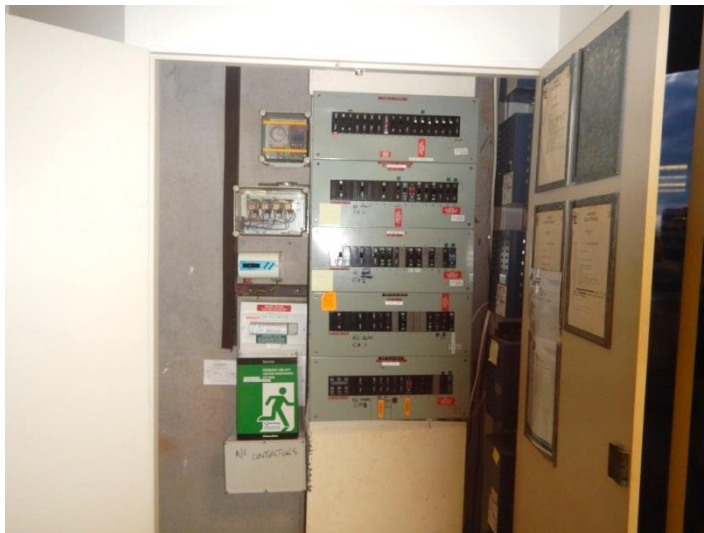
Photo 5

Inaccessible during site investigation and excluded from this survey:

Backing board and fuses to internal electrical switchboard, adjacent to main entryway

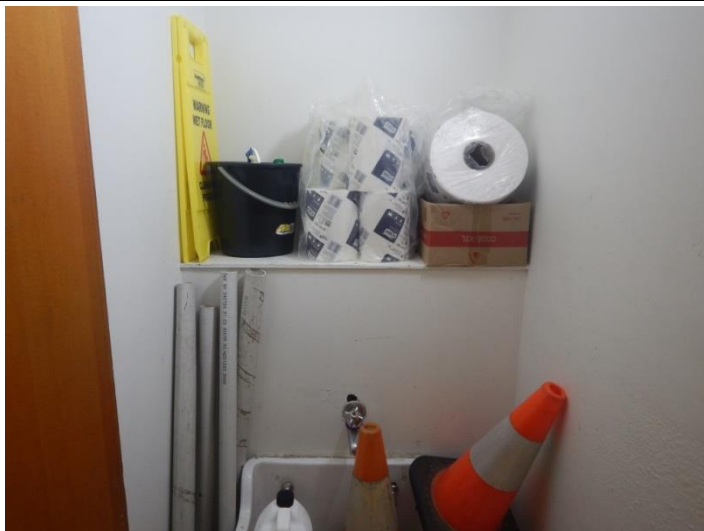
Photo 6

Non-ACM panels above trough sink in cleaning cupboard, as confirmed by laboratory analysis of what is presumed to be the same material (i.e.: sample I.D. MVR3)

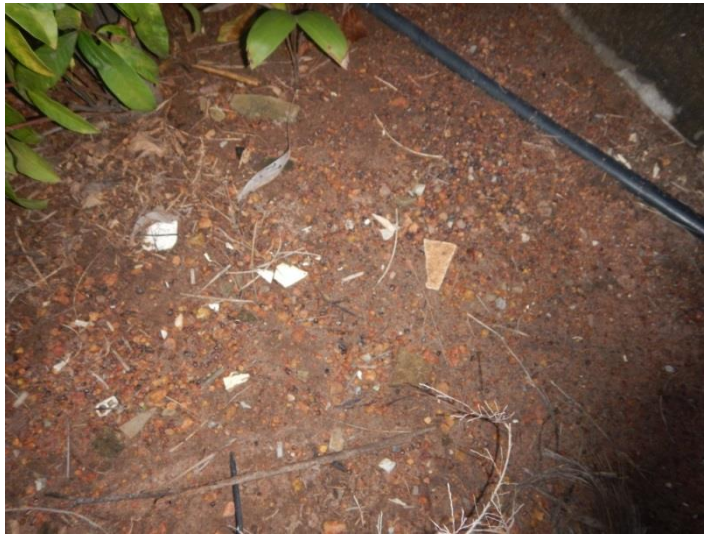
Photo 7

Non-ACM fragments on ground surface at north western boundary of building, as confirmed by laboratory analysis of what is presumed to be the same material (i.e.: sample I.D. MVR1)

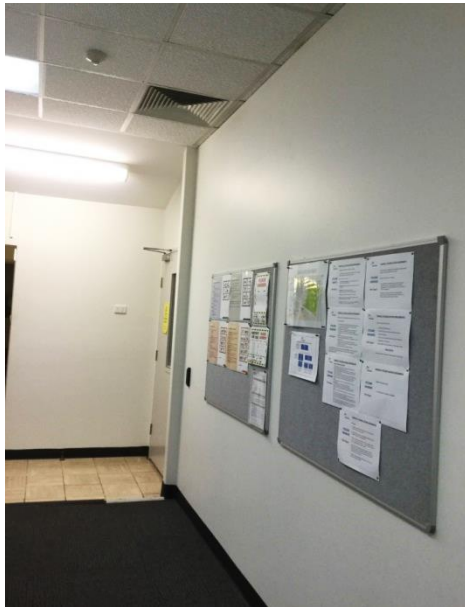
Photo 8

Representative of non-ACM linings to ceiling, walls and floor coverings in open plan office spaces, meeting rooms and staff room
