ASBESTOS CONTAINING BUILDING MATERIALS SURVEY REPORT

Rapid Creek Business Village

Report Number 680.10137.00000/01/ASR

22 January 2015

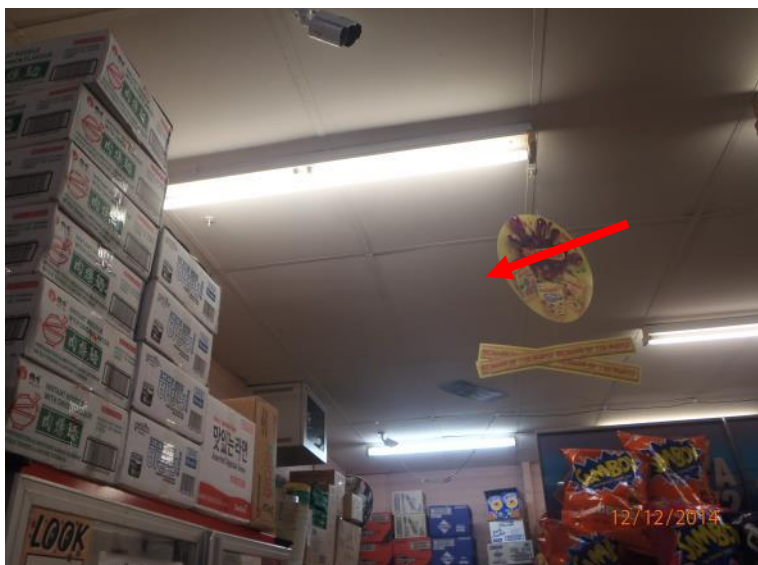
Photograph 1

AC ceiling tiles throughout Shop 1
(assumed asbestos containing).

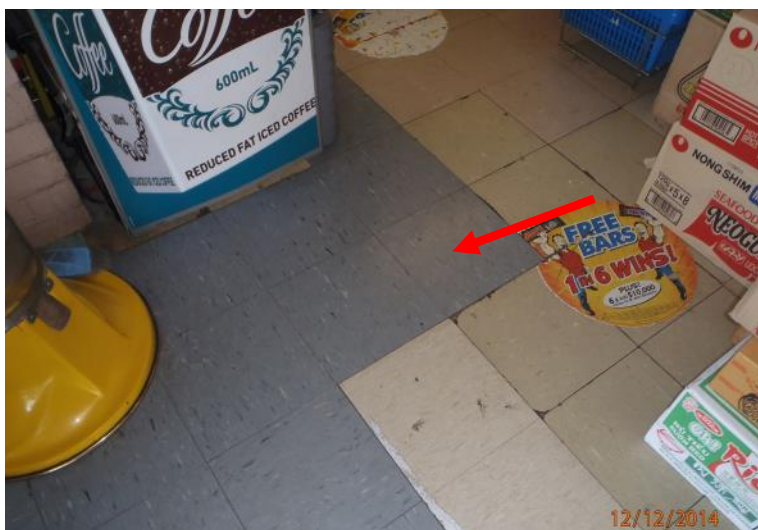
Photograph 2

Vinyl Floor Tiles to Shop 1 – photo
shows numerous different tile colours
(assumed asbestos containing).

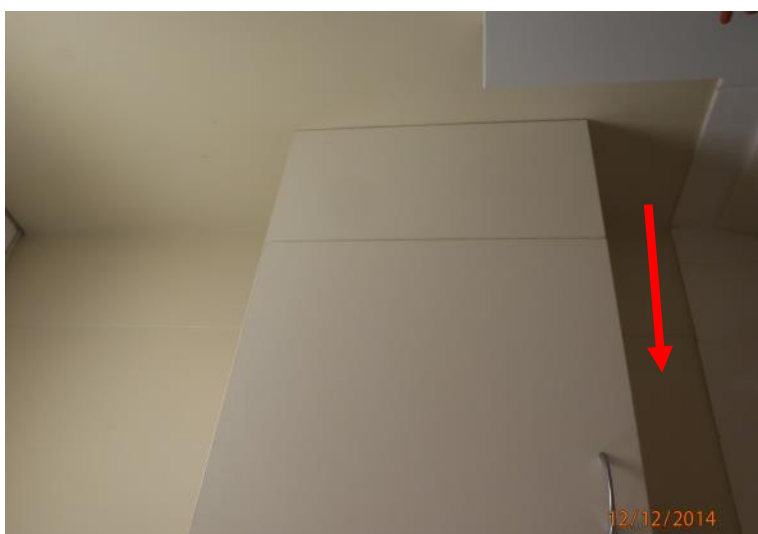
Photograph 3

AC sheeting to riser in Shop 3 kitchen
(asbestos containing).

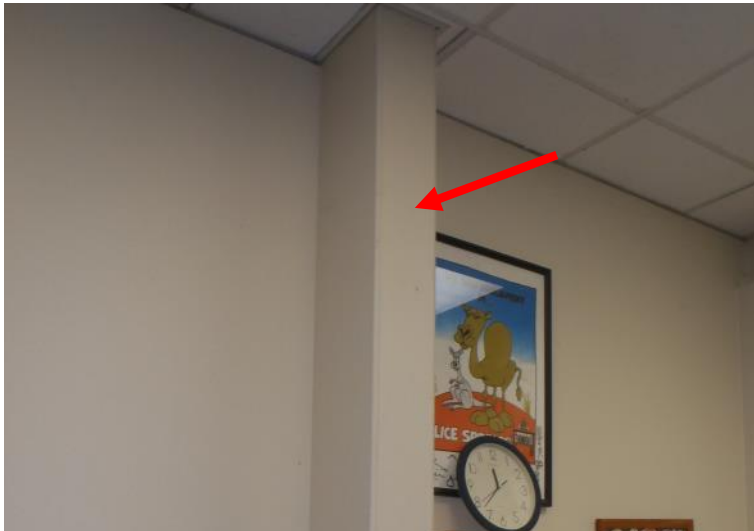
Photograph 4

AC Sheeting to riser in Shop 3
boardroom
(assumed asbestos containing).

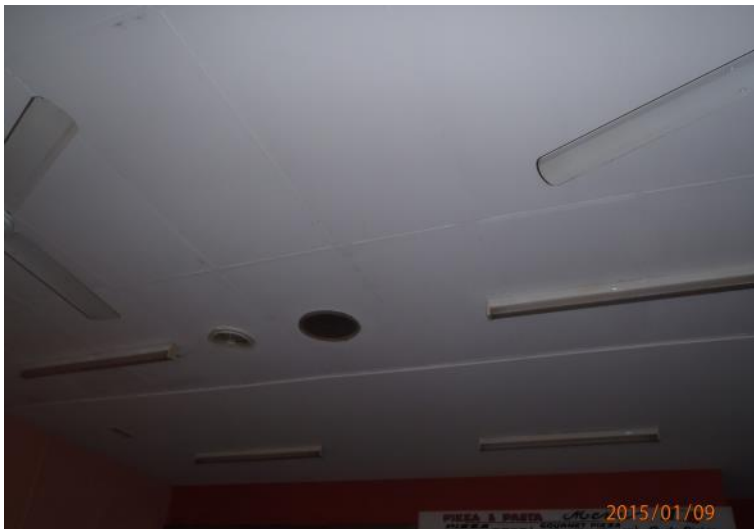
Photograph 5

AC Ceiling tiles to Shop 4
(assumed asbestos containing).

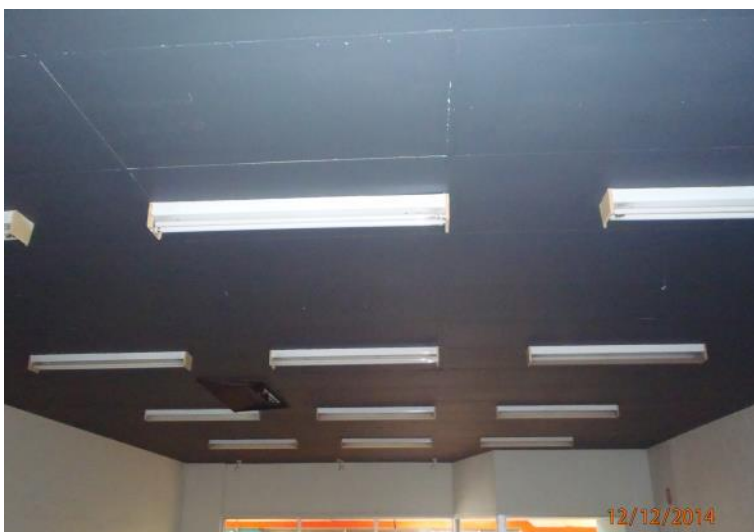
Photograph 6

AC Ceiling tiles to Shop 5
(assumed asbestos containing).

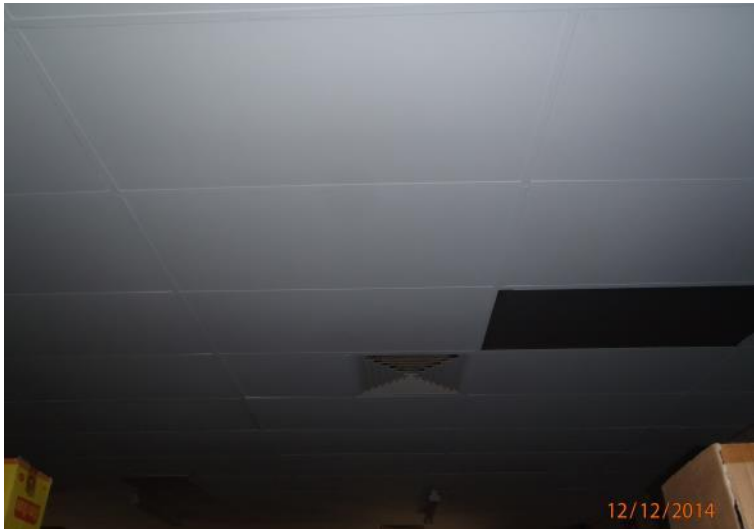
Photograph 7

AC Ceiling tiles to Shop 6

(assumed asbestos containing).

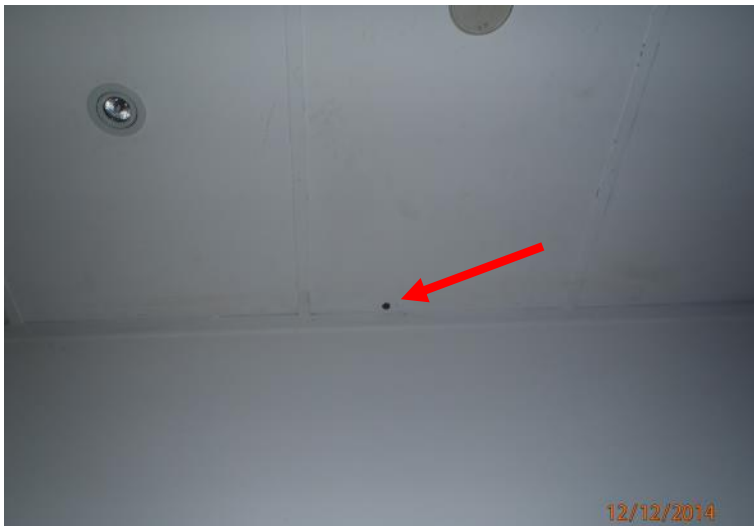
Photograph 8

Minor damage to AC Ceiling tiles to Shop 6

(assumed asbestos containing).

- Materials which have been marked as damaged should be repaired as soon as possible.
- The ACM identified to be present within Power Room 2 requires immediate attention. These materials should be remediated as soon as possible.

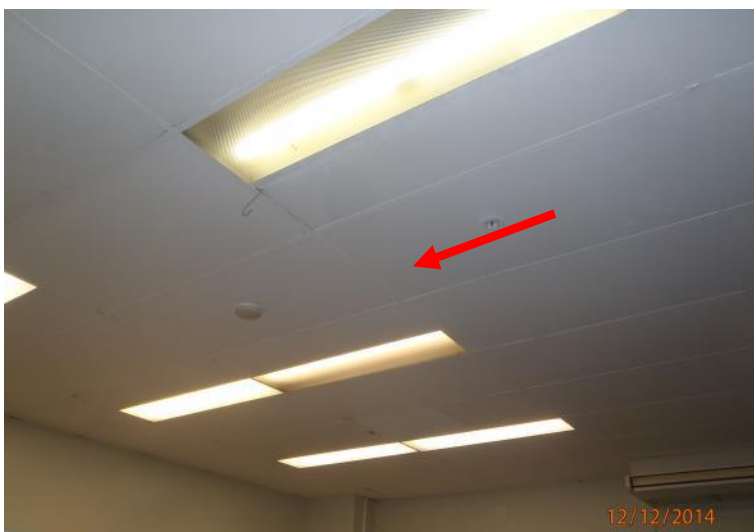
Photograph 9

AC Ceiling tiles to main office area of Shop 7

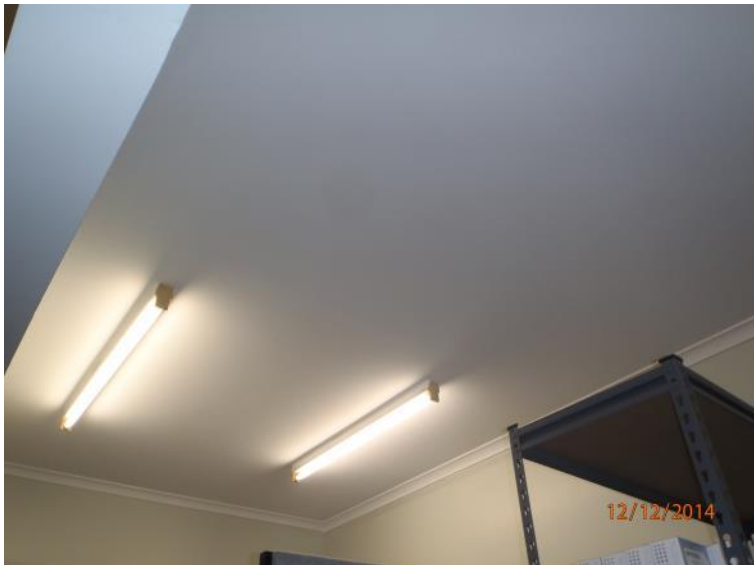
Photograph 10

AC Ceiling tiles assumed to be present above the refurbished false ceiling to the rear office of Shop 7 (assumed asbestos containing).

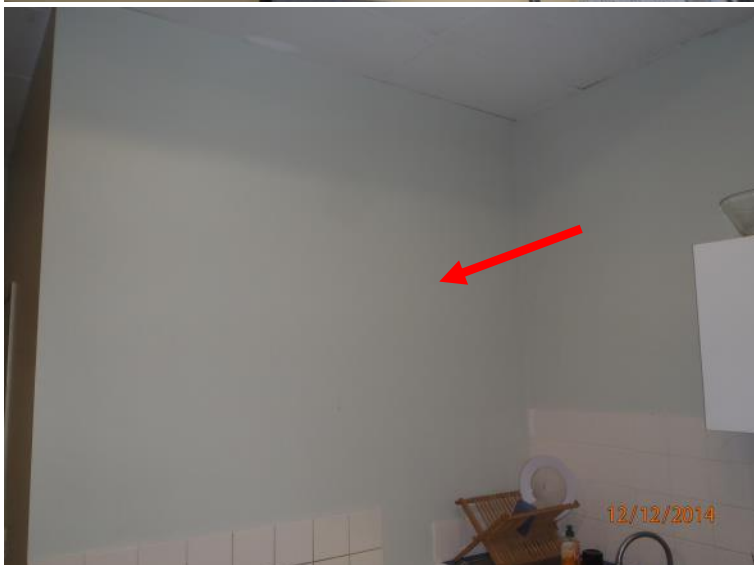
Photograph 11

Item Location & Material Type	Sample No./ Assumed	Photo No.	Approx. Extent	Non-Friable/Friable	Product Type (A)	Extent of Damage /Deterioration (B)	Surface Treatment (C)	Asbestos Type (D)	Risk Assessment (Material Assessment) Score & Rating (A+B+C+D)	Recommended Control Actions	Comments
External - Within the scope and limitations of this survey, no asbestos containing materials were identified to the accessible external areas of Shop 6 during the investigation											
Shop 7 – H&R Block											
Internal / FCS / AC ceiling tiles to front office area	Assumed	9	~60m ²	Non-Friable	1	0	0	3	4 - Very Low	C1, C2, C3, C4, C8	
Internal / FCS / AC ceiling tiles to rear office area	Assumed	10	~40m ²	Non-Friable	1	0	0	3	4 - Very Low	C1, C2, C3, C4, C8	Note – AC tiles assumed to be in situ beneath newly refurbished office area to the south of the tenancy
Internal/FCS/Wall linings to toilet	Assumed	11	~10m ²	Non-Friable	1	0	0	3	4 – Very Low	C1, C2, C3, C4, C5, C8

AC sheet wall lining to toilet area in Shop 7 (assumed asbestos containing).

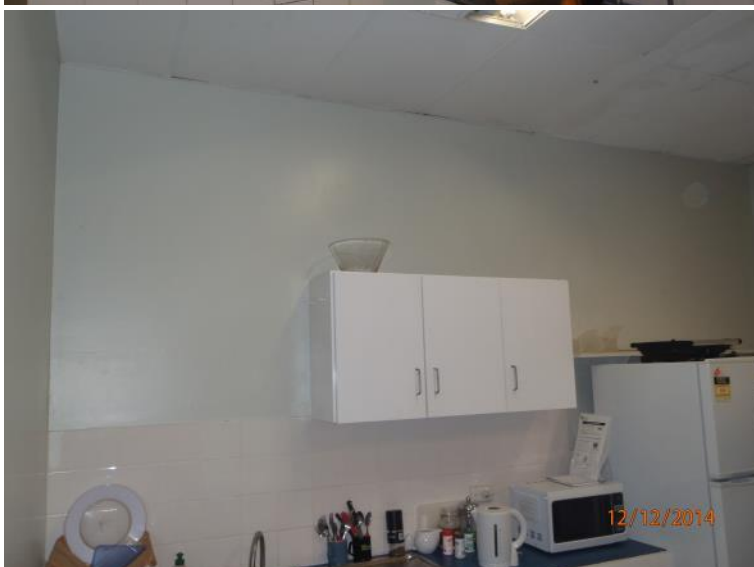
Photograph 12

AC sheet wall lining to kitchen area in Shop 7 (assumed asbestos containing).

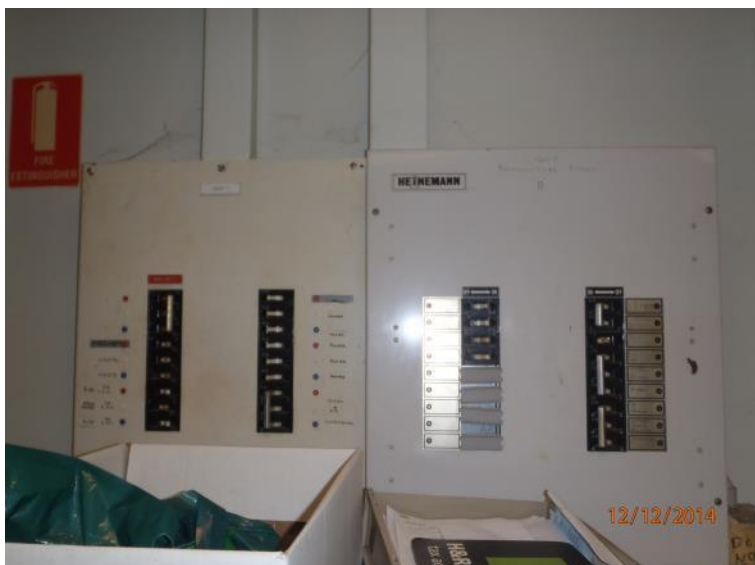
Photograph 13
Backing boards to electrical boxes in
Shop 7
(assumed asbestos containing).

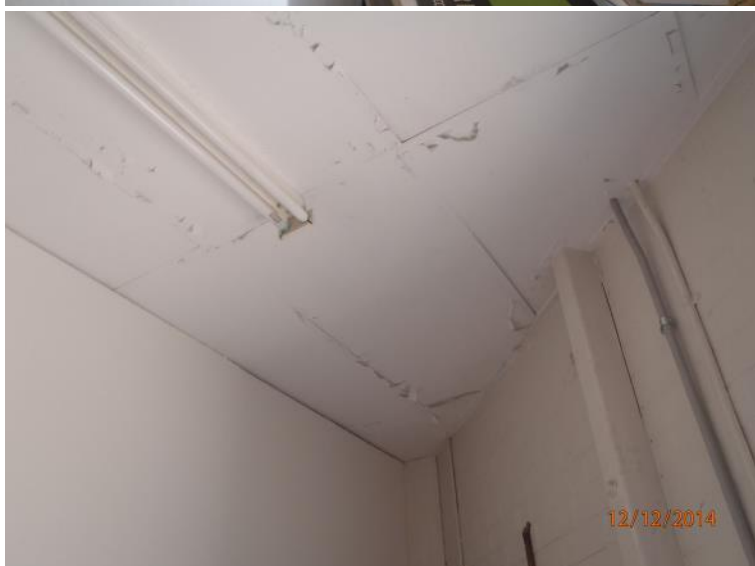
Photograph 14
AC ceiling tiles throughout Shop 8
(assumed asbestos containing).

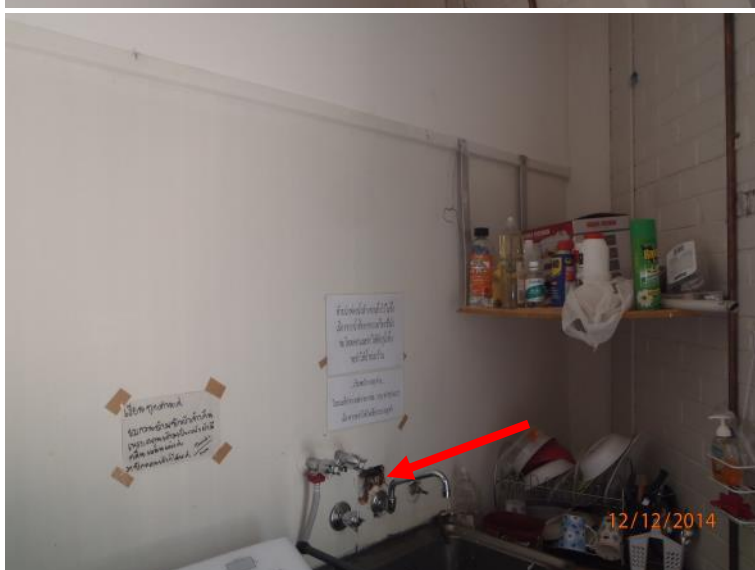
Photograph 15
AC sheet to lower wall lining to
laundry area of Shop 8 – note
damage around tap
(assumed asbestos containing).

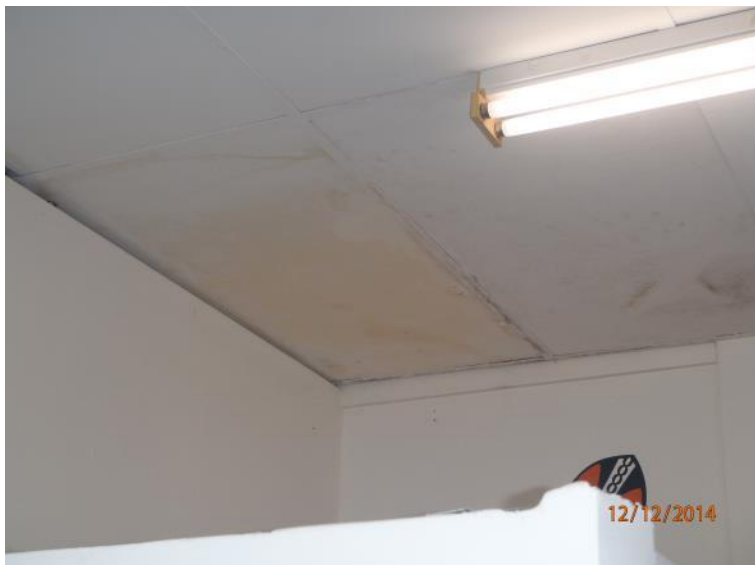
Photograph 16

AC ceiling tiles throughout Shop 10
(note water damage)

(assumed asbestos containing).

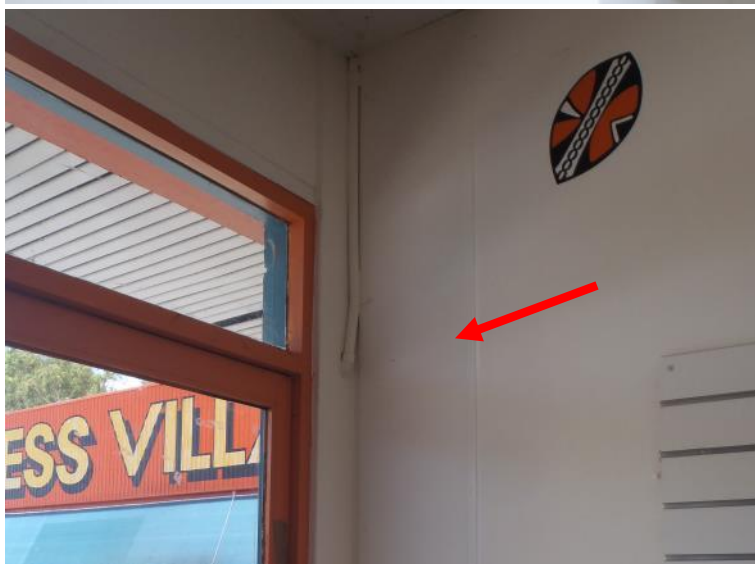
Photograph 17

AC sheeting to riser in Shop 10

(assumed asbestos containing).

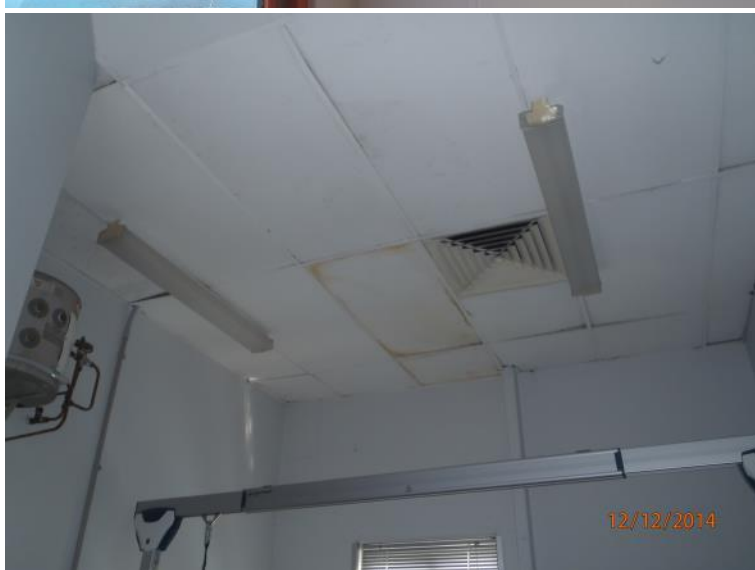
Photograph 18

AC ceiling tiles throughout Shop 11
(note water damage)

(assumed asbestos containing).

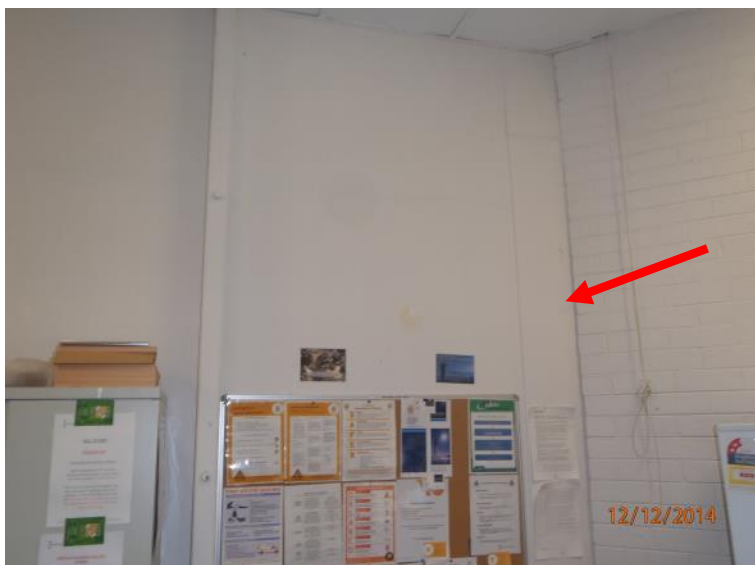
Photograph 19

AC ceiling tiles throughout Shop 10
(note water damage)
(assumed asbestos containing).

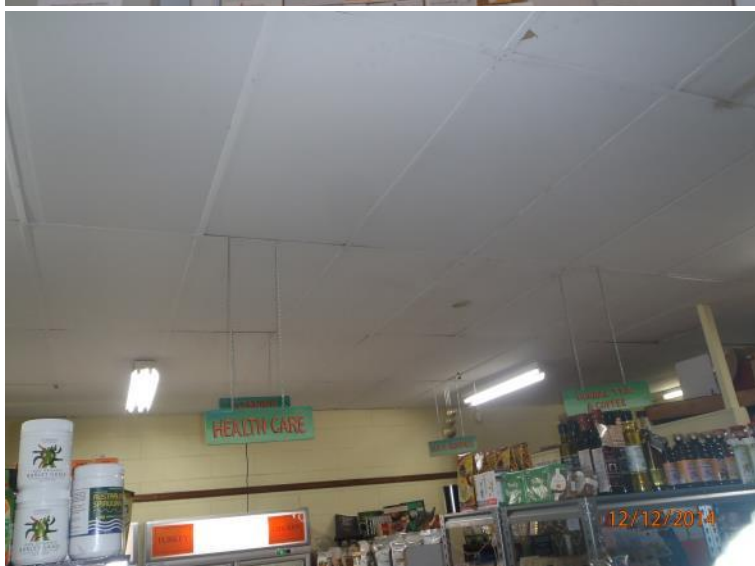
Photograph 20

AC ceiling tiles throughout Shops 12,
13 and 14 (representative)
(assumed asbestos containing).

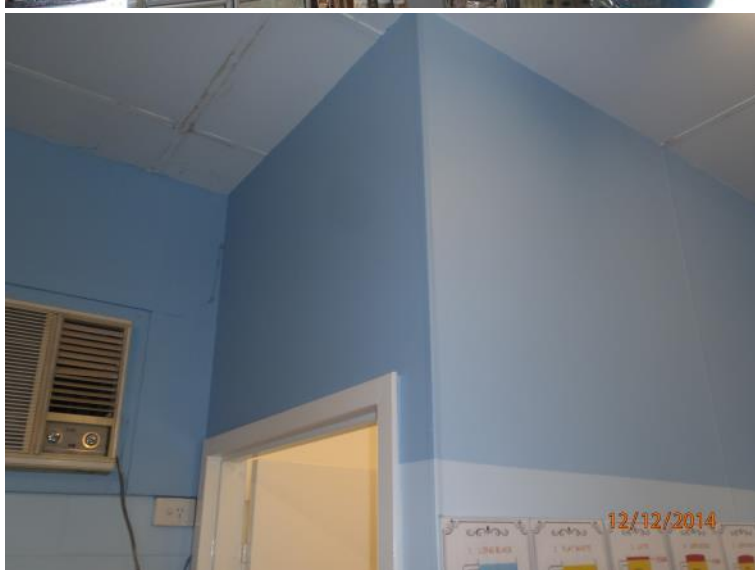
Photograph 21

AC ceiling tiles throughout Shop 15
and AC wall lining to toilet
(assumed asbestos containing).

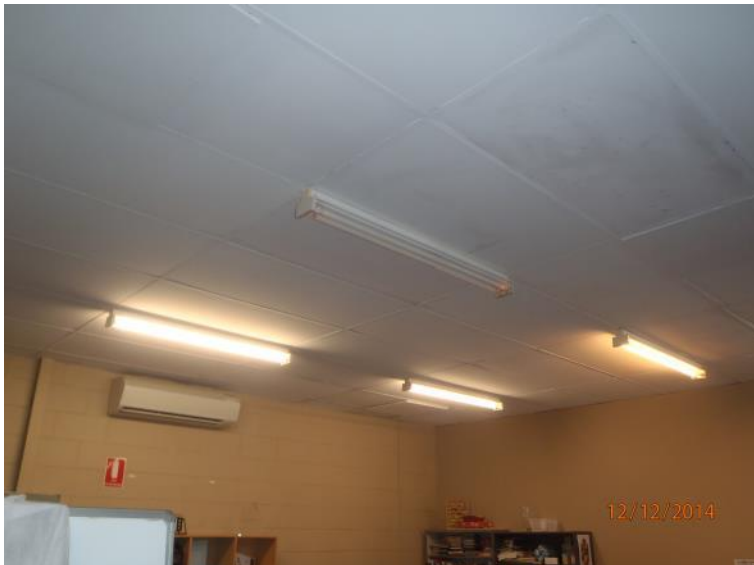
Photograph 22

AC ceiling tiles throughout Shop 16

(assumed asbestos containing).

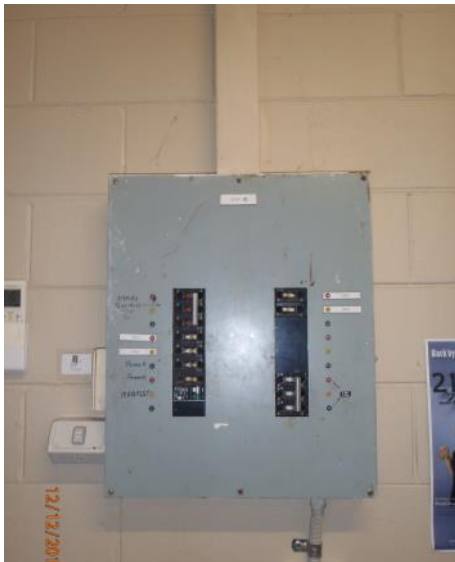
Photograph 23

Backing board to electrical box in Shop 16

(assumed asbestos containing).

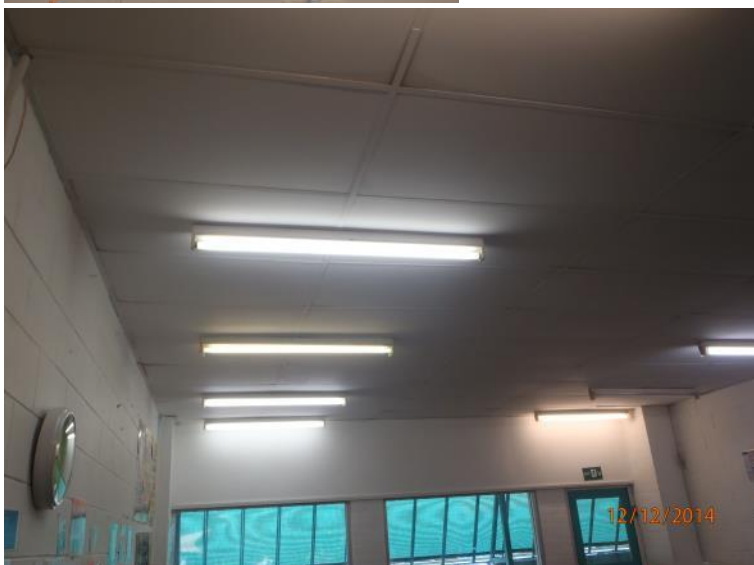
Photograph 24

AC ceiling tiles throughout Shop 17
(assumed asbestos containing).

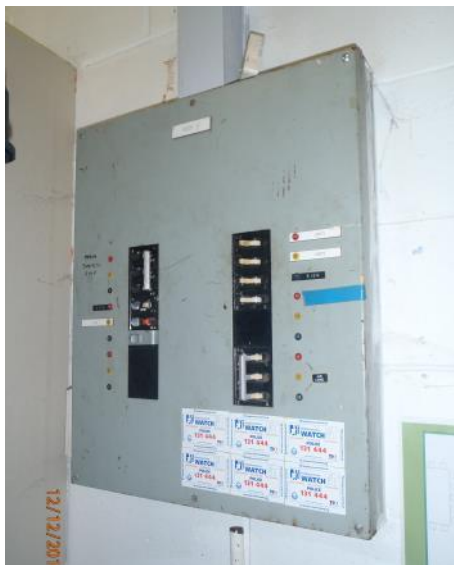
Photograph 25

Backing board to electrical box in
Shop 17

(assumed asbestos containing).

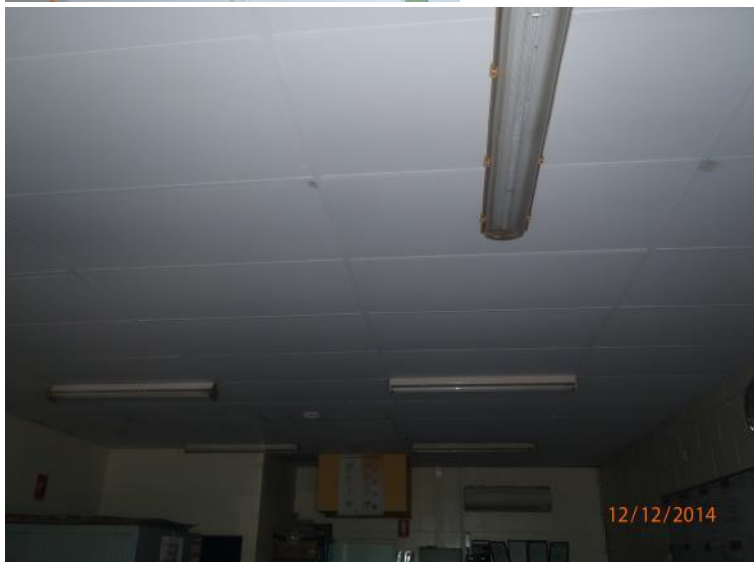
Photograph 26

AC ceiling tiles throughout Shop 18
(assumed asbestos containing).

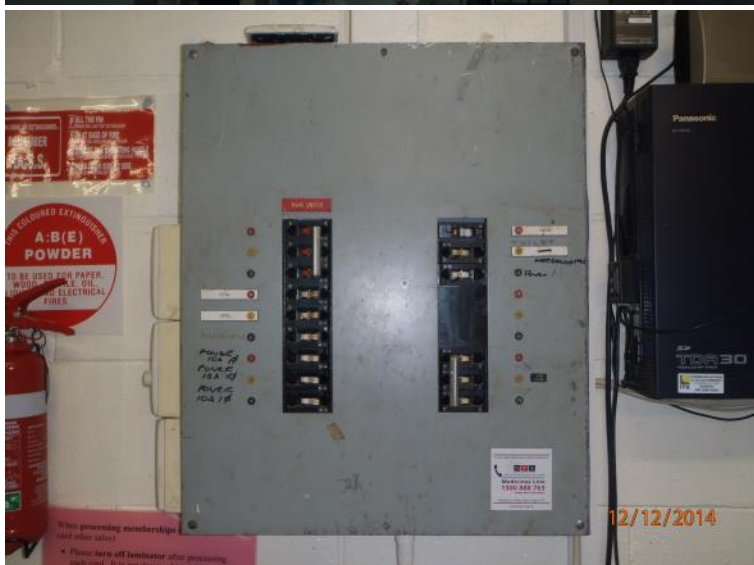
Photograph 27

Backing board to electrical box
(assumed asbestos containing).

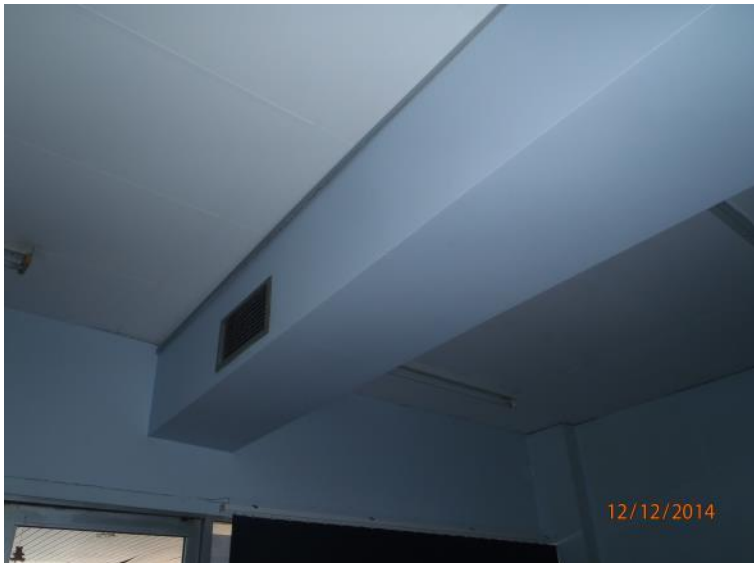
Photograph 28

AC ceiling tiles throughout Shop 19
and AC sheeting to A/C ductwork
(assumed asbestos containing).

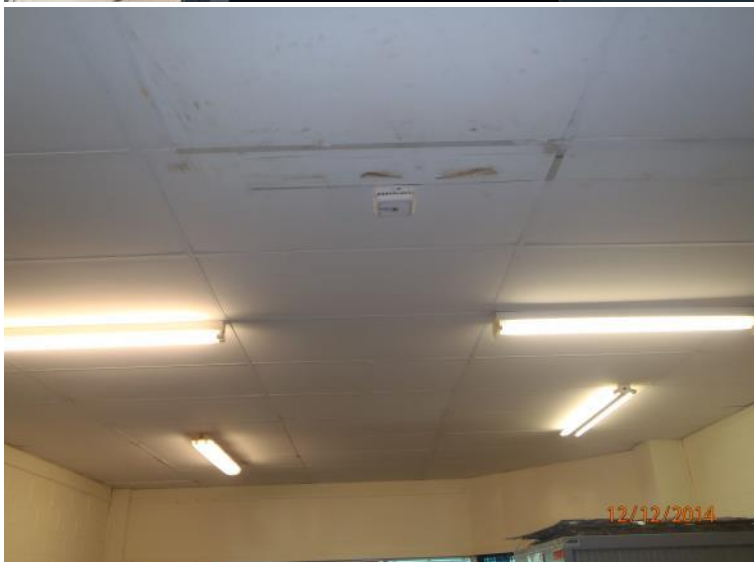
Photograph 29

AC ceiling tiles throughout Shop 20
(assumed asbestos containing).

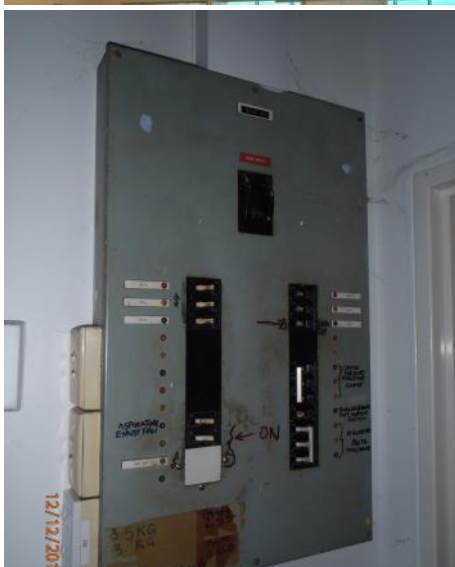
Photograph 30

Backing board to electrical box in
Shop 20
(assumed asbestos containing).

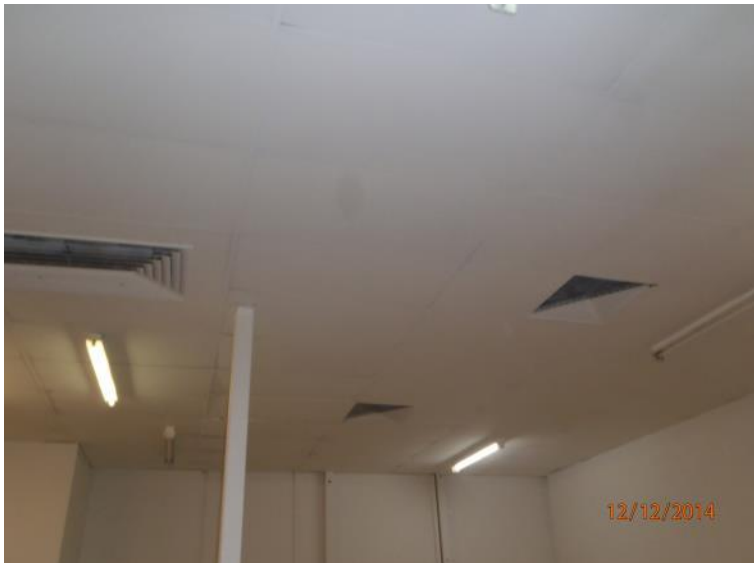
Photograph 31

AC ceiling tiles throughout Shop 21
(assumed asbestos containing).

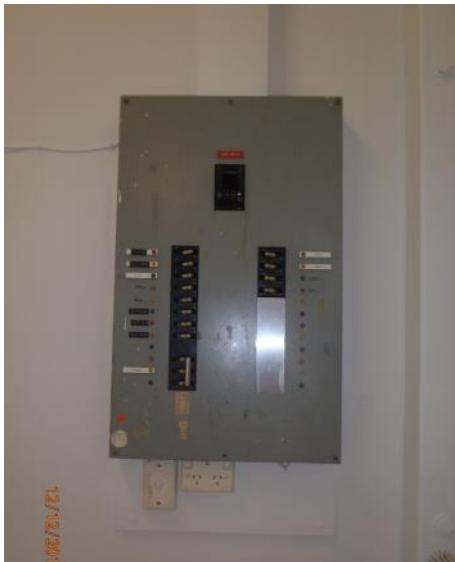
Photograph 32

Backing board to electrical box
(assumed asbestos containing).

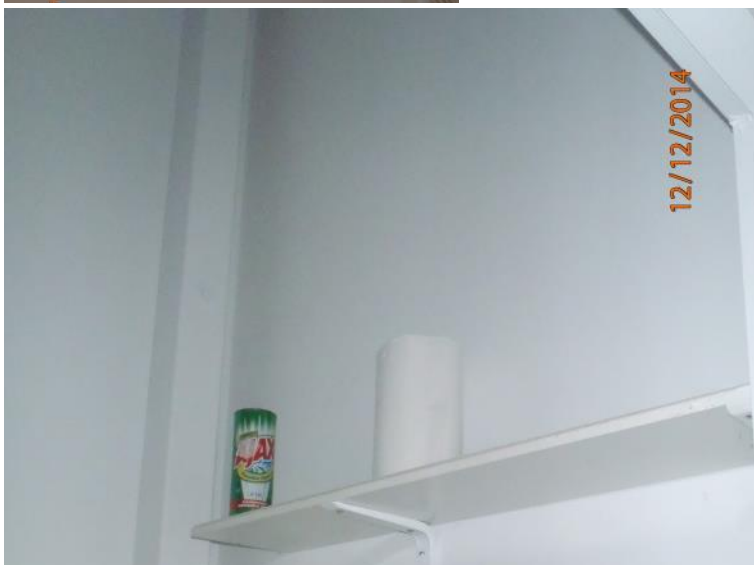
Photograph 33

AC sheeting to wall linings of toilet
(assumed asbestos containing).

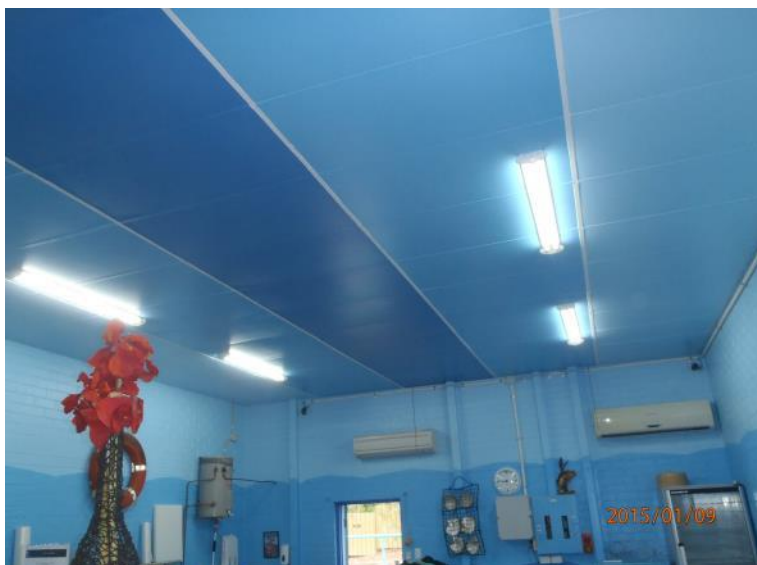
Photograph 34

AC ceiling tiles throughout Shop 22
and backing board to electrical box
(assumed asbestos containing).

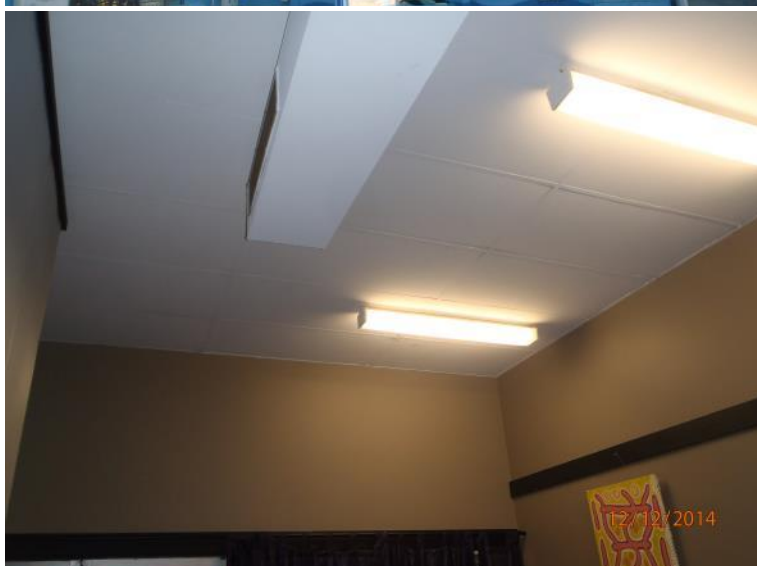
Photograph 35

AC ceiling tiles throughout Shop 23
(assumed asbestos containing).

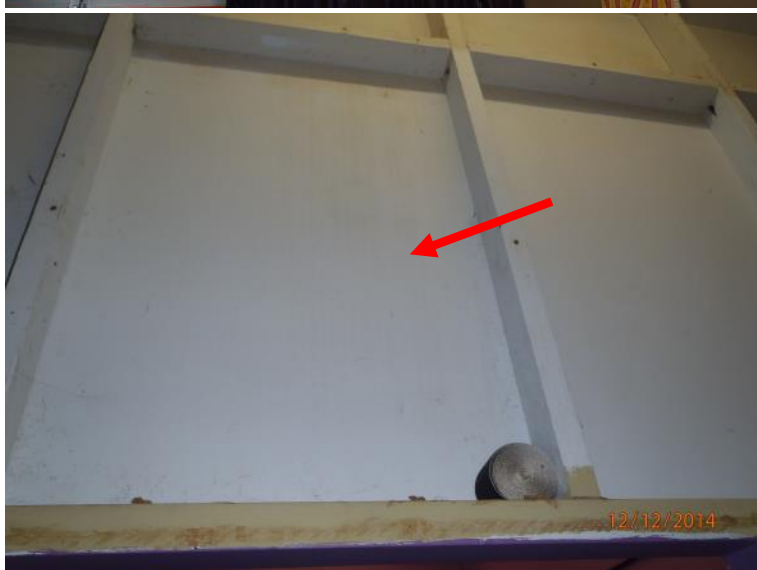
Photograph 36

AC sheeting to upper walls in rear
area of Shop 23
(assumed asbestos containing).

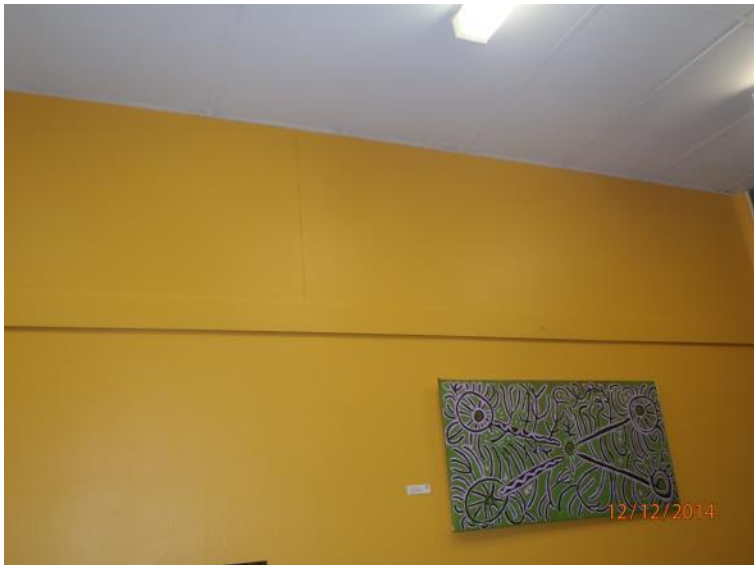
Photograph 37

AC sheeting to upper walls in kitchen area of Shop 23
(assumed asbestos containing).

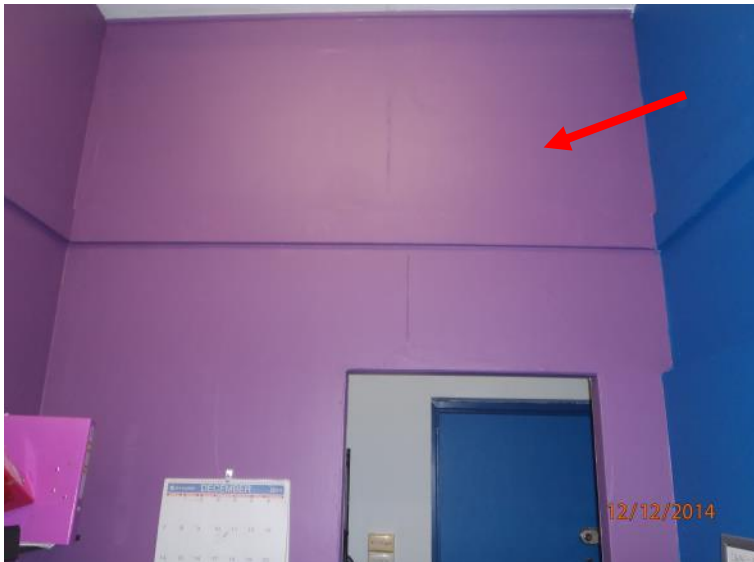
Photograph 38

AC sheeting to upper walls in office area of Shop 23
(assumed asbestos containing).

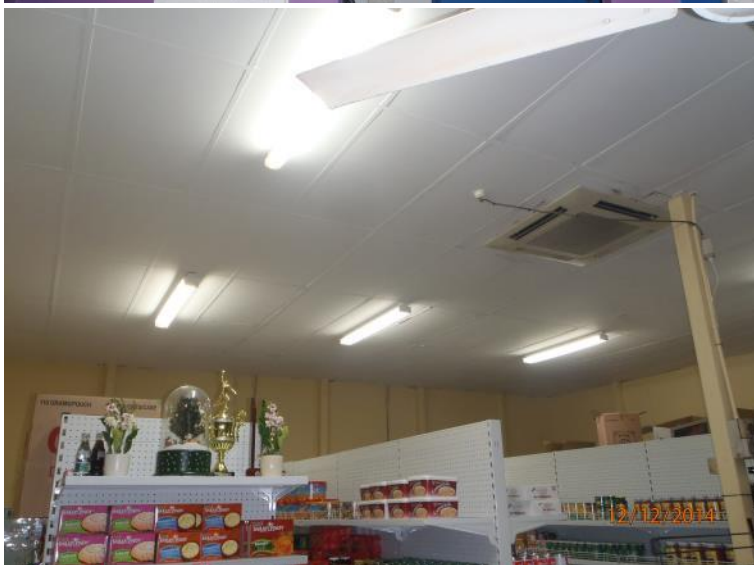
Photograph 39

AC ceiling tiles throughout Shops 24 and 25
(assumed asbestos containing).

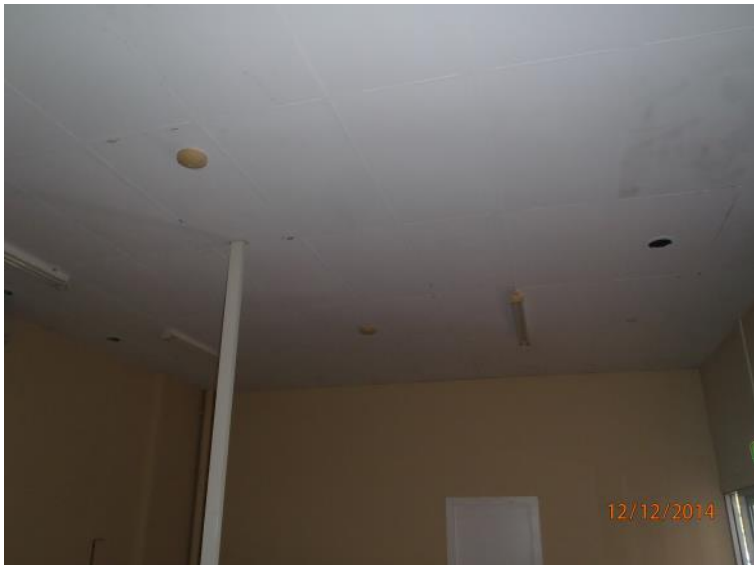
Photograph 40

AC ceiling tiles throughout Shop 26
(assumed asbestos containing).

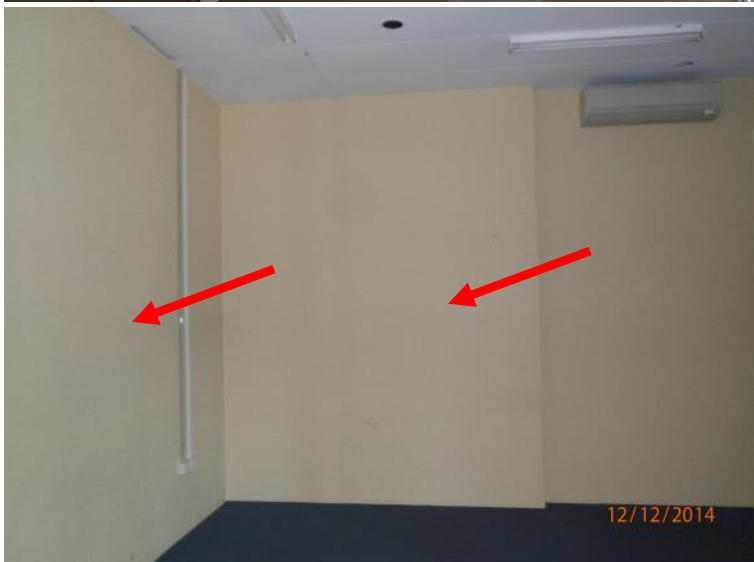
Photograph 41

Textured AC sheeting to wall linings
in Shop 26
(asbestos containing).

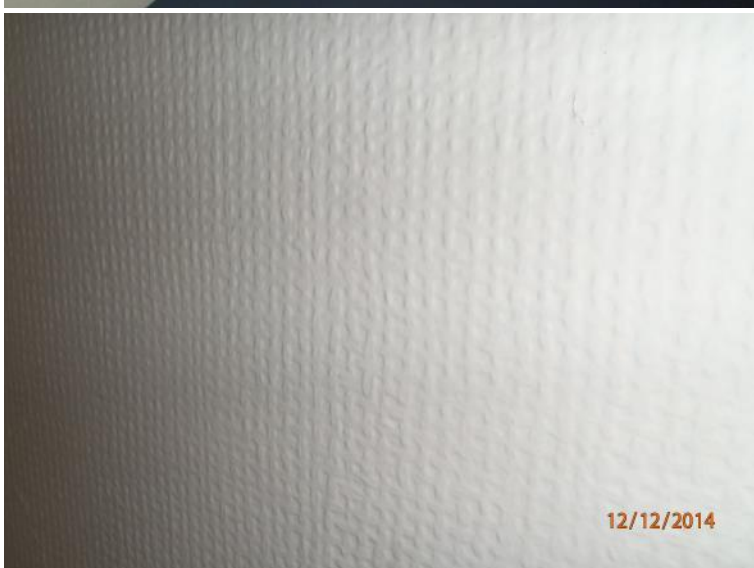
Photograph 42

Textured AC sheeting to wall linings
in Shop 26
(asbestos containing).

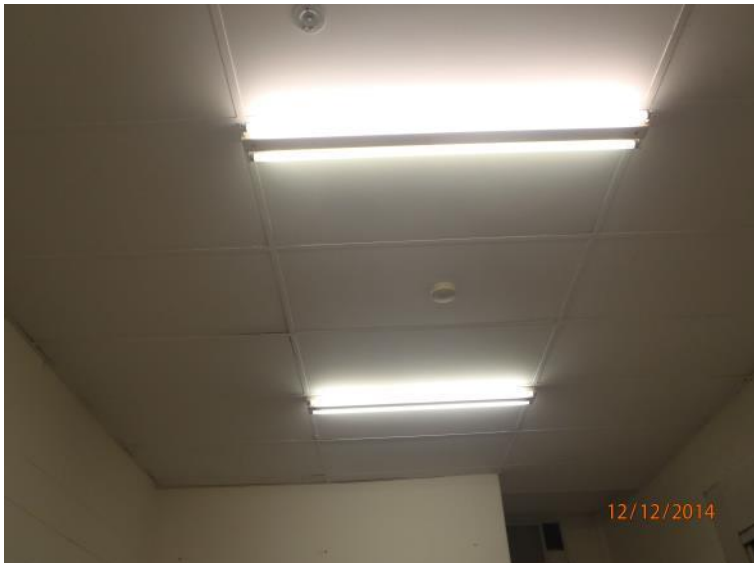
Photograph 43

AC ceiling tiles throughout Shop 27A
(assumed asbestos containing).

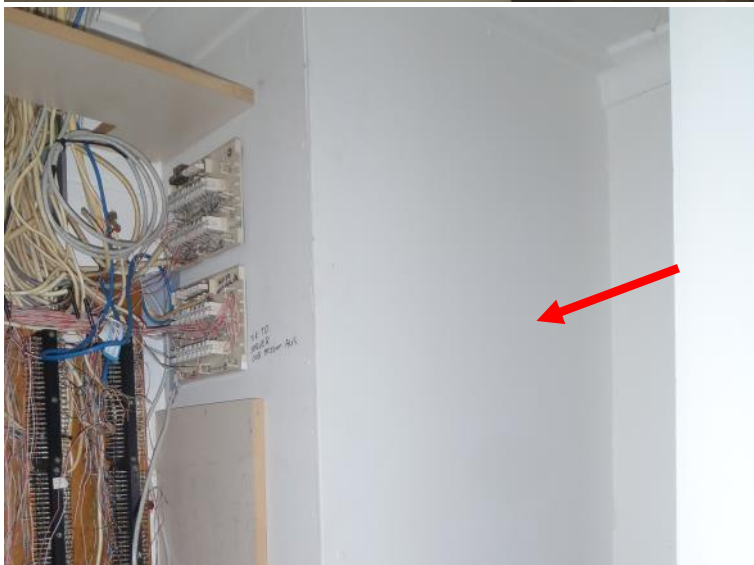
Photograph 44

AC sheeting to riser in Shop 27A
(assumed asbestos containing).

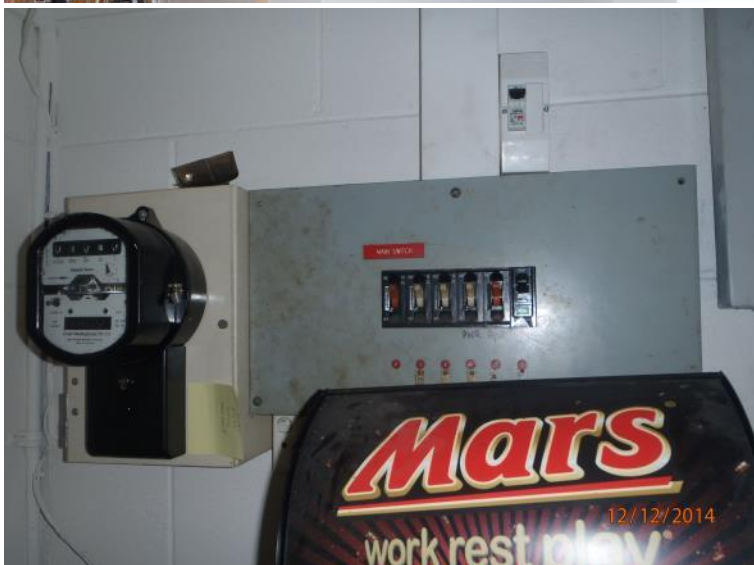
Photograph 45

Backing board to electrical box in
Shop 27A
(assumed asbestos containing).

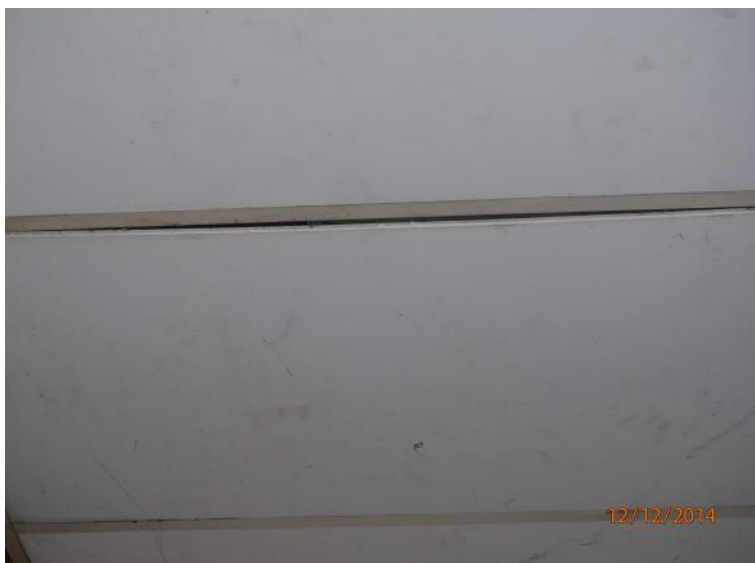
Photograph 46
AC ceiling tiles throughout Shop 28
(assumed asbestos containing).

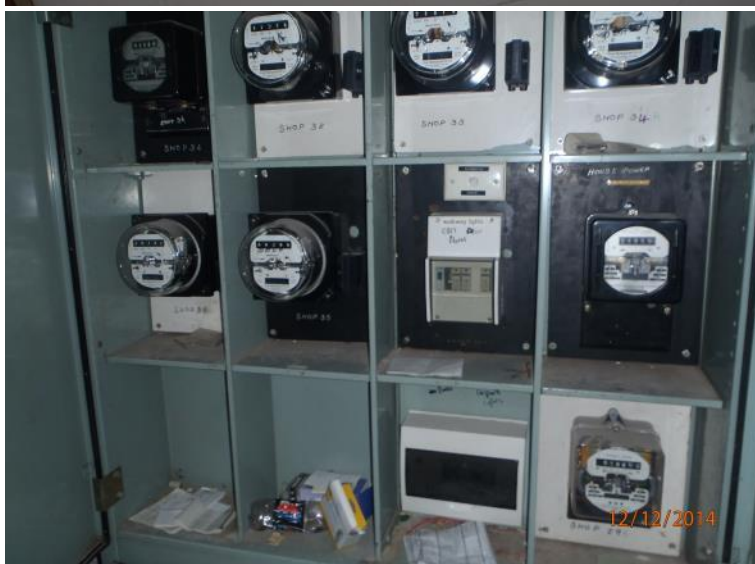
Photograph 47
Backing boards to electrical boxes (x
2) to Shop 28 (Power Room 1)
(assumed asbestos containing).

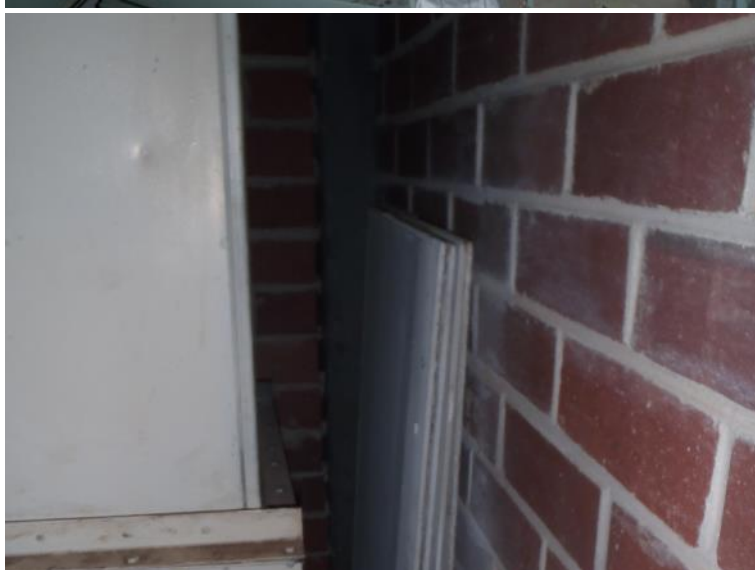
Photograph 48
Loose AC ceiling tiles stored behind
AC ducting to upper plant room off
Shop 28A
(assumed asbestos containing).

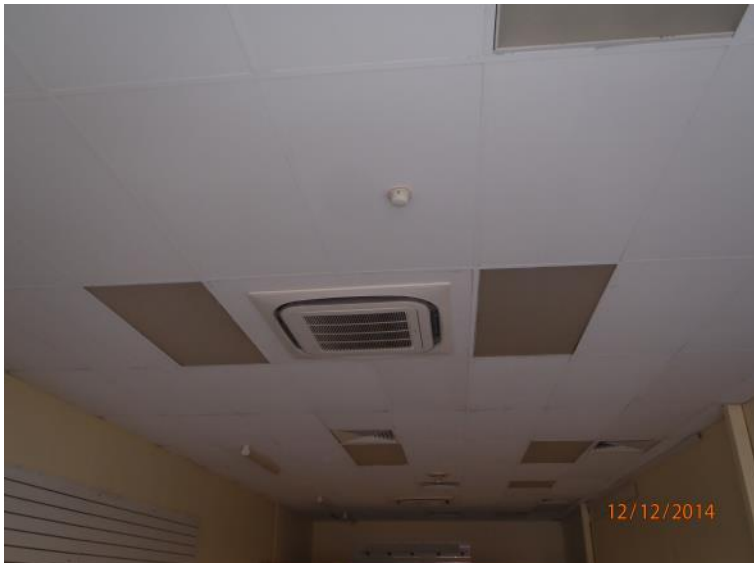
Photograph 49

AC ceiling tiles throughout Shop 29
(assumed asbestos containing).

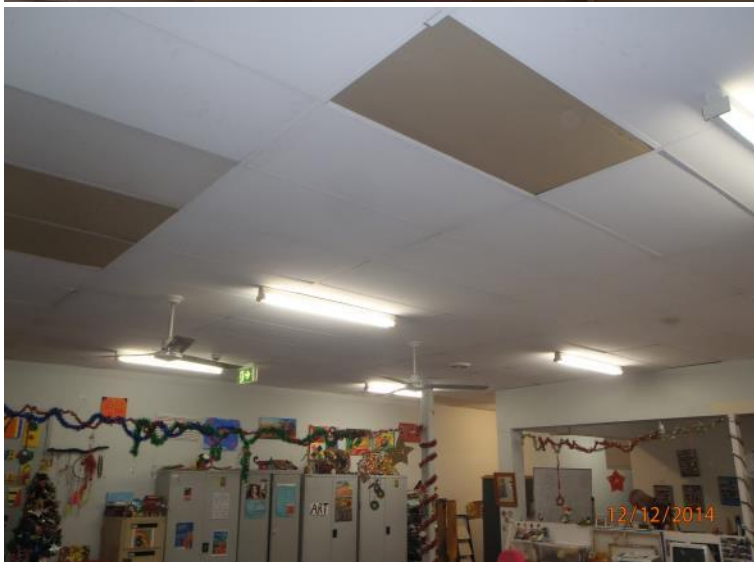
Photograph 50

AC ceiling tiles throughout Shop 29
(assumed asbestos containing).

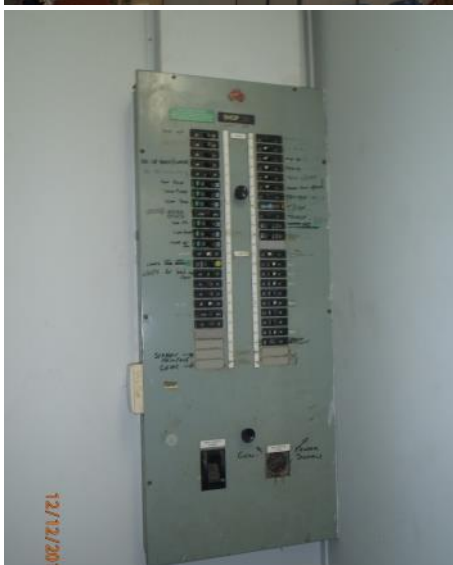
Photograph 51

Backing board to electrical box
(assumed asbestos containing).

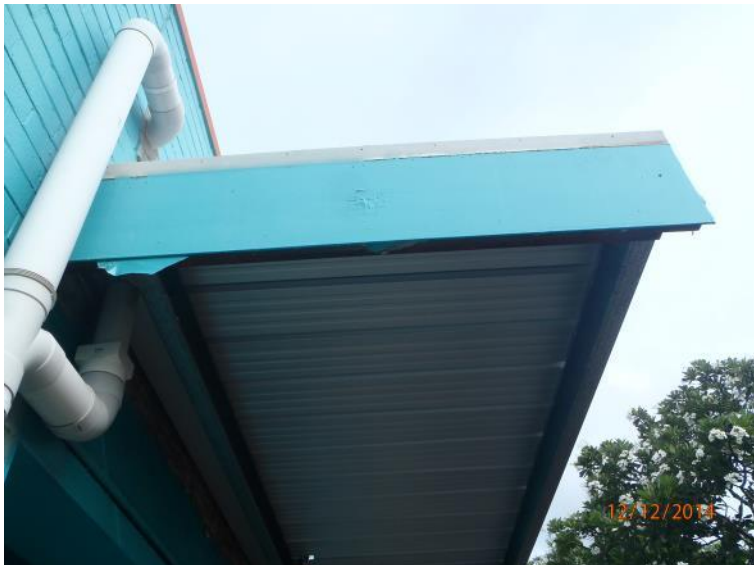
Photograph 52

AC sheeting to awning (x 2 – north and south elevations)

(asbestos containing).

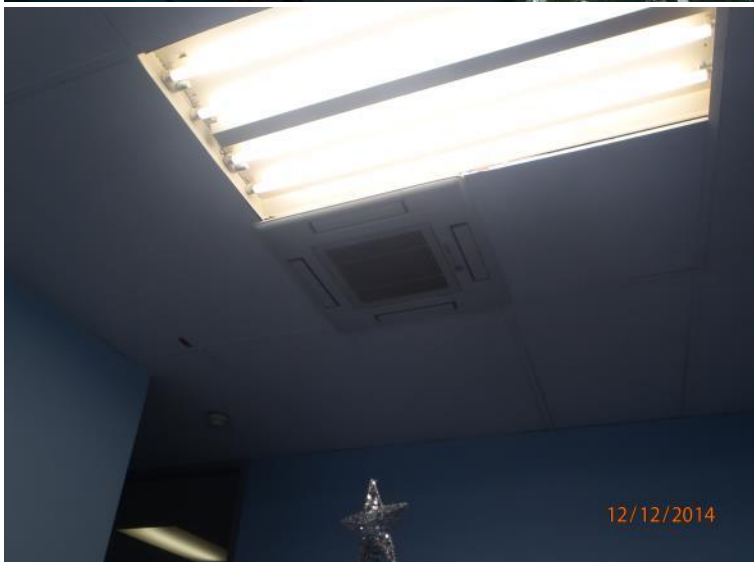
Photograph 53

AC ceiling tiles throughout Shop 32

(assumed asbestos containing).
