ASBESTOS CONTAINING BUILDING MATERIALS SURVEY REPORT

Rapid Creek Business Village

Report Number 680.10137.00000/01/ASR

22 January 2015

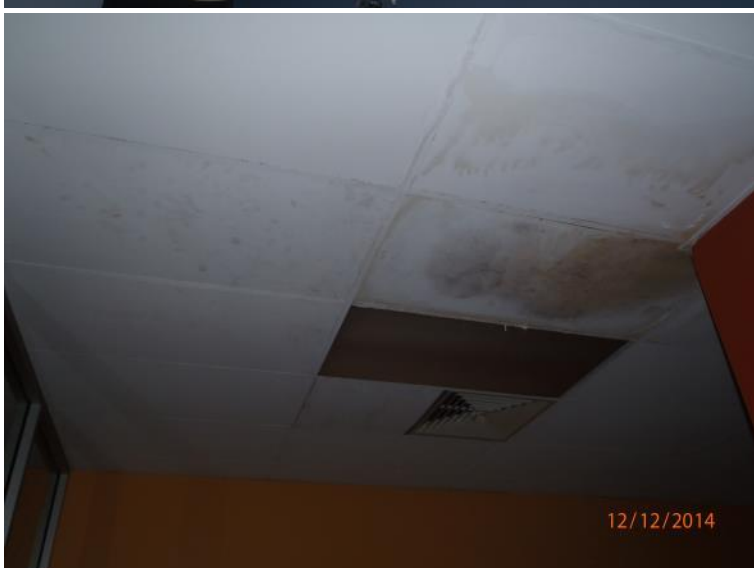
Photograph 54

AC ceiling tiles throughout Shop 33 – note water damage

(assumed asbestos containing).

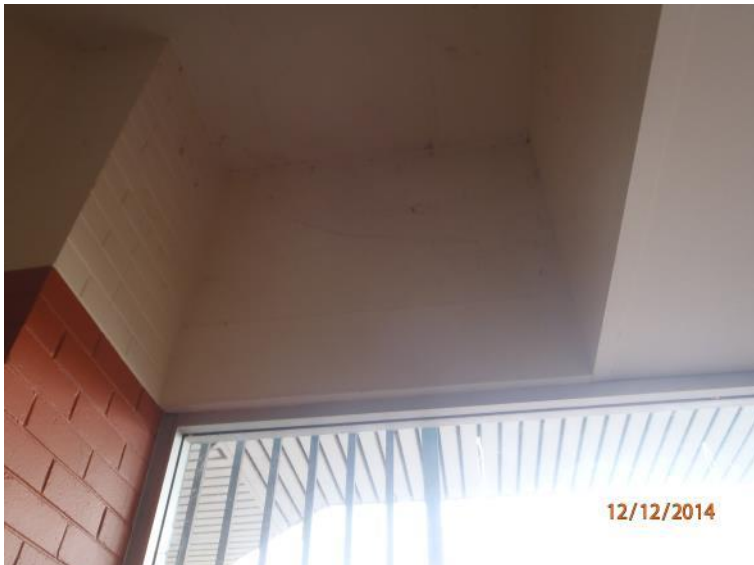
Photograph 55

AC sheeting to upper walls of Shop 33

(assumed asbestos containing).

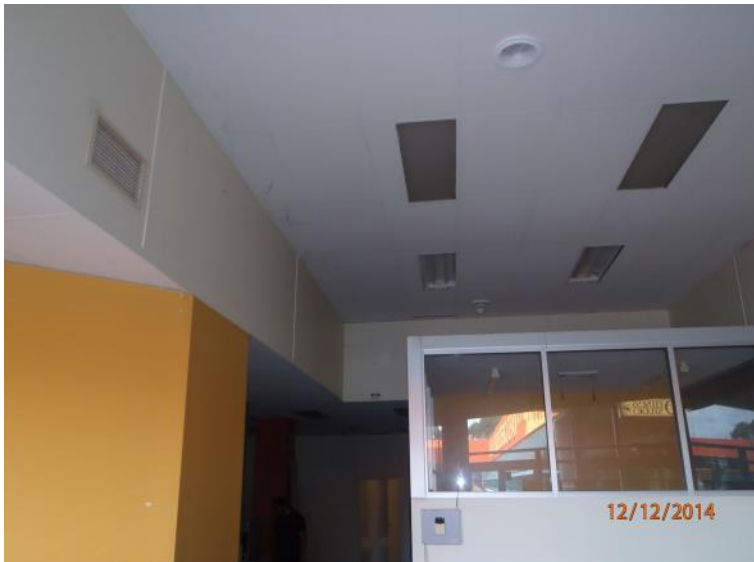
Photograph 56

AC sheeting to upper walls of Shop 33

(assumed asbestos containing).

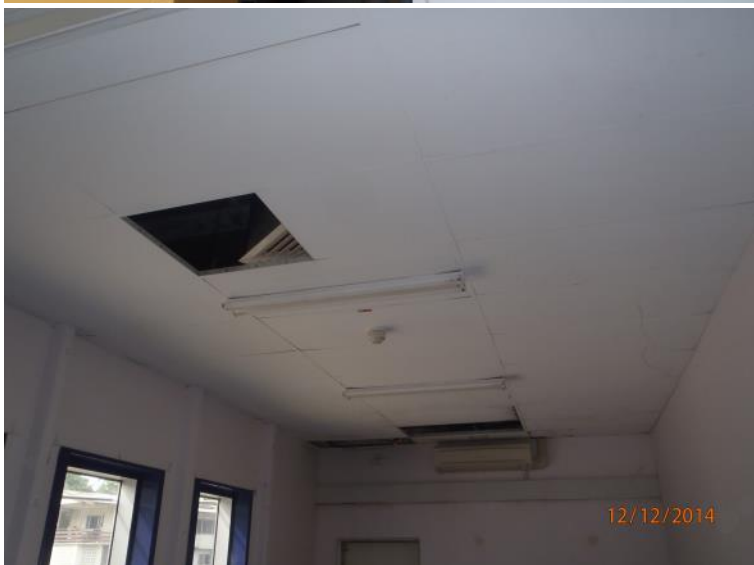
Photograph 57

AC ceiling tiles throughout Shop 34
(representative)

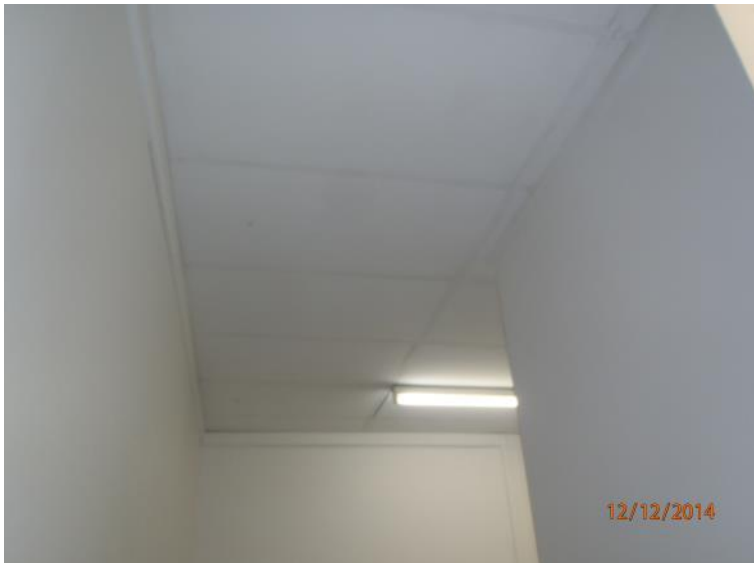
Photograph 58

AC ceiling lining throughout Shop 34 male toilet (representative)
(assumed asbestos containing).

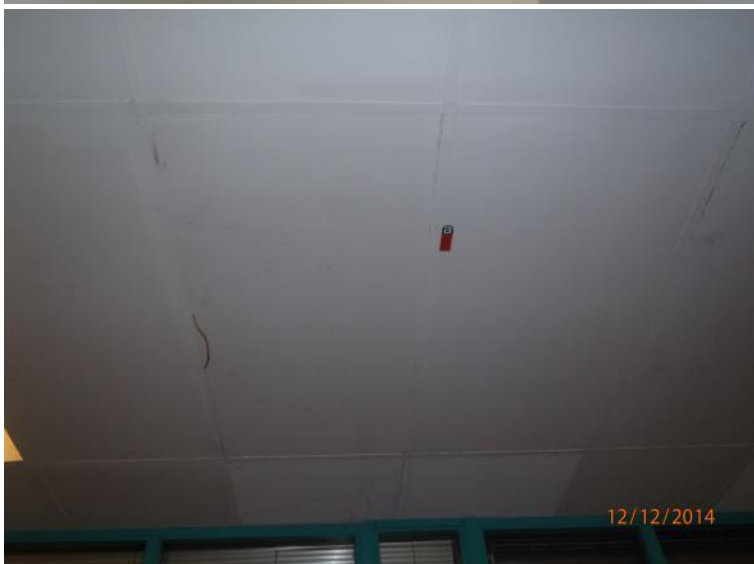
Photograph 59

AC ceiling tiles to walkway area between Shops 34, 35 and 27A
(assumed asbestos containing).

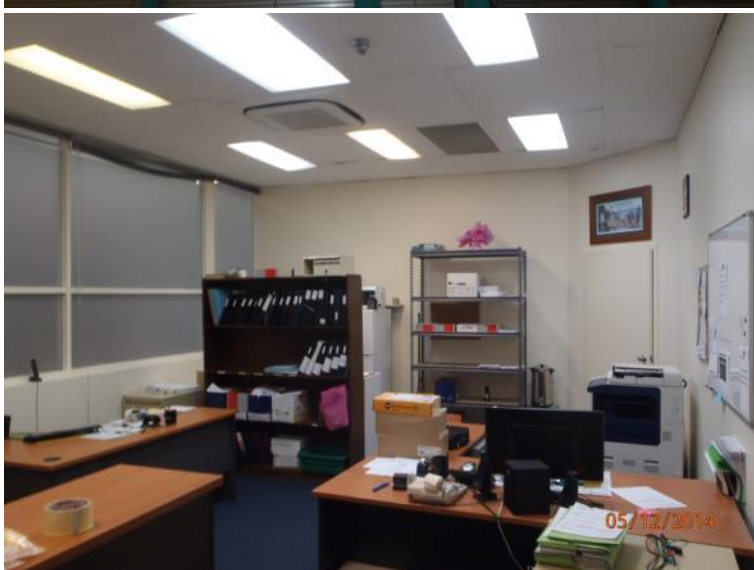
Photograph 60

AC ceiling tiles throughout Shop 35
(assumed asbestos containing).

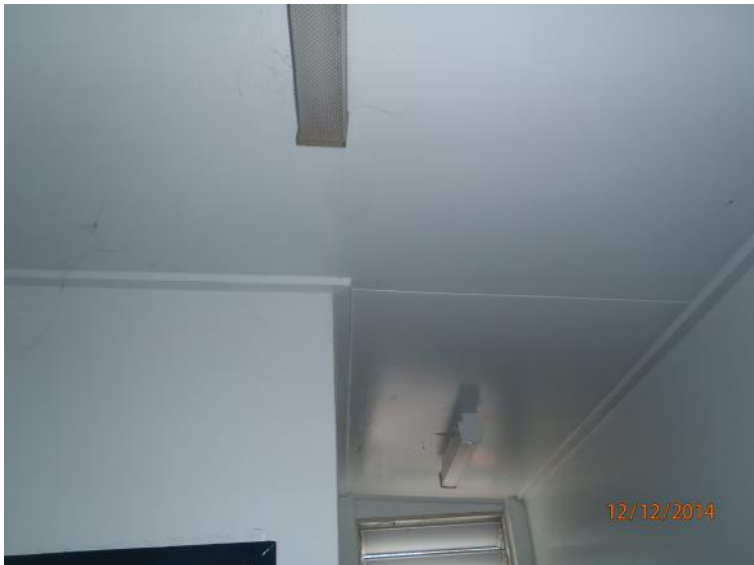
Photograph 61
AC sheeting ceiling to Male public
toilets
(asbestos containing).

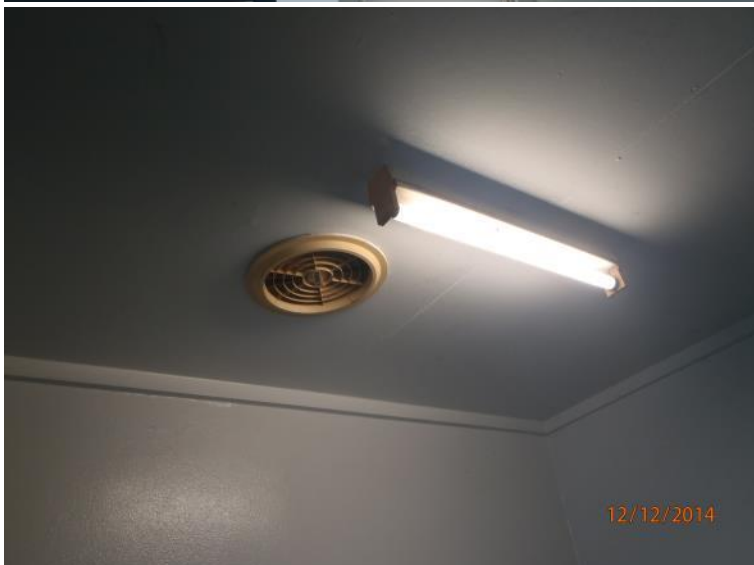
Photograph 62
AC sheeting ceiling to female public
toilets
(assumed asbestos containing).

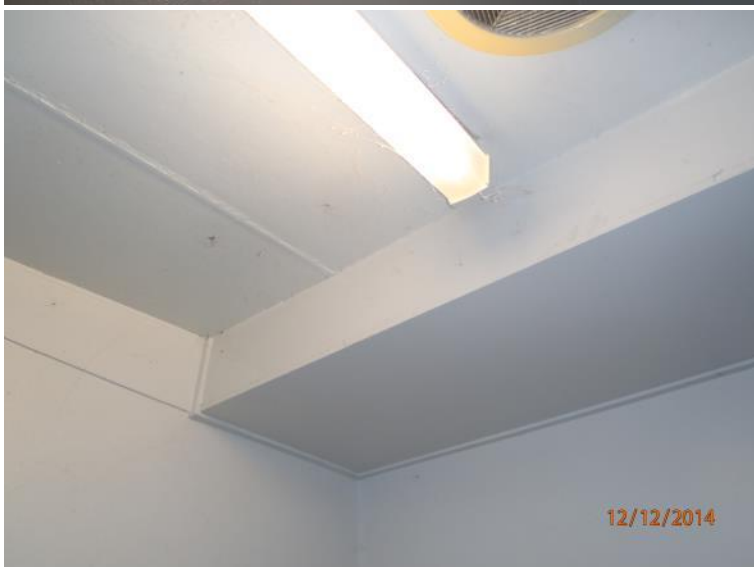
Photograph 63
AC sheeting to ceiling and bulkhead
of male tenant toilets
(assumed asbestos containing).

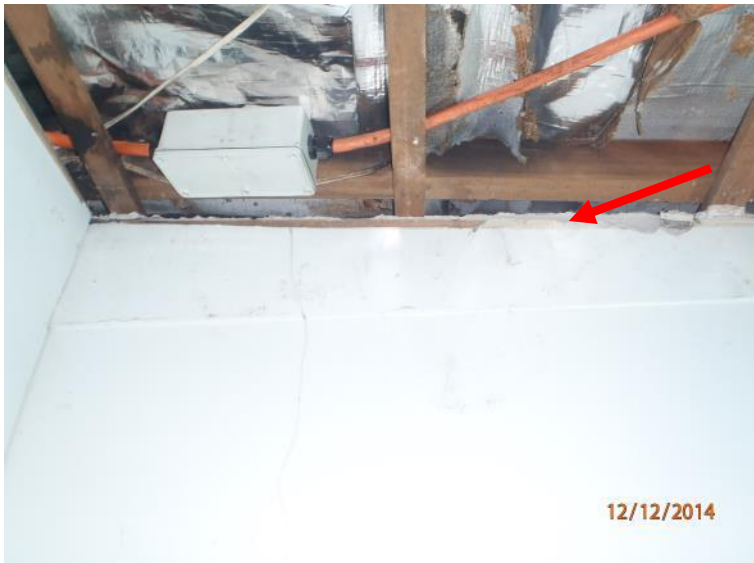
Photograph 64

AC sheeting to ceiling of Power Room 2 – note broken edges
(assumed asbestos containing).

- Materials which have been marked as damaged should be repaired as soon as possible.
- The ACM identified to be present within Power Room 2 requires immediate attention. These materials should be remediated as soon as possible.

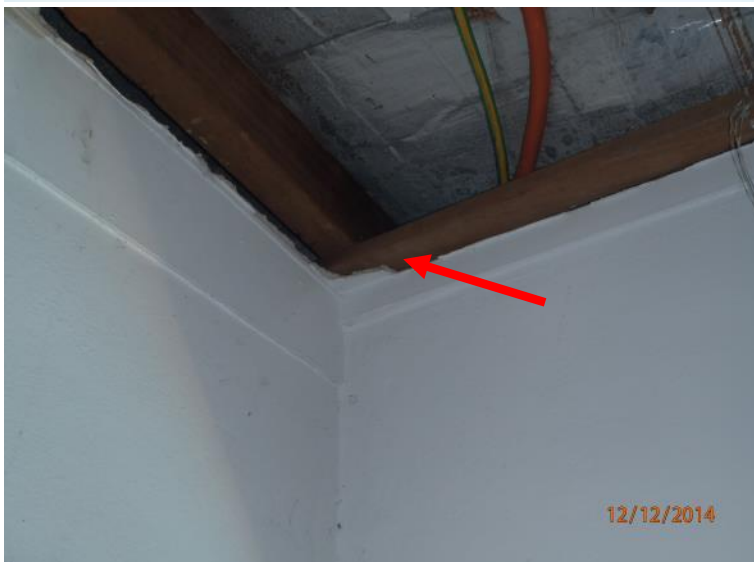
Photograph 65

AC sheeting to ceiling of Power Room 2 – note broken edges
(assumed asbestos containing).

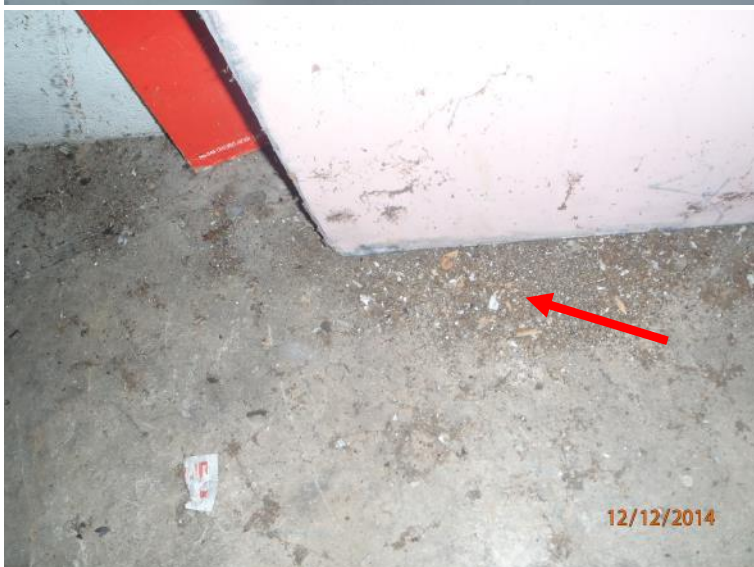
Photograph 66

AC sheeting debris to ground of Power Room 2
(assumed asbestos containing).

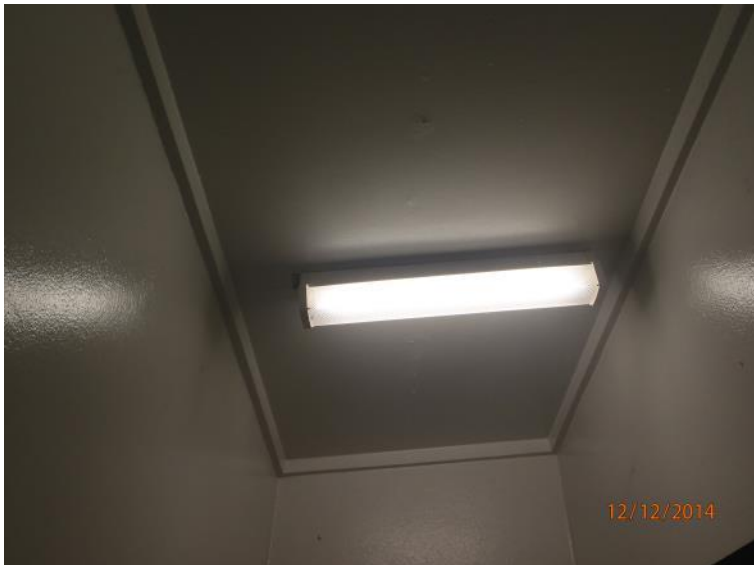
Photograph 67

Item Location & Material Type	Sample No./ Assumed	Photo No.	Approx. Extent	Non-Friable/ Friable	Product Type (A)	Extent of Damage /Deterioration (B)	Surface Treatment (C)	Asbestos Type (D)	Risk Assessment (Material Assessment) Score & Rating (A+B+C+D)	Recommended Control Actions	Comments
Internal / FCS / AC sheet ceiling lining to Power Room 2	Assumed – based on consistency of material with 680.10137.00000/6	64, 65	~1m ²	Non-Friable	1	2	2	2	7 – Medium	C1, C2, C3, C5, C8	Ceiling reportedly damaged by fire. Broken edges of AC sheeting material remain in situ. This needs to be remediated
Internal / FCS / AC sheet debris to Power Room 2 floor	Assumed – based on consistency of material with 680.10137.00000/6	66	~1m ²	Non-Friable	1	2	2	2	7 – Medium	C1, C2, C3, C5, C8	AC sheeting debris present to ground. Area is to be remediated
Internal / FCS / AC sheet ceiling lining to Female toilets	Assumed – based on consistency of material with 680.10137.00000/6	67	~10m ²	Non-Friable	1	0	0	2	3 – Very Low	C1, C2, C3, C4, C5, C8

AC sheeting to ceiling of Female
tenant toilets
