ASBESTOS CONTAINING BUILDING MATERIALS SURVEY REPORT

16 - 18 Katherine Terrace

Katherine

Report Number 680.10025.00070 ASR R1 20130819

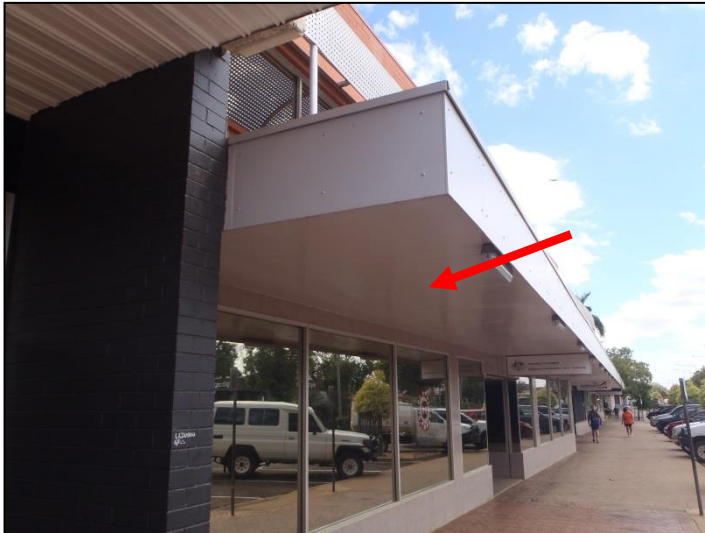
Photograph 1

Ground Floor, - FCS Soffit lining to north elevation (**assumed asbestos containing**).

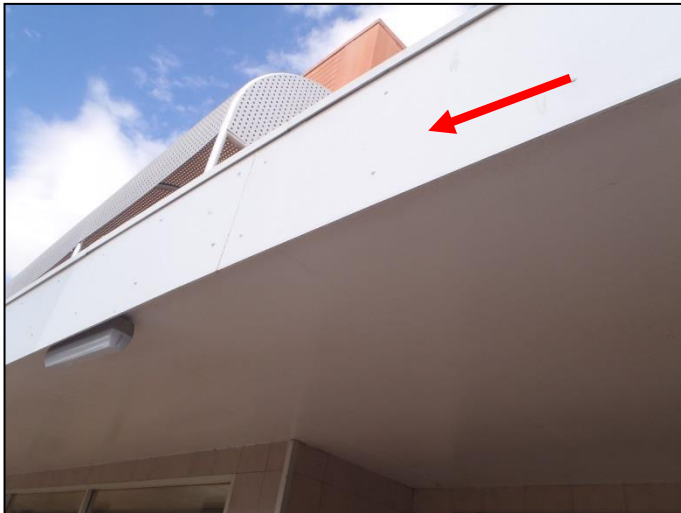
Photograph 2

Ground Floor, - FCS fascia panels to soffit overhang to north elevation (**assumed asbestos containing**).

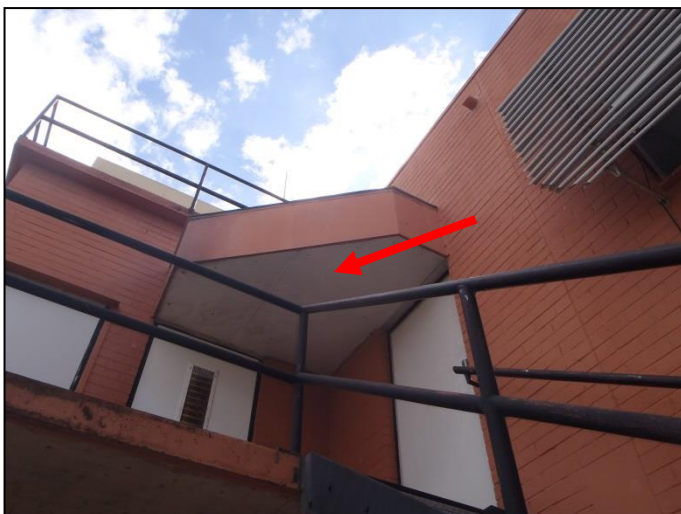
Photograph 3

First Floor, - FCS Soffit lining above stairs to south elevation (Item removed from register – NAD)

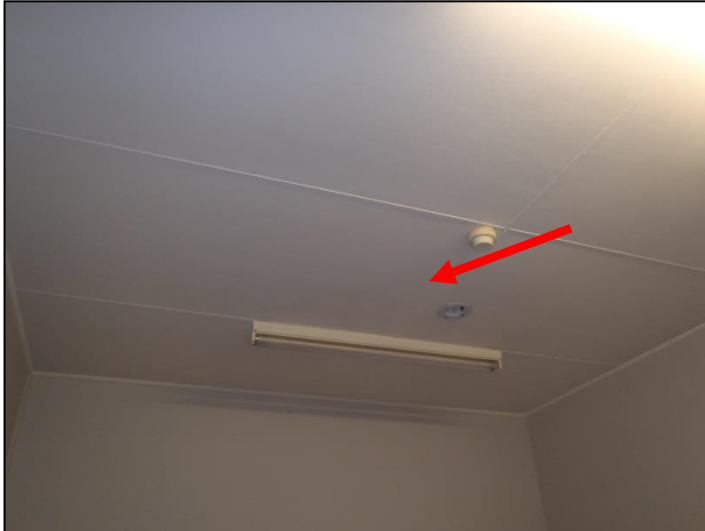
Photograph 4

Ground Floor – Entry foyer to west, FCS ceiling lining (**asbestos containing**).

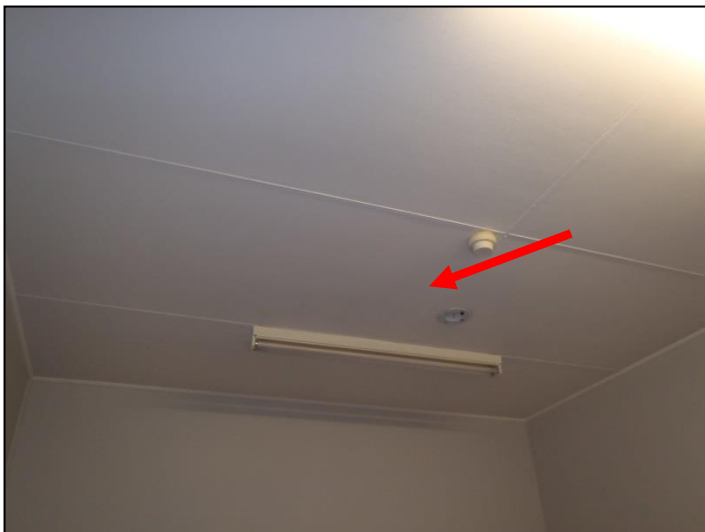
Photograph 5

First Floor – Internal stair-well to west leading to public library staff entrance, FCS ceiling lining (**assumed asbestos containing**).

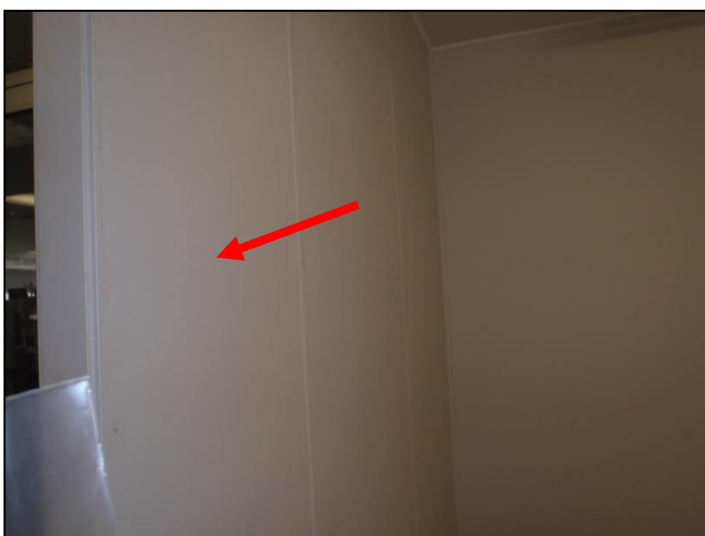
Photograph 6

First Floor – Internal stair-well to west leading to public library staff entrance, FCS wall lining to west elevation (**asbestos containing**).

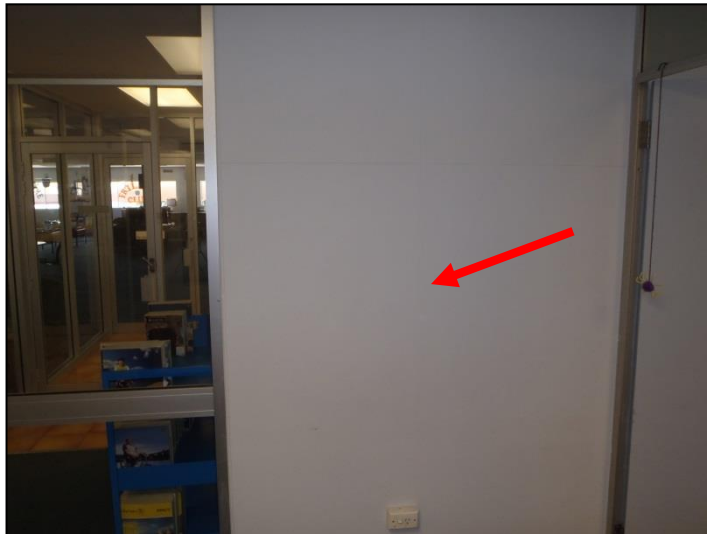
Photograph 7

First Floor – Internal stair-well to west leading to public library staff entrance, FCS wall lining to east elevation **(assumed asbestos containing)**.

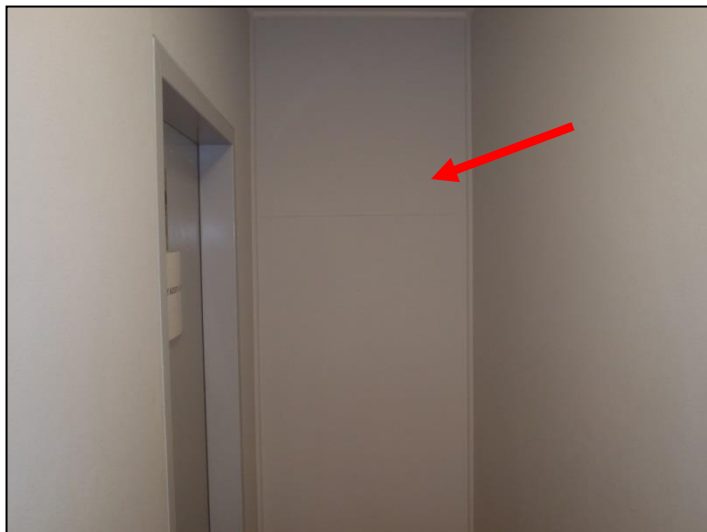
Photograph 8

First Floor – Hallway to public toilets, FCS wall lining to end of hallway **assumed (asbestos containing)**.

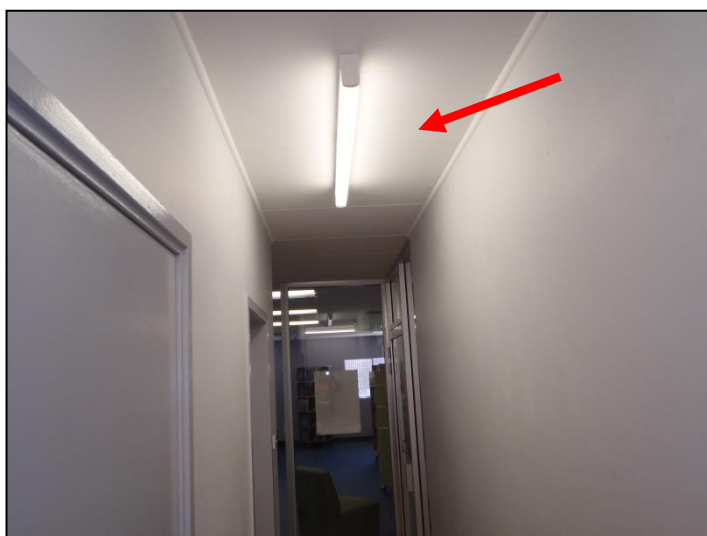
Photograph 9

First Floor – Hallway to public toilets, FCS ceiling lining to hallway **(assumed asbestos containing)**.

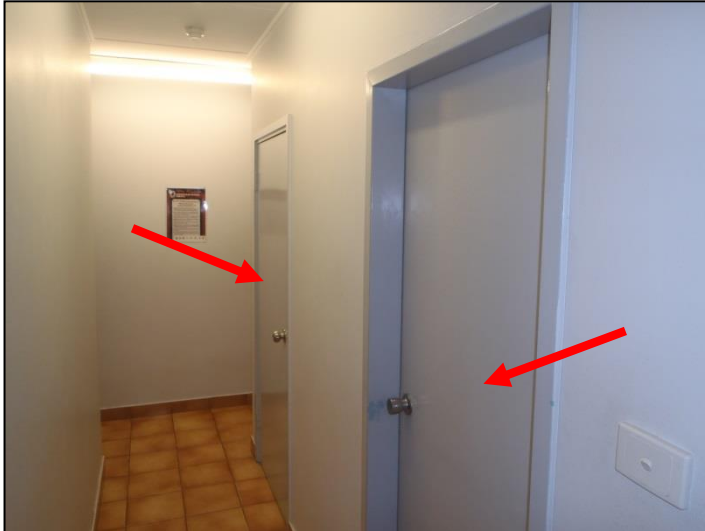
Photograph 10

~~First Floor – Hallway to public toilets – No access to locked doors off hallway (areas accessed and entered into register see photographs below).~~

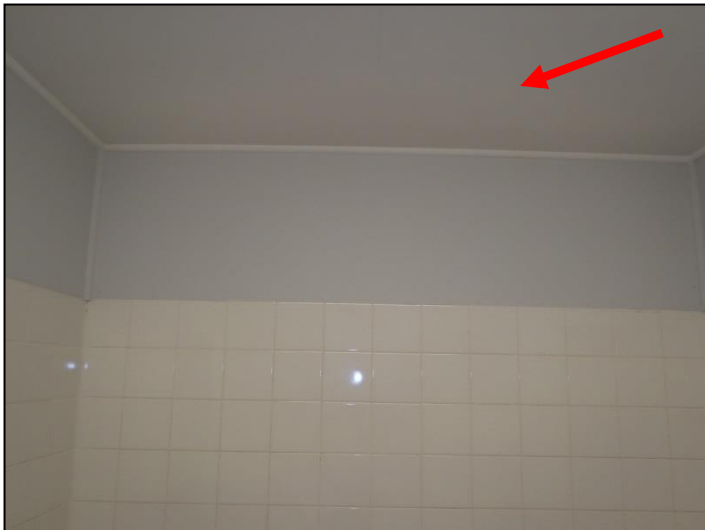
Photograph 11

First Floor – Male Toilets, FCS Ceiling lining (**assumed asbestos containing**).

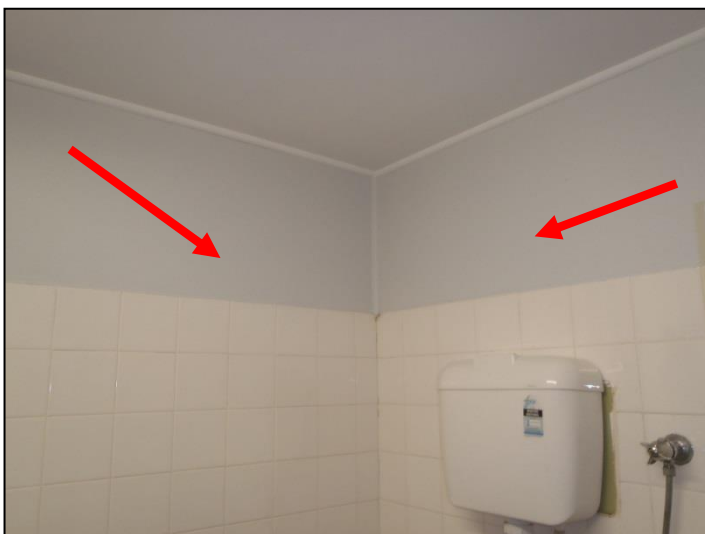
Photograph 12

First Floor – Male Toilets, FCS wall linings above tiled sections to south and east elevations (**assumed asbestos containing**).

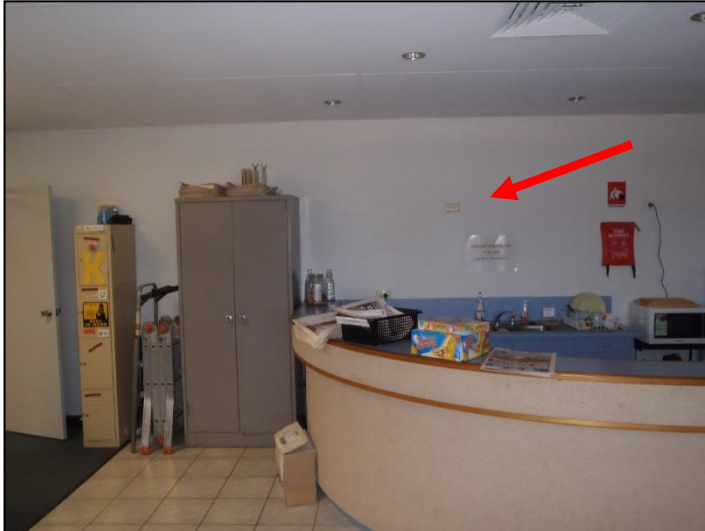
Photograph 13

First Floor – Library Staff Kitchen, FCS wall lining to north elevation (**assumed asbestos containing**).

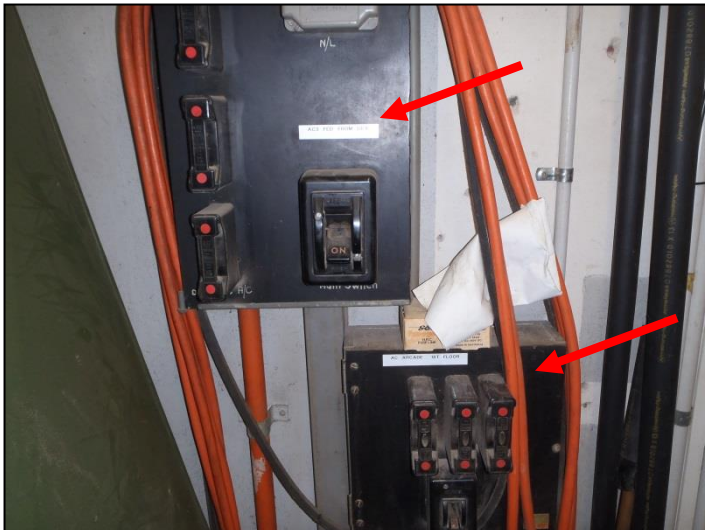
Photograph 14

First Floor – Plant Room, BEBB to switchboards (**assumed asbestos containing**).

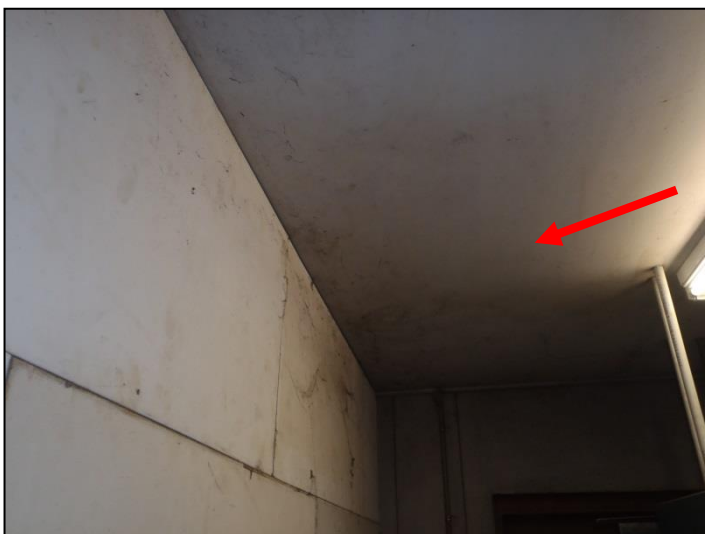
Photograph 15

First Floor – Plant Room, FCS Ceiling lining (**asbestos containing**).

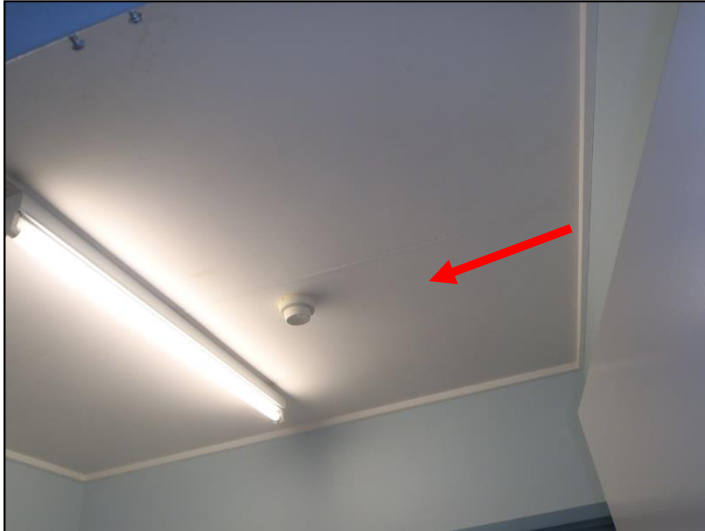
Photograph 16

First Floor – NAAFVLS, Male and Female Toilets, FCS Ceiling lining (**assumed asbestos containing**).

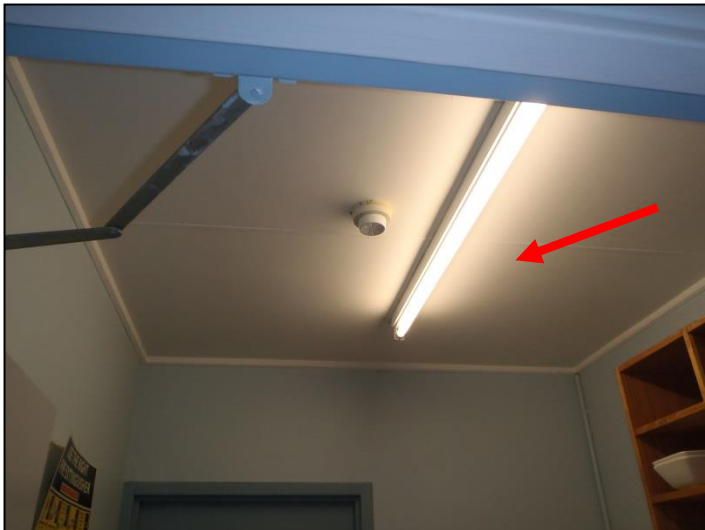
Photograph 17

First Floor – NAAFVLS, Kitchen, FCS Ceiling lining (**assumed asbestos containing**).

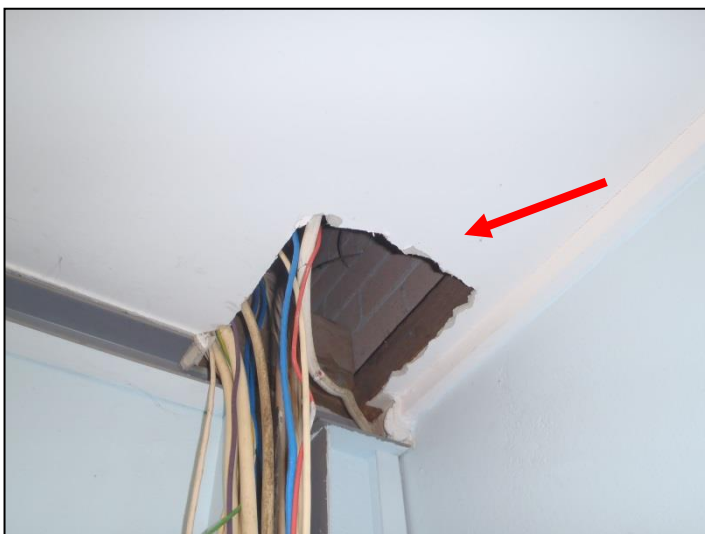
Photograph 18

First Floor – NAAFVLS Cleaners Room, FCS Ceiling lining (**asbestos containing**).

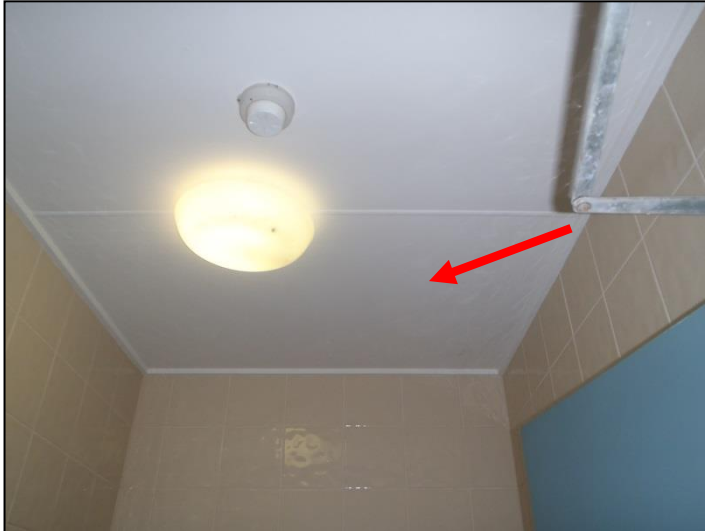
Photograph 19

Ground Floor – Traditional Credit Union, Male and Female Toilets, FCS Ceiling lining (**assumed asbestos containing**).

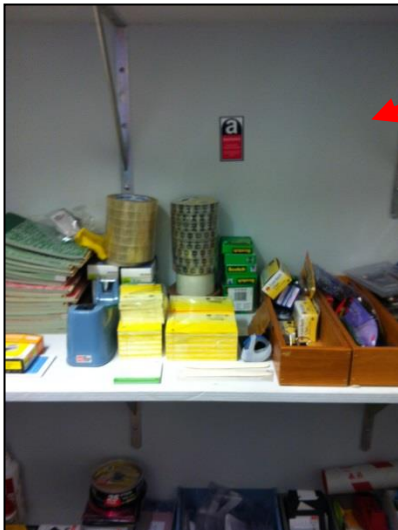
Photograph 20

First Floor – Library – Store room in hallway to staff toilets, FCS lining to south, east and west elevations (**assumed asbestos containing**).

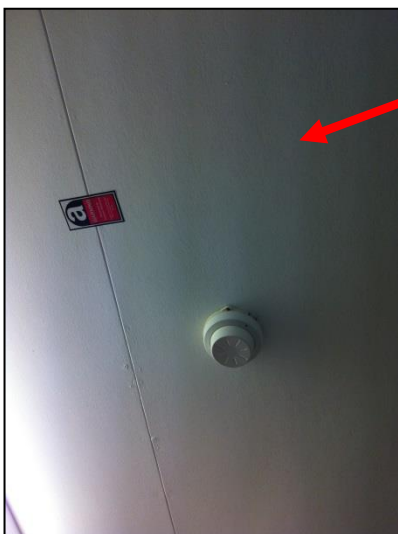
Photograph 21

First Floor – Library – Cleaners room/shower in hallway to staff toilets, FCS lining to ceiling (**assumed asbestos containing**).

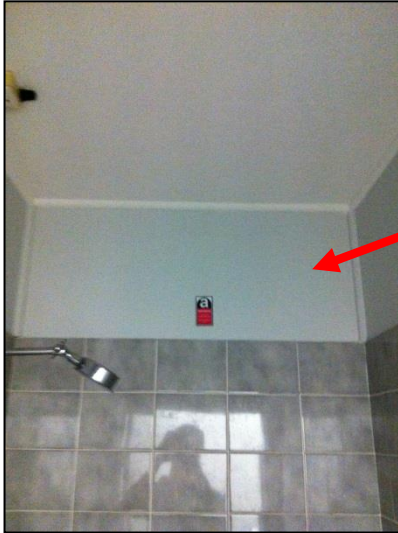
Photograph 22

First Floor – Library – Cleaners room/
shower in hallway to staff toilets, FCS
lining to south, east and west elevations.
(assumed asbestos containing).

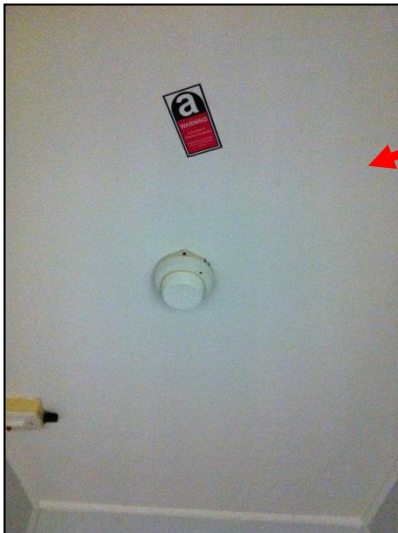
Photograph 23

First Floor – Library – Cleaners room/
shower in hallway to staff toilets, FCS
ceiling lining. **(assumed asbestos
containing).**
