## ASBESTOS CONTAINING BUILDING MATERIALS SURVEY REPORT

19 - 23 Albatross Street

Winnellie

Report Number 680.10025.00050 ASR R0 20130731

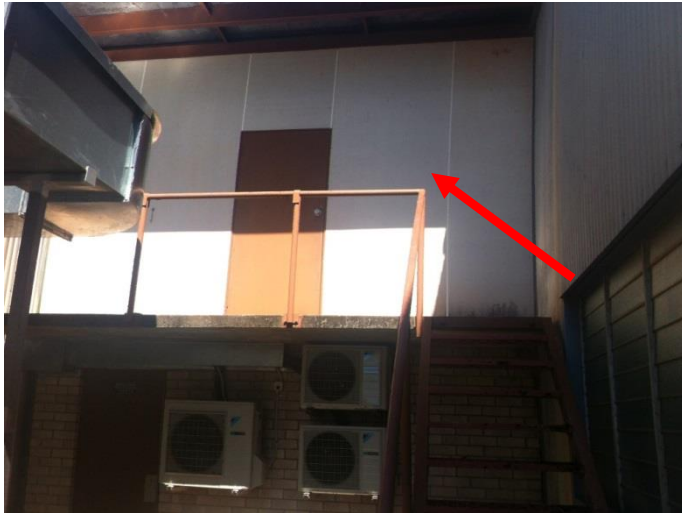
**Photograph 1**

Exterior - FCS lining to exterior of plant room between tenancies 1 and 2  
(asbestos containing).

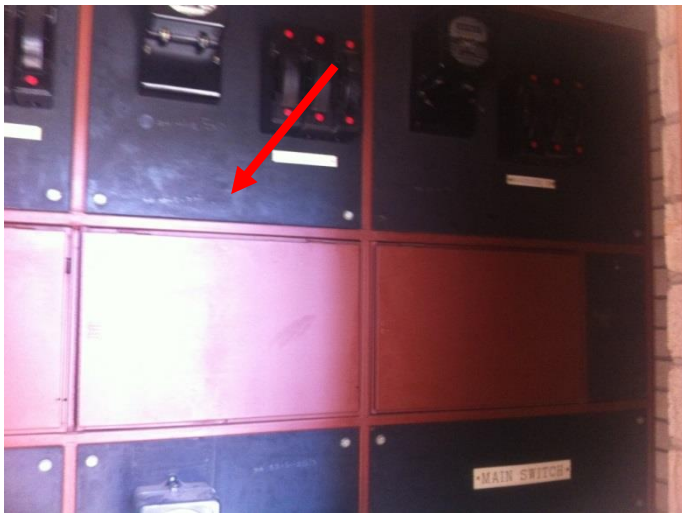
**Photograph 2**

Electrical backing board to switch room between tenancies 2 and 3	680.10025.00000/ 03	2	10 m <sup>2</sup>	Non friable	1	1	0	1	3 – Very Low	C1, C2, C3, C4, C5, C12	Material requires labelling
Soffit lining to southern (front) elevation of property – vinyl floor tiles and adhesive backing to electrical cupboard	Assumed to contain asbestos	3	100 m <sup>2</sup>	Non-friable	1	1	0	1	3 – Very Low	C1, C2, C3, C4, C12	Material requires labelling

Exterior - Electrical backing board to switch room between tenancies 2 and 3  
(asbestos containing).

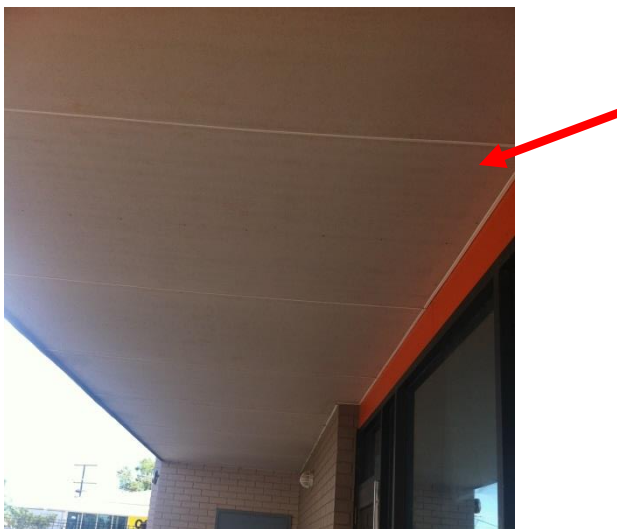
**Photograph 3**

Exterior – Soffit lining to front elevation (southern) of the main building (assumed asbestos containing).
