**ASBESTOS REGISTER
No. NT0407**

**CASUARINA PLAZA SHOPPING CENTRE
Cnr TROWER ROAD & VANDERLIN DRIVE
CASUARINA
NORTHERN TERRITORY**

Date: February 2011
Register No: NT0407
Our Ref: DO/PP/nh

Prepared by:
AEC Environmental Pty Ltd

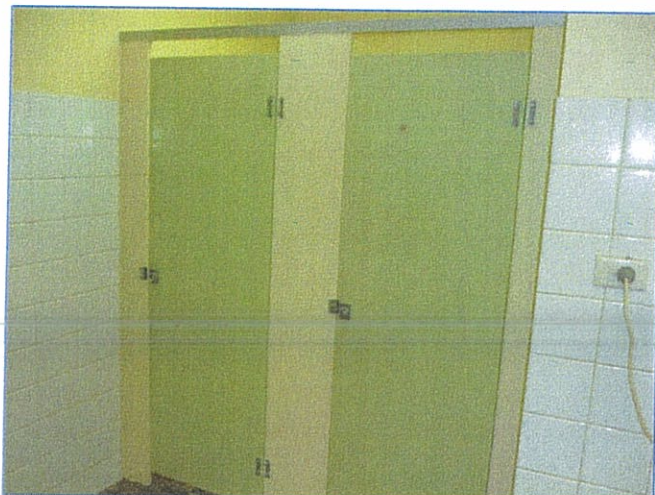
1. Cubicle partitions to male & female "Public toilets" at east end of building (5m ²) <i>*Refer Photo 1</i>	Fibre cement sheet material containing white (Chrysotile) asbestos (sample no.2)	Stable	Warning signs, 3 small. Refer Section 6.0: Management Procedures.

Photo 1 Cubicle partitions Male & Female public toilets

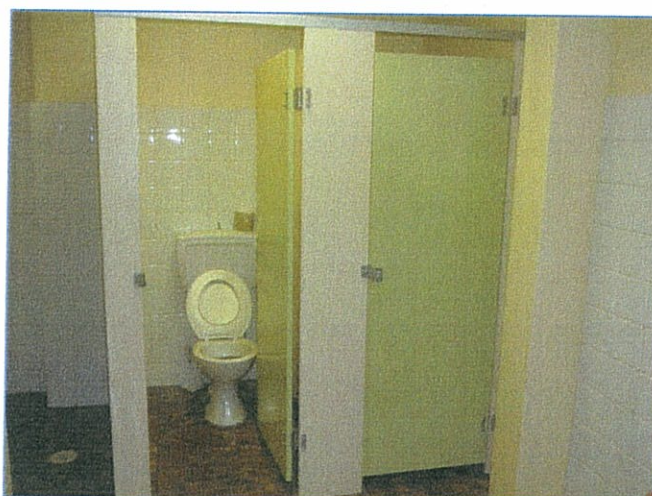
2. Cubicle partitions to male & female "Staff toilets" at east end of building (10m ²) <i>*Refer Photo 2</i>	Fibre cement sheet material containing white (Chrysotile) asbestos (per sample no.2)	Stable	Warning signs, 8 small. Refer Section 6.0: Management Procedures.	
INTERNAL - Sub station

Photo 2 Cubicle partitions Male & Female staff toilets

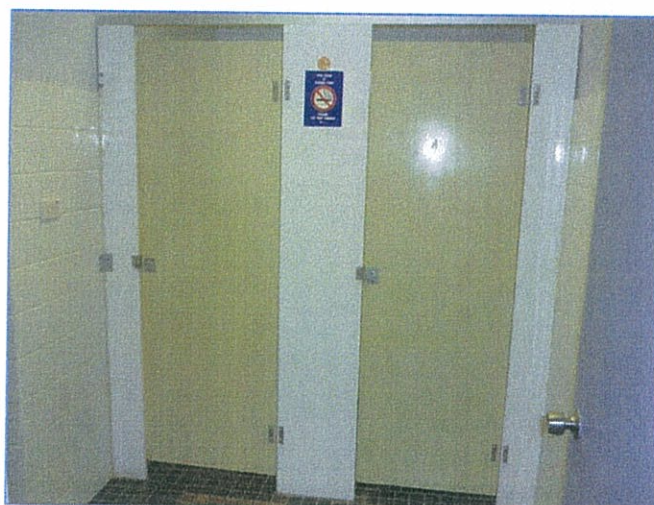
5. Cubicle partitions to male & female "Staff toilets" (18m ²) <i>*Refer Photo 3</i>	Fibre cement sheet material containing white (Chrysotile) asbestos (per sample no.2)	Stable	Warning signs, 12 small. Refer Section 6.0: Management Procedures.

Photo 3 Cubicle partitions Male & Female staff toilets

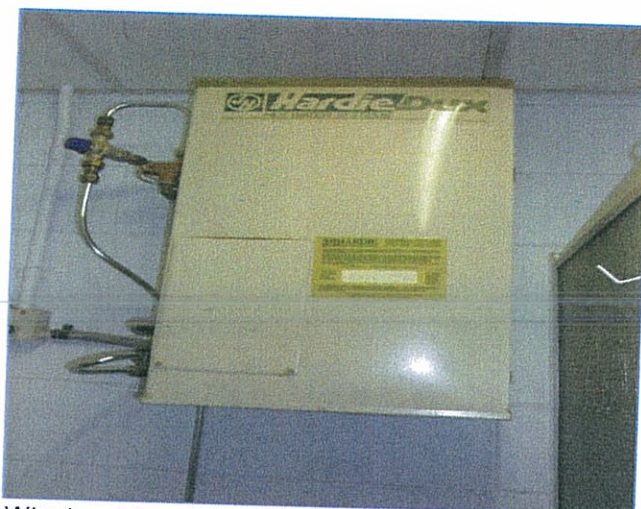
6. Wire insulation to "Hardie Dux" Hot Water System in Shower room (<1m ²) <i>*Refer Photo 4</i>	Not accessed or sampled. Based on past experience in similar areas, asbestos in some form may exist. It is recommended that if work is contemplated in this area, due care and diligence should be exercised.	Friable when exposed	Warning signs, 1 small. Refer Section 6.0: Management Procedures.

Photo 4. Wire insulation "Hardie Dux" hot water service in Shower Rm.

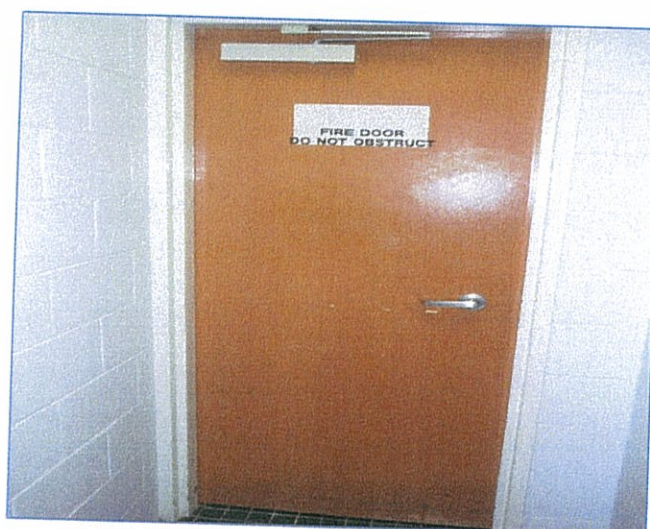
7. Fire door to stairwell/fire exit Core Material (2m ²) <i>*Refer Photo 5</i>	Not accessed or sampled. Based on past experience in similar areas, asbestos in some form may exist. It is recommended that if work is contemplated in this area, due care and diligence should be exercised.	Friable when exposed	Warning signs, 2 small. Refer Section 6.0: Management Procedures.	
COMICS NT (Tenancy)

Photo 5. Fire door to stairwell/fire exit

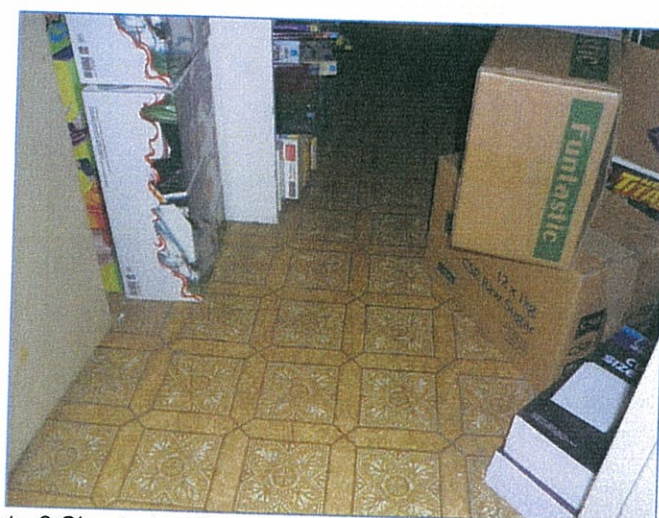
8. Floor covering to store room adjacent toilet (6m ²) <i>*Refer Photo 6</i>	Fibrous backing to vinyl sheeting material containing white (Chrysotile) asbestos (sample no.3)	Friable when exposed	Warning signs, 2 small. Refer Section 6.0: Management Procedures.	
INTERNAL – Level 1				
NT HEARING SERVICES (Tenancy)

Photo 6 Sheet vinyl floor covering to storeroom of "Comics NT"

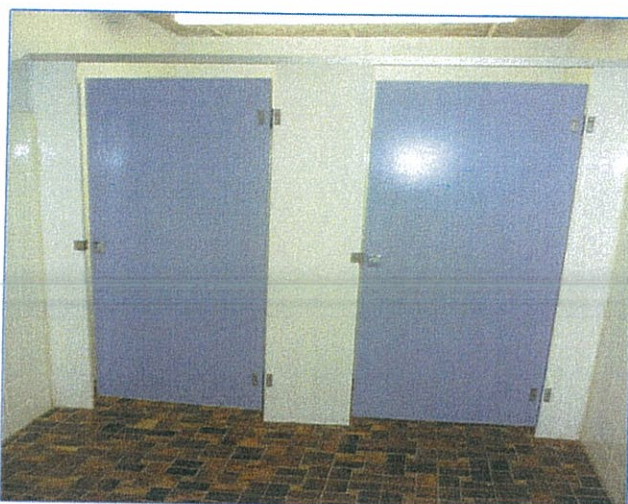
10. Cubicle partitions to male & female "Staff toilets" (18m ²) <i>*Refer Photo 7</i>	Fibre cement sheet material containing white (Chrysotile) asbestos (per sample no.2)	Stable	Warning signs, 8 small. Refer Section 6.0: Management Procedures.

13. Cubicle partitions to male & female staff toilets (18m ²) *Refer Photo 7	Fibre cement sheet material containing white (Chrysotile) asbestos (per sample no.2)	Stable	Warning signs, 8 small. Refer Section 6.0: Management Procedures.	
AGED & DISABILITY SERVICES (Tenancy)

Photo 7 Cubicle partitions to Male & Female staff toilets

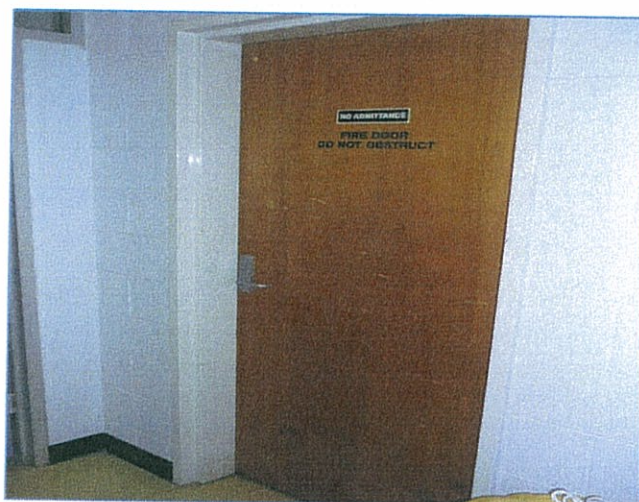
11. Fire door to entry of A/C Plant room, east side of Tenancy Core Material (2m ²) <i>*Refer Photo 8</i>	Not accessed or sampled. Based on past experience in similar areas, asbestos in some form may exist. It is recommended that if work is contemplated in this area, due care and diligence should be exercised.	Friable when exposed	Warning signs, 2 small. Refer Section 6.0: Management Procedures.

12. Fire door to entry of A/C Plant room, north side of Tenancy Core Material (2m ²) <i>*Refer Photo 8</i>	Not accessed or sampled. Based on past experience in similar areas, asbestos in some form may exist. It is recommended that if work is contemplated in this area, due care and diligence should be exercised.	Friable when exposed	Warning signs, 2 small. Refer Section 6.0: Management Procedures.

Photo 8 Fire door to entry of AC plant room

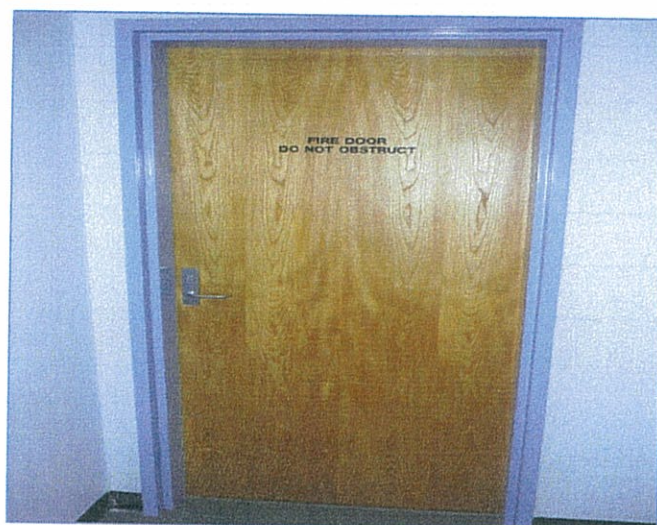
14. Fire door to Plant room entry Core Material (2m ²) *Refer Photo 9	Not accessed or sampled. Based on past experience in similar areas, asbestos in some form may exist. It is recommended that if work is contemplated in this area, due care and diligence should be exercised.	Friable when exposed	Warning signs, 2 small. Refer Section 6.0: Management Procedures.

Photo 9 Fire door to plant room entry

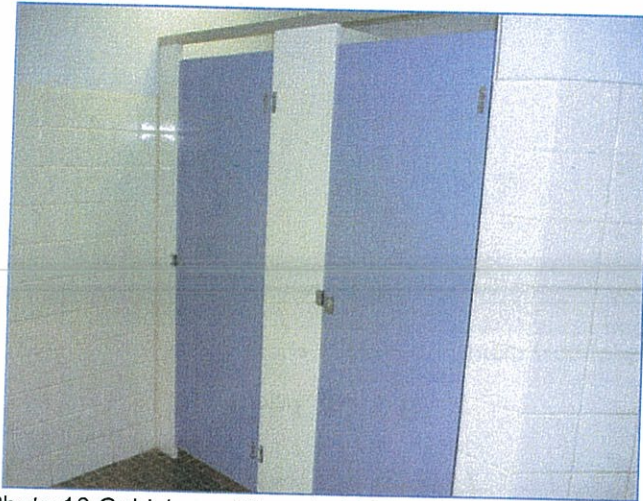
15. Cubicle partitions to male & female staff toilets (15m ²) *Refer Photo 10	Fibre cement sheet material containing white (Chrysotile) asbestos (per sample no.2)	Stable	Warning signs, 1 small. Refer Section 6.0: Management Procedures.	
INTERNAL – Level 2

Photo 10 Cubicle partitions to Male & Female staff toilets

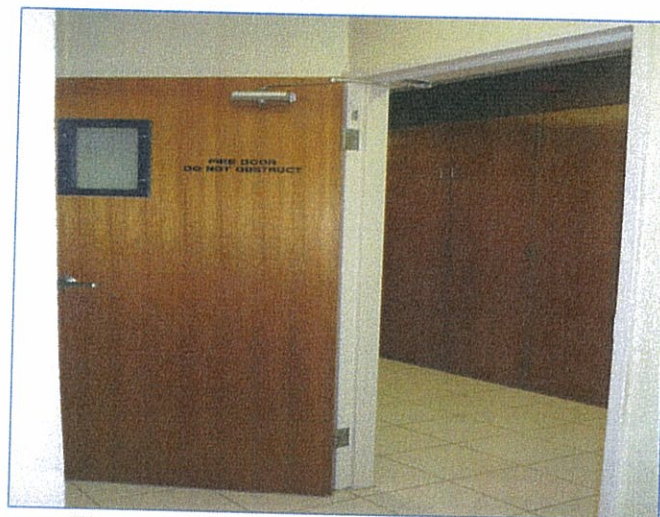
16. Fire door at Level 2 entry at Top of central staircase Core Material (2m ²) *Refer Photo 11	Not accessed or sampled. Based on past experience in similar areas, asbestos in some form may exist. It is recommended that if work is contemplated in this area, due care and diligence should be exercised.	Friable when exposed	Warning signs, 2 small. Refer Section 6.0: Management Procedures.	
PEOPLE & ORGANIZATIONAL LEARNING (Tenancy)

Photo 11 Fire door Lvl.2 entry at top of stairs

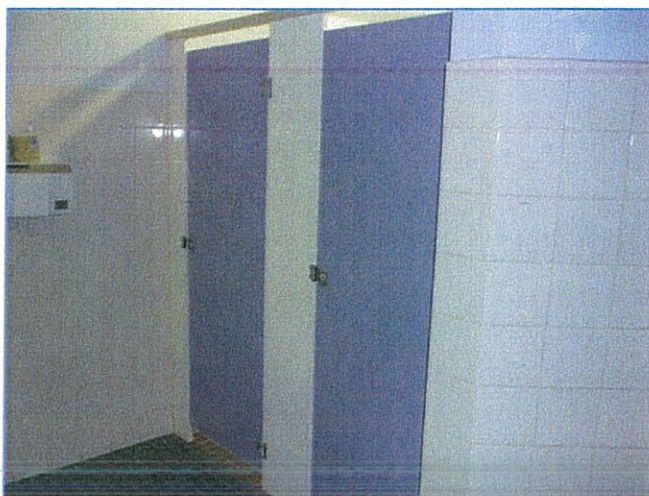
17. Cubicle partitions to male & female staff toilets, south end of tenancy (15m ²) *Refer Photo 12	Fibre cement sheet material containing white (Chrysotile) asbestos (per sample no.2)	Stable	Warning signs, 8 small. Refer Section 6.0: Management Procedures.

Photo 12 Cubicle partitions to Male & Female staff toilets

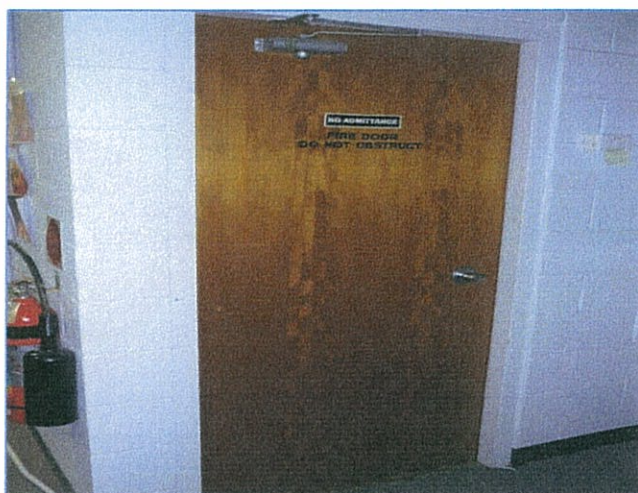
18. Fire door to entry of A/C Plant room Core Material (2m ²) <i>*Refer Photo 13</i>	Not accessed or sampled. Based on past experience in similar areas, asbestos in some form may exist. It is recommended that if work is contemplated in this area, due care and diligence should be exercised.	Friable when exposed	Warning signs, 2 small. Refer Section 6.0: Management Procedures.

Photo 13 Fire door to entry of AC plant room

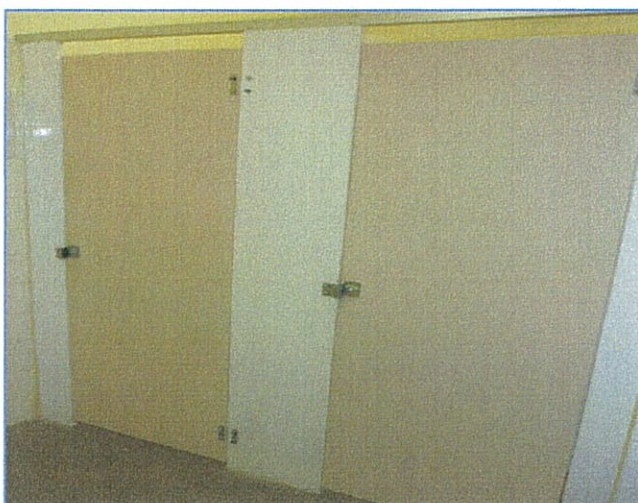
19. Cubicle partitions to male & female staff toilets, north side of tenancy (15m ²) <i>*Refer Photo 14</i>	Fibre cement sheet material containing white (Chrysotile) asbestos (per sample no.2)	Stable	Warning signs, 1 small. Refer Section 6.0: Management Procedures.

Photo 14 Cubicle partitions to Male & Female staff toilet

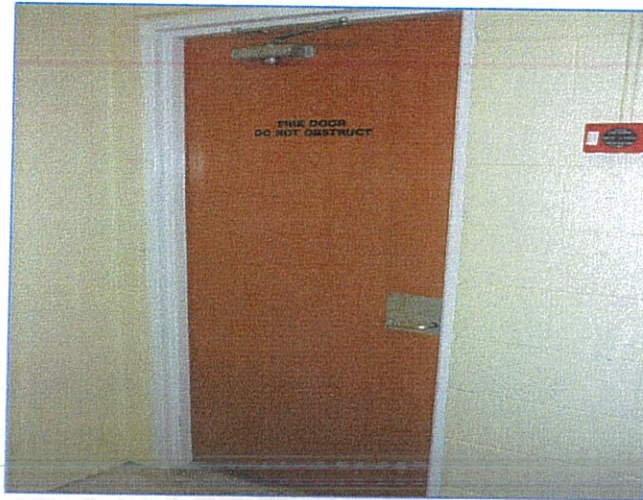
21. Fire door to emergency exit stairwell at northeast corner of Tenancy Core Material (2m ²) <i>*Refer Photo 15</i>	Not accessed or sampled. Based on past experience in similar areas, asbestos in some form may exist. It is recommended that if work is contemplated in this area, due care and diligence should be exercised.	Friable when exposed	Warning signs, 2 small. Refer Section 6.0: Management Procedures.	
DEPARTMENT OF HEALTH & FAMILIES – Remote Health Branch (Tenancy)

Photo 15 Fire door to entry of AC plant room.

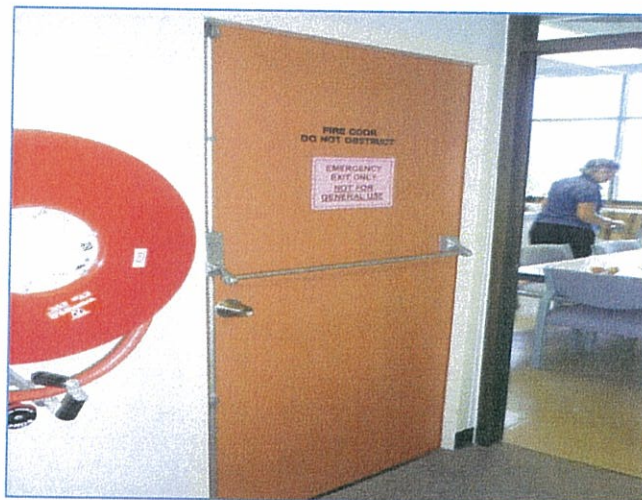
22. Fire door to emergency exit stairwell at north west corner of Tenancy Core Material (2m ²) <i>*Refer Photo 16</i>	Not accessed or sampled. Based on past experience in similar areas, asbestos in some form may exist. It is recommended that if work is contemplated in this area, due care and diligence should be exercised.	Friable when exposed	Warning signs, 2 small. Refer Section 6.0: Management Procedures.

Photo 16 Fire door to stairwell/fire exit

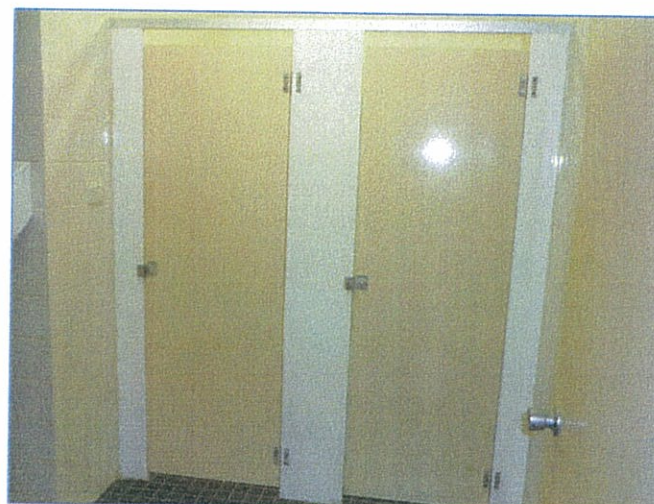
23. Cubicle partitions to male & female toilets (15m ²) <i>*Refer Photo 17</i>	Fibre cement sheet material containing white (Chrysotile) asbestos (per sample no.2)	Stable	Warning signs, 8 small. Refer Section 6.0: Management Procedures.

Photo 17 Cubicle partitions to Male & Female toilets

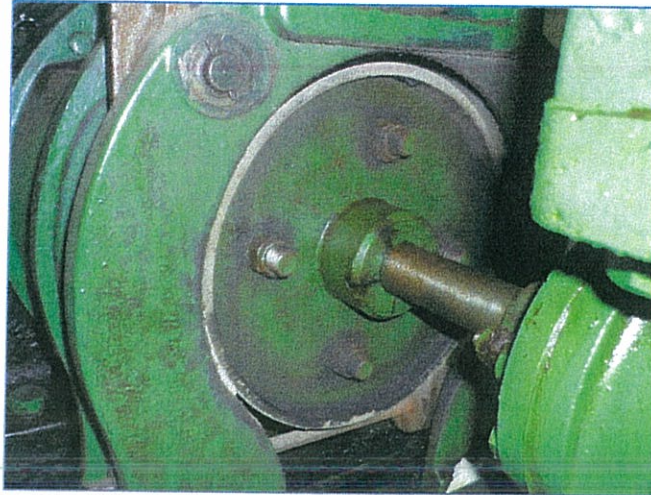
25. Brake shoes to elevator plant (<1m ²) <i>*Refer Photo 18</i>	Not accessed or sampled. Based on past experience in similar areas, asbestos in some form may exist. It is recommended that if work is contemplated in this area, due care and diligence should be exercised.	Stable	Warning signs, 1 small. Refer Section 6.0: Management Procedures.

Photo 18 Brake shoes to elevator motor

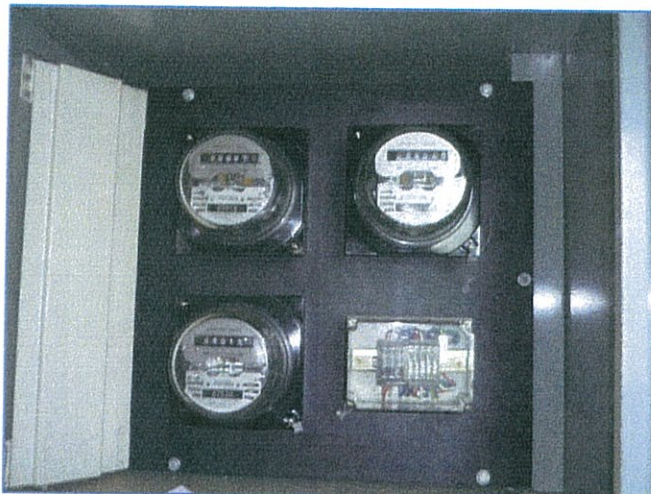
3. Backing board in meterbox (<1m ²) <i>*Refer Photo 19</i>	Area accessed but not sampled. Based on findings in similar areas, it is highly likely to contain asbestos.	Stable	Warning signs, 1 small. Refer Section 6.0: Management Procedures.

Photo 19 Backing board to meterbox in Sub Station area

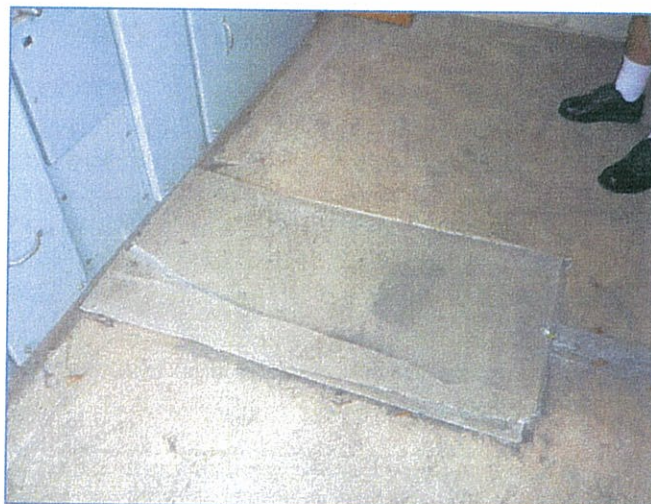
4. Cement sheet covers to floor trap area (2m ²) <i>*Refer Photo 20</i>	Fibre cement sheet material containing white (Chrysotile) asbestos (sample no.13)	Poor	Remove Refer Section 6.0: Management Procedures.	
CASUARINA COMMUNITY CARE CENTRE (Tenancy)

Photo 20 Cement sheet covers to sub floor area of Sub Station area
