# **Hazardous Materials Risk Assessment**

## **Ray White Woolongong**

### **Wanguri Shops**

**Date: June 2013**

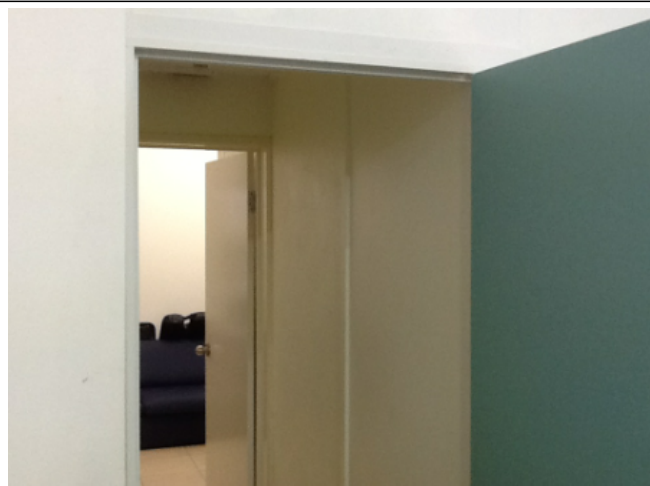
Photo No: j119922-NT0554-330  
Result: Asbestos - Positive  
Building/Level: Main Building - Anglicare-Ground Level  
Room/Location: Connecting passage-South  
Feature/Material: Wall Lining-Compressed Cement Sheet

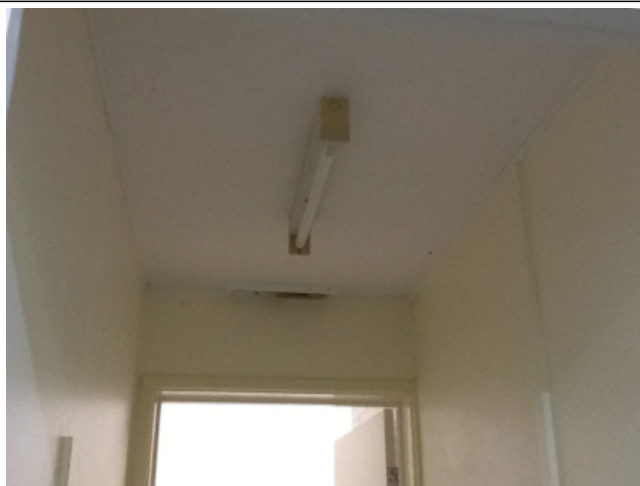
Photo No: j119922-NT0554-331  
Result: Asbestos - Positive  
Building/Level: Main Building - Anglicare-Ground Level  
Room/Location: Connecting passage-Throughout  
Feature/Material: Ceiling-Compressed Cement Sheet

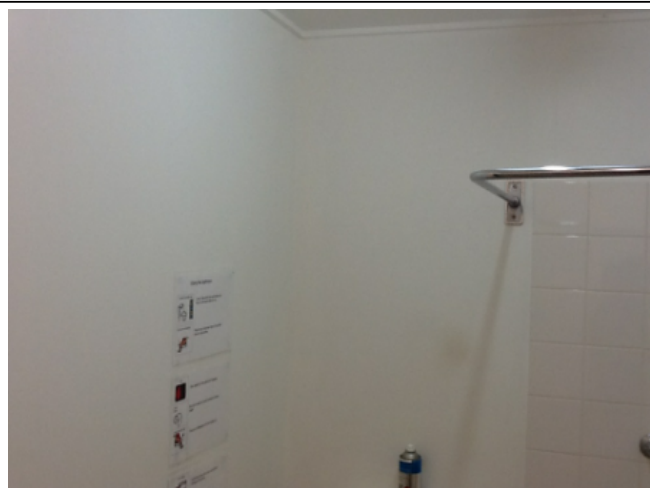
Female Toilets - North & West Wall Lining - Insulating Board - Respite office.	Asbestos	j119922-NT0554-12	Positive	j119922-NT0554-332	10 m <sup>2</sup>	Good	Friable	Low	Low	Not Labelled	20-06-2014	P3	Maintain in current condition, label and incorporate into an HMMP. Remove by licensed asbestos contractor prior to demolition or refurbishment.	
Female Toilets - Throughout Ceiling - Insulating Board	Asbestos	Similar To: j119922-NT0554-12	Presumed Positive	j119922-NT0554-333	3 m <sup>2</sup>	Good	Friable	Low	Low	Not Labelled	20-06-2014	P3	Confirm status, label, maintain in current condition and incorporate into an HMMP. Remove by licensed asbestos contractor prior to demolition or refurbishment.	
Meeting Room - Below sink Sink Lining - Bituminous Material	Asbestos	j119922-NT0554-15	Positive	j119922-NT0554-337	1 m <sup>2</sup>	Good	Non Friable	Low	Low	Not Labelled	20-06-2018	P4	Maintain in current condition, label and incorporate into an HMMP. Remove by licensed asbestos contractor prior to demolition or refurbishment.

Photo No: j119922-NT0554-332  
Result: Asbestos - Positive  
Building/Level: Main Building - Anglicare-Ground Level  
Room/Location: Female Toilets-North & West  
Feature/Material: Wall Lining-Insulating Board

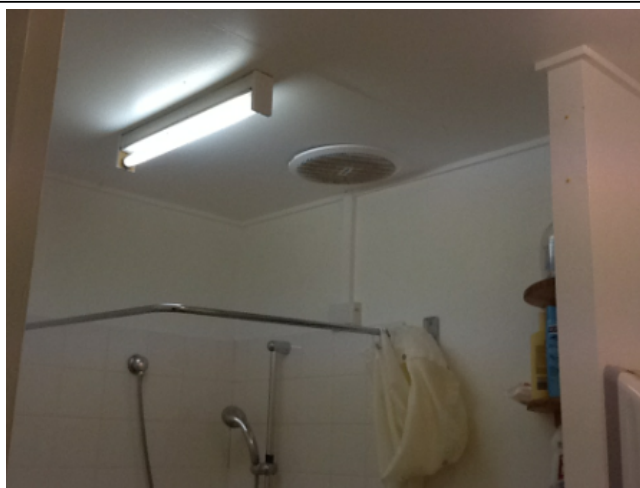
Photo No: j119922-NT0554-333  
Result: Asbestos - Presumed Positive  
Building/Level: Main Building - Anglicare-Ground Level  
Room/Location: Female Toilets-Throughout  
Feature/Material: Ceiling-Insulating Board

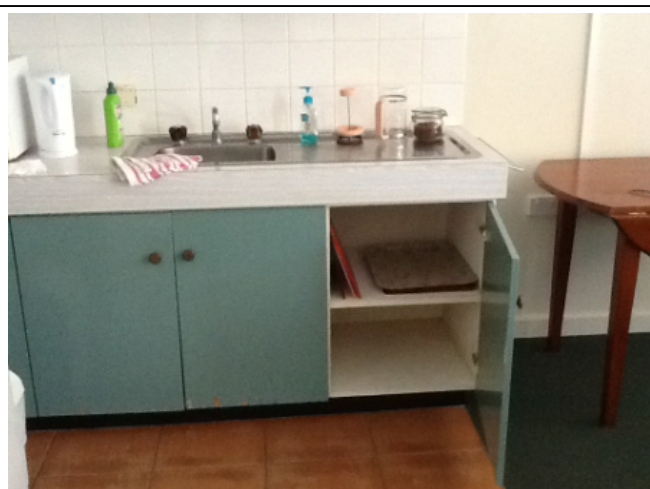
Photo No: j119922-NT0554-337  
Result: Asbestos - Positive  
Building/Level: Main Building - Anglicare-Ground Level  
Room/Location: Meeting Room-Below sink  
Feature/Material: Sink Lining-Bituminous Material

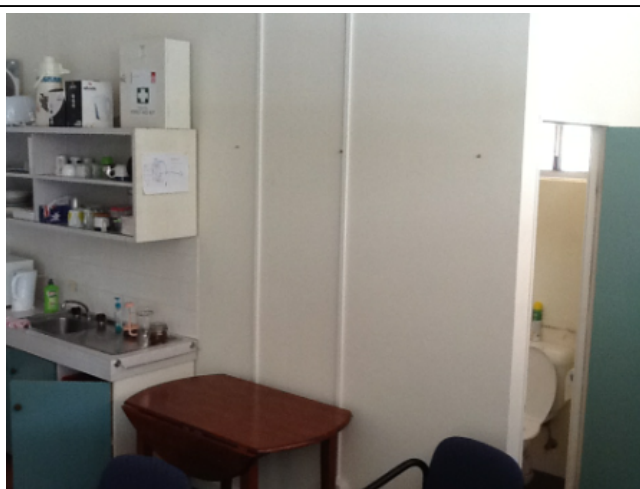
Meeting Room - Throughout Wall Lining - Insulating Board - Behind kitchenette , partially covered with ceramic tiles. Joins adjacent shower/toilet. Minor damage, needs repair/encapsulation.	Asbestos	j119922-NT0554-14	Positive	j119922-NT0554-335	25 m <sup>2</sup>	Fair	Friable	Medium	Medium	Not Labelled	20-12-2013	P2	Engage a licensed asbestos contractor to undertake remedial/removal works on this item as soon as practicable (within 3 months).	
Meeting room toilets - Throughout Ceiling - Insulating Board	Asbestos	Similar To: j119922-NT0554-14	Presumed Positive	j119922-NT0554-336	6 m <sup>2</sup>	Good	Friable	Low	Low	Not Labelled	20-06-2014	P3	Confirm status, label, maintain in current condition and incorporate into an HMMP. Remove by licensed asbestos contractor prior to demolition or refurbishment.	
Storage Cupboard - Throughout Floor Covering - Vinyl Tiles & Adhesive - In respite office under carpet. May exist throughout rest of offices carpeted areas (restricted access).	Asbestos	j119922-NT0554-13	Positive	j119922-NT0554-334	4 m <sup>2</sup>	Good	Non Friable	Low	Low	Not Labelled	20-06-2018	P4	Maintain in current condition, label and incorporate into an HMMP. Remove by licensed asbestos contractor prior to demolition or refurbishment.

Photo No: j119922-NT0554-335  
Result: Asbestos - Positive  
Building/Level: Main Building - Anglicare-Ground Level  
Room/Location: Meeting Room-Throughout  
Feature/Material: Wall Lining-Insulating Board

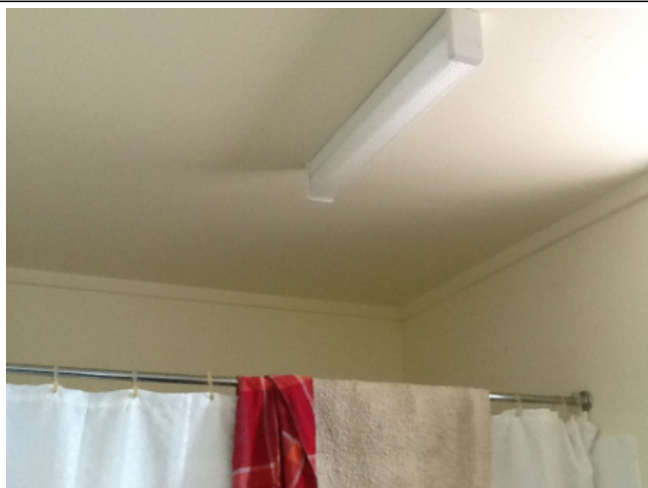
Photo No: j119922-NT0554-336  
Result: Asbestos - Presumed Positive  
Building/Level: Main Building - Anglicare-Ground Level  
Room/Location: Meeting room toilets-Throughout  
Feature/Material: Ceiling-Insulating Board

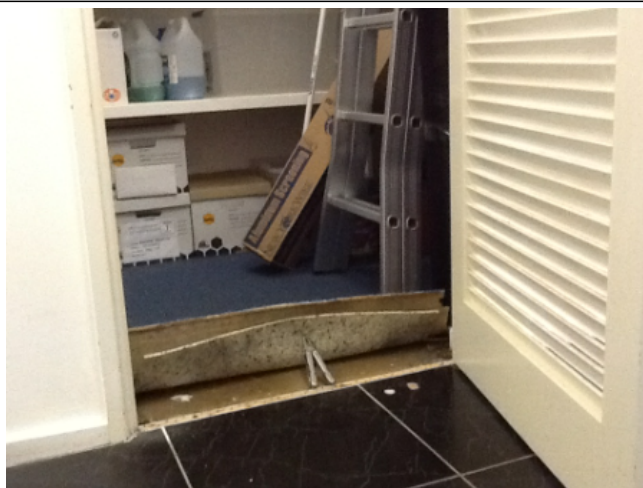
Photo No: j119922-NT0554-334  
Result: Asbestos - Positive  
Building/Level: Main Building - Anglicare-Ground Level  
Room/Location: Storage Cupboard-Throughout  
Feature/Material: Floor Covering-Vinyl Tiles & Adhesive

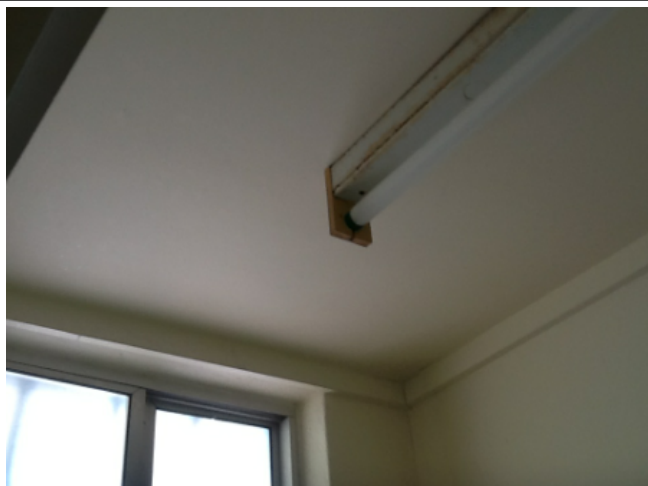
Photo No: j119922-NT0554-328  
Result: Asbestos - Presumed Positive  
Building/Level: Main Building - Anglicare-Ground Level  
Room/Location: Toilets-Throughout  
Feature/Material: Ceiling-Insulating Board

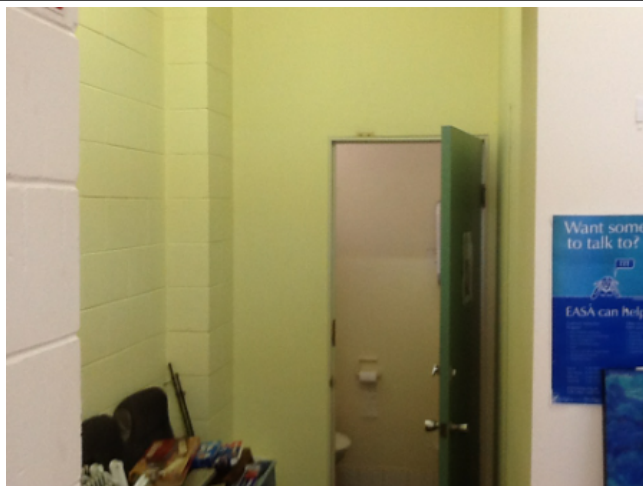
Photo No: j119922-NT0554-327  
Result: Asbestos - Positive  
Building/Level: Main Building - Anglicare-Ground Level  
Room/Location: Toilets-Throughout  
Feature/Material: Wall Lining-Insulating Board

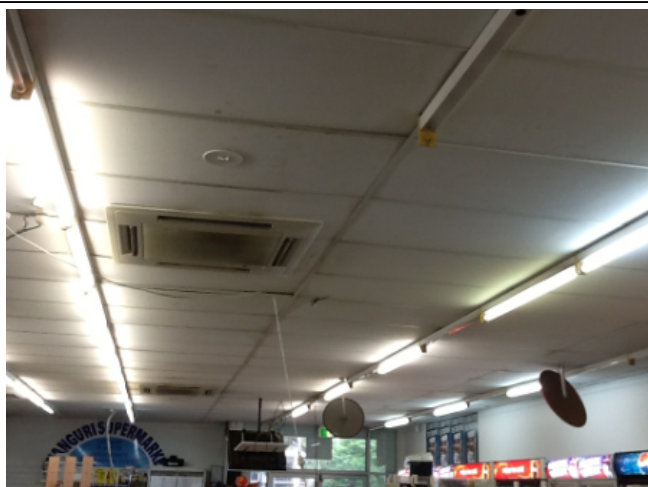
Photo No: j119922-NT0554-321  
Result: Asbestos - Positive  
Building/Level: Main Building - Supermarket-Ground Level  
Room/Location: Retail area-Throughout  
Feature/Material: Ceiling Tiles-Compressed Cement Sheet

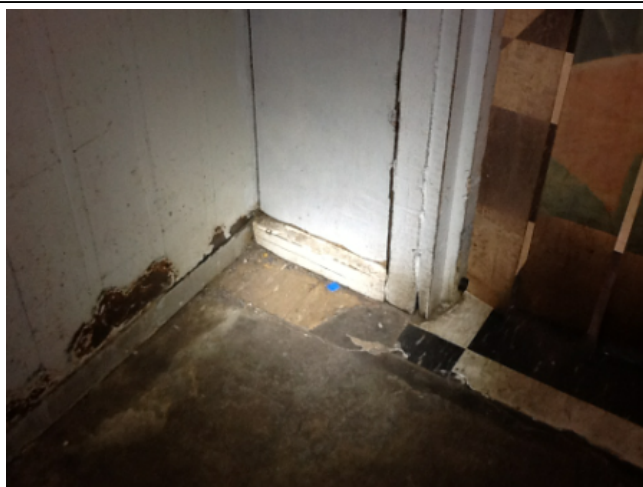
Photo No: j119922-NT0554-320  
Result: Asbestos - Positive  
Building/Level: Main Building - Supermarket-Ground Level  
Room/Location: Storage Room-Adjacent to store entry door  
Feature/Material: Floor Covering Adhesive-Vinyl Tiles & Adhesive

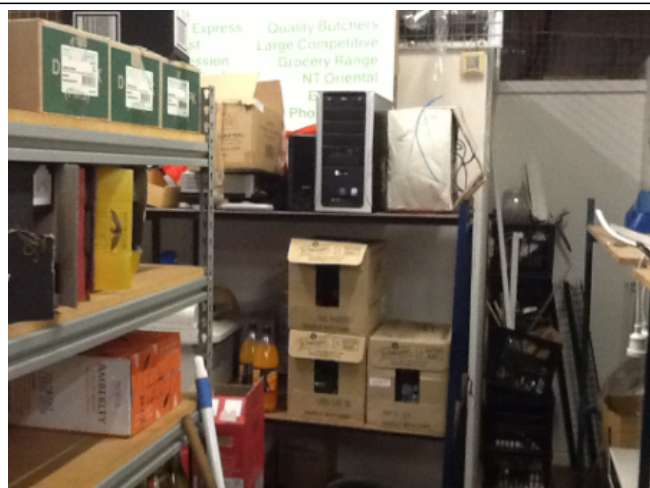
Storage Room - East Wall Lining - Insulating Board		Asbestos	j119922-NT0554-04	Positive	j119922-NT0554-322	10 m²	Good	Friable	Low	Low	Not Labelled	20-06-2014	P3	Maintain in current condition, label and incorporate into an HMMP. Remove by licensed asbestos contractor prior to demolition or refurbishment.	
Store floor - Throughout Floor Covering - Vinyl Tiles & Adhesive - Black and White Tiles are Negative for asbestos. Attached adhesive is positive for asbestos. (See attached analysis report)		Asbestos	j119922-NT0554-01	Positive	j119922-NT0554-319	130 m²	Good	Non Friable	Low	Low	Not Labelled	20-06-2018	P4	Maintain in current condition, label and incorporate into an HMMP. Remove by licensed asbestos contractor prior to demolition or refurbishment.	
Toilets - East Wall Lining - Insulating Board - Toilet partition (double sided) and east wall. Has hole in wall with exposed edges, door handle has penetrated lining.		Asbestos	j119922-NT0554-05	Positive	j119922-NT0554-323	8 m²	Fair	Friable	Medium	Medium	Not Labelled	20-12-2013	P2	Engage a licensed asbestos contractor to undertake remedial/removal works on this item as soon as practicable (within 3 months).

Photo No: j119922-NT0554-322  
Result: Asbestos - Positive  
Building/Level: Main Building - Supermarket-Ground Level  
Room/Location: Storage Room-East  
Feature/Material: Wall Lining-Insulating Board

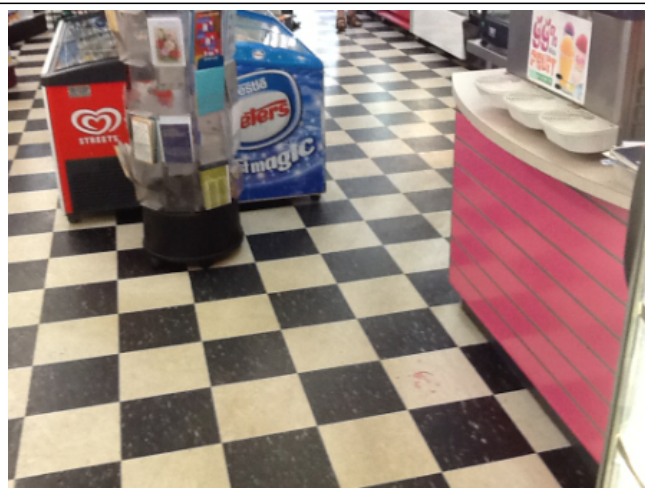
Photo No: j119922-NT0554-319  
Result: Asbestos - Positive  
Building/Level: Main Building - Supermarket-Ground Level  
Room/Location: Store floor-Throughout  
Feature/Material: Floor Covering-Vinyl Tiles & Adhesive

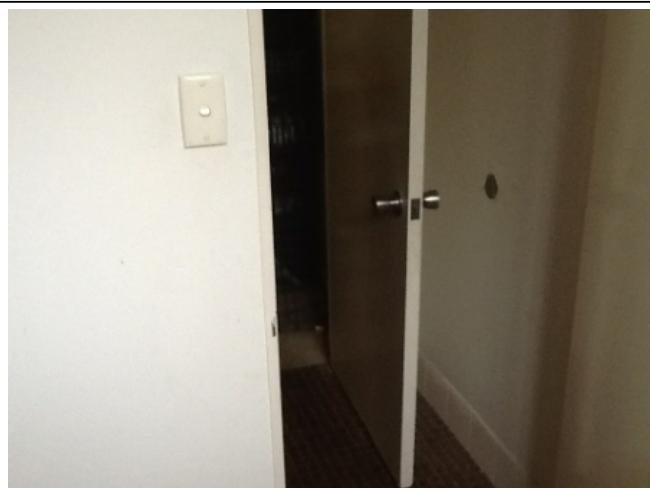
Photo No: j119922-NT0554-323  
Result: Asbestos - Positive  
Building/Level: Main Building - Supermarket-Ground Level  
Room/Location: Toilets-East  
Feature/Material: Wall Lining-Insulating Board

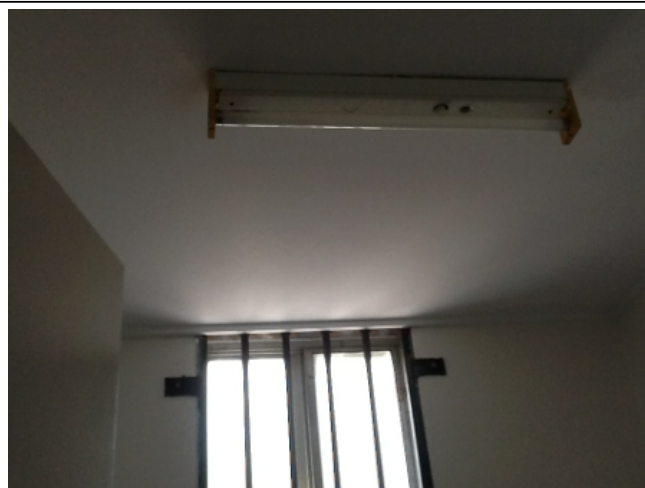
Toilets - Throughout Ceiling - Insulating Board		Asbestos	Similar To: j119922-NT0554-05	Presumed Positive	j119922-NT0554-324	5 m²	Good	Friable	Low	Low	Not Labelled	20-06-2014	P3	Confirm status, label, maintain in current condition and incorporate into an HMMP. Remove by licensed asbestos contractor prior to demolition or refurbishment.

Photo No: j119922-NT0554-324  
Result: Asbestos - Presumed Positive  
Building/Level: Main Building - Supermarket-Ground Level  
Room/Location: Toilets-Throughout  
Feature/Material: Ceiling-Insulating Board

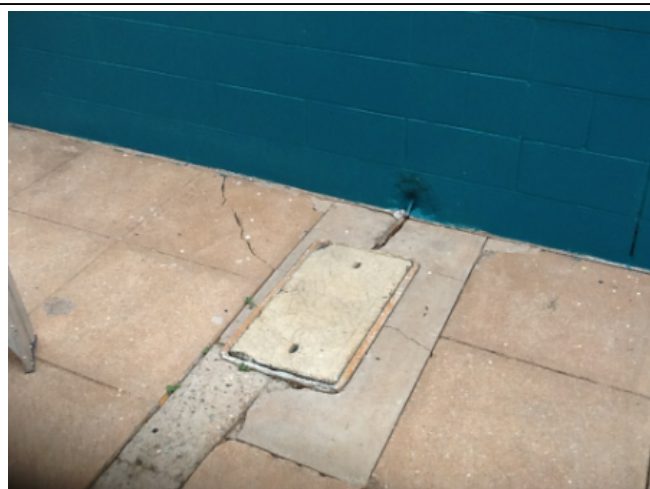
Photo No: j119922-NT0554-338  
Result: Asbestos - Positive  
Building/Level: Main Building - Darwin Midwifery Group-Ground Level  
Room/Location: Exterior-East  
Feature/Material: Pit-Moulded Fibre Cement

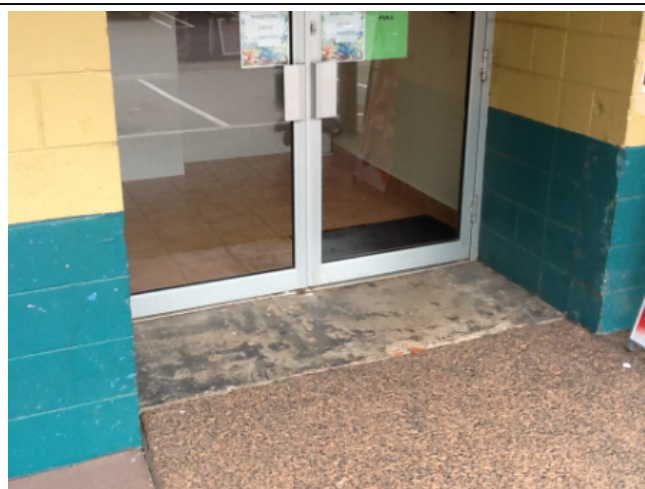
Exterior - North Floor - Adhesive - Adhesive may extend under ceramic tiles. Is at front door of business.	Asbestos	Similar To: j119922-NT0554-07	Presumed Positive	j119922-NT0554-339	1 m <sup>2</sup>	Fair	Non Friable	Medium	Medium	Not Labelled	20-12-2013	P2	Engage a licensed asbestos contractor to undertake remedial/removal works on this item as soon as practicable (within 3 months).	
<b>Main Building - Darwin Midwifery Group - Interior - Ground Level</b>														
Consult Room - Under carpet Floor - Adhesive - All consult rooms	Asbestos	j119922-NT0554-07	Positive	j119922-NT0554-326	50 m <sup>2</sup>	Good	Non Friable	Low	Low	Not Labelled	20-06-2018	P4	Maintain in current condition, label and incorporate into an HMMP. Remove by licensed asbestos contractor prior to demolition or refurbishment.

Photo No: j119922-NT0554-339  
Result: Asbestos - Presumed Positive  
Building/Level: Main Building - Darwin Midwifery Group-Ground Level  
Room/Location: Exterior-North  
Feature/Material: Floor-Adhesive

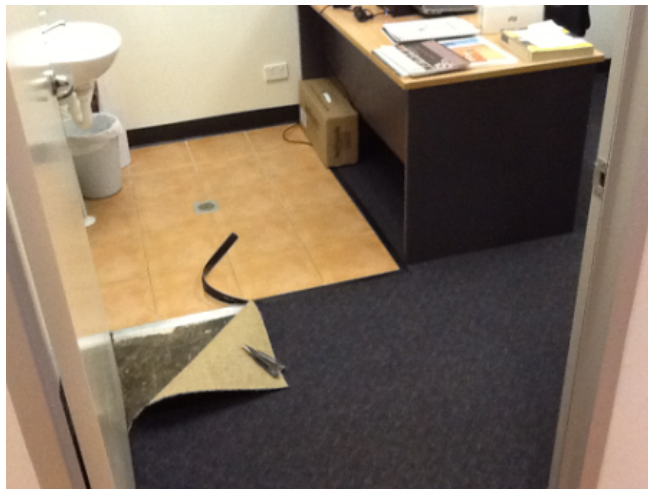
Photo No: j119922-NT0554-326  
Result: Asbestos - Positive  
Building/Level: Main Building - Darwin Midwifery Group-Ground Level  
Room/Location: Consult Room-Under carpet  
Feature/Material: Floor-Adhesive
