ASBESTOS REGISTER

REGISTER NO.: AS 4744-1

FOR THE PROPERTY AT: Lot 51 Paterson Street
Tennant Creek, NT

DATE INSPECTED: 29/01/2015

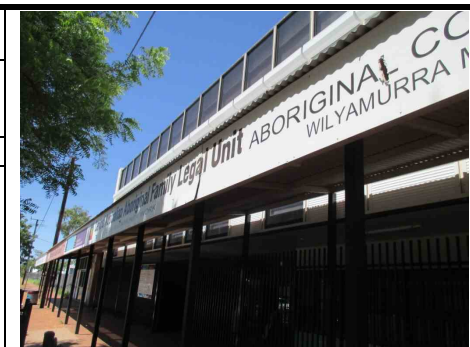
LOCATION - DESCRIPTION	EXTENT	ASBESTOS ASSESSMENT	CONDITION	SAMPLE NO VISUAL TEST	SIGNAGE STATUS
A. External, front elevation verandah fascia lining . fibre cement sheet.	Approx 12m ² Limited access	No asbestos detected	-	02/TH/290115	-
<i>SURVEY FINDINGS and HAZARD MANAGEMENT RECOMMENDATIONS</i>					
No asbestos detected upon laboratory analysis of sample.

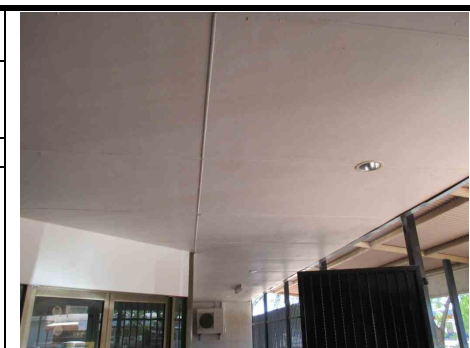
LOCATION - DESCRIPTION	EXTENT	ASBESTOS ASSESSMENT	CONDITION	SAMPLE NO VISUAL TEST	SIGNAGE STATUS
B. External front elevation entrance ceiling lining . fibre cement sheet.	Approx 56m ² Limited access	No asbestos detected	-	04/TH/290115	-
<i>SURVEY FINDINGS and HAZARD MANAGEMENT RECOMMENDATIONS</i>					
No asbestos detected upon laboratory analysis of sample.

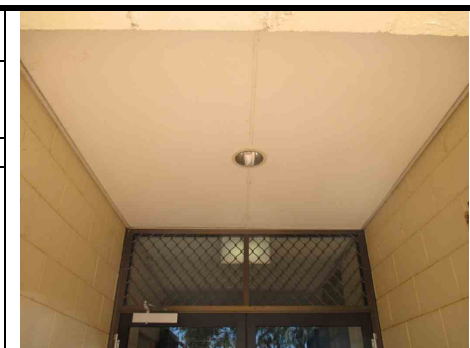
LOCATION - DESCRIPTION	EXTENT	ASBESTOS ASSESSMENT	CONDITION	SAMPLE NO VISUAL TEST	SIGNAGE STATUS
C. External side elevation entrance ceiling lining . fibre cement sheet.	Approx 4m ² Limited access	No asbestos detected	-	Representative of sample 04/TH/290115	-
<i>SURVEY FINDINGS and HAZARD MANAGEMENT RECOMMENDATIONS</i>					
No asbestos detected upon laboratory analysis of sample.

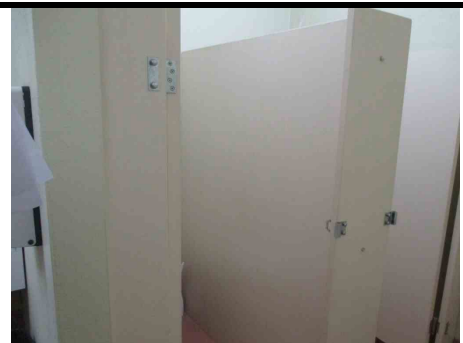
LOCATION - DESCRIPTION	EXTENT	ASBESTOS ASSESSMENT	CONDITION	SAMPLE NO VISUAL TEST	SIGNAGE STATUS
1. Internal, 1 st floor staff toilet partition lining . fibre cement thick sheet.	Approx 4m ² Accessible	No asbestos detected	-	Representative of sample 03/TH/290115	-
SURVEY FINDINGS and HAZARD MANAGEMENT RECOMMENDATIONS					
No asbestos detected upon laboratory analysis of sample.

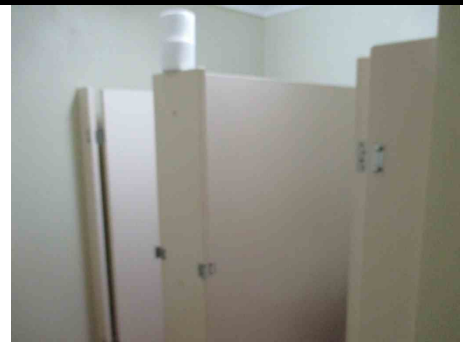
LOCATION - DESCRIPTION	EXTENT	ASBESTOS ASSESSMENT	CONDITION	SAMPLE NO VISUAL TEST	SIGNAGE STATUS
2. Internal, 1 st floor public toilet partition lining . fibre cement thick sheet.	Approx 4m ² Accessible	No asbestos detected	-	03/TH/290115	-
SURVEY FINDINGS and HAZARD MANAGEMENT RECOMMENDATIONS					
No asbestos detected upon laboratory analysis of sample.

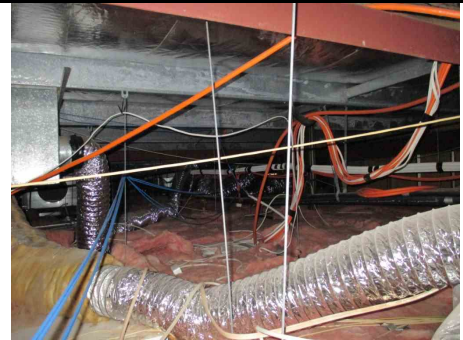
LOCATION - DESCRIPTION	EXTENT	ASBESTOS ASSESSMENT	CONDITION	SAMPLE NO VISUAL TEST	SIGNAGE STATUS
3. Internal ceiling space	-	-	-	-	-
SURVEY FINDINGS and HAZARD MANAGEMENT RECOMMENDATIONS					
Limited access to this item. No asbestos visible upon inspection.
