ASBESTOS REGISTER UPDATE No. NT0271/01

NT HOUSE 22 MITCHELL STREET DARWIN NT

Date: January 2014 Register No: NT0271/01 Register Version: V02 Our Ref: DK/sk

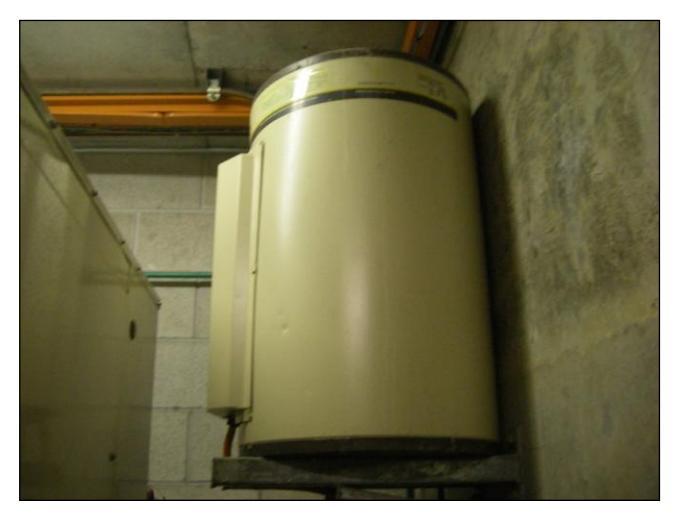
Photo 1. Hot water system to Plant Room 2, Level 1

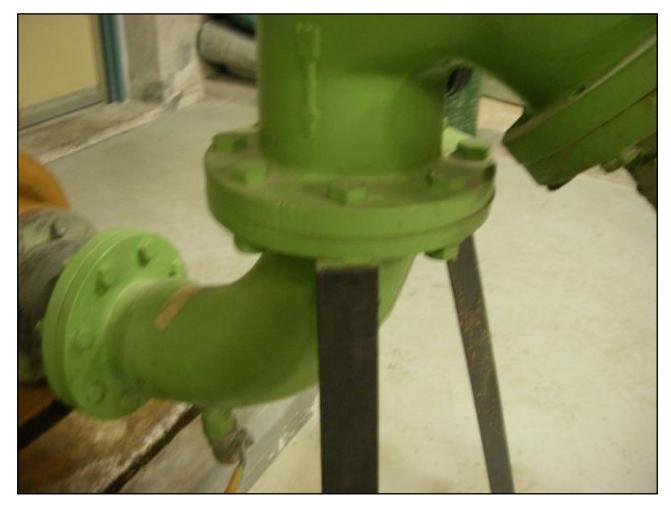
Level 3 (Plant Roor	n)		•		
Gasket to condenser water cooling pipe (assume all gaskets to water pipes contain asbestos)	Gasket material containing white (Chrysotile) asbestos (sample no.10)	Stable	Warning sign in place Refer Section 6.0: Management Procedures.	No change noted	
Refer Photo 2					
Note: No asbestos was detected from the internal core of fire doors tested from the ground floor. It is assumed these fire doors are representative of those in all other floor levels.

Photo 2. Gasket to pipework, Level 3
