# ASBESTOS MANAGEMENT PLAN

AMP NT0702

Barkley House 99 Paterson Street  
Tennant Creek NT

February 2015  
J131287

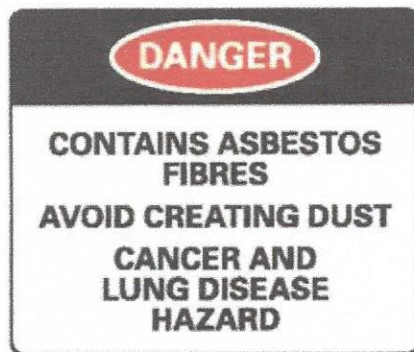
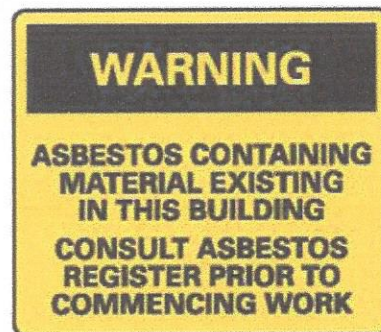
Below are typical of signage found in commercial buildings.

Warning signs that have been wrongly removed, encapsulated or painted over should be replaced. All labels should comply with AS1319 Safety Signs for the Occupational Environment.

The practicability of labeling non-friable asbestos items in public access areas should be carefully considered in relation to the potential risks of exposure. Labeling is not always considered appropriate for asbestos situations in occupied areas as signs warning of the presence of asbestos may cause unnecessary alarm and disruption. In this case it may be appropriate to apply General Awareness warning signs indicating that asbestos does exist on the site.
