ASBESTOS MATERIALS REPORT & REGISTER

Katherine Government Centre
5 First Street
Katherine, NT, 0850

Project No. PJ.204471.NTa

Project No. PJ.204471.NTa
Site Visit Date: 16 July 2015
Consultant: Darren Kenny

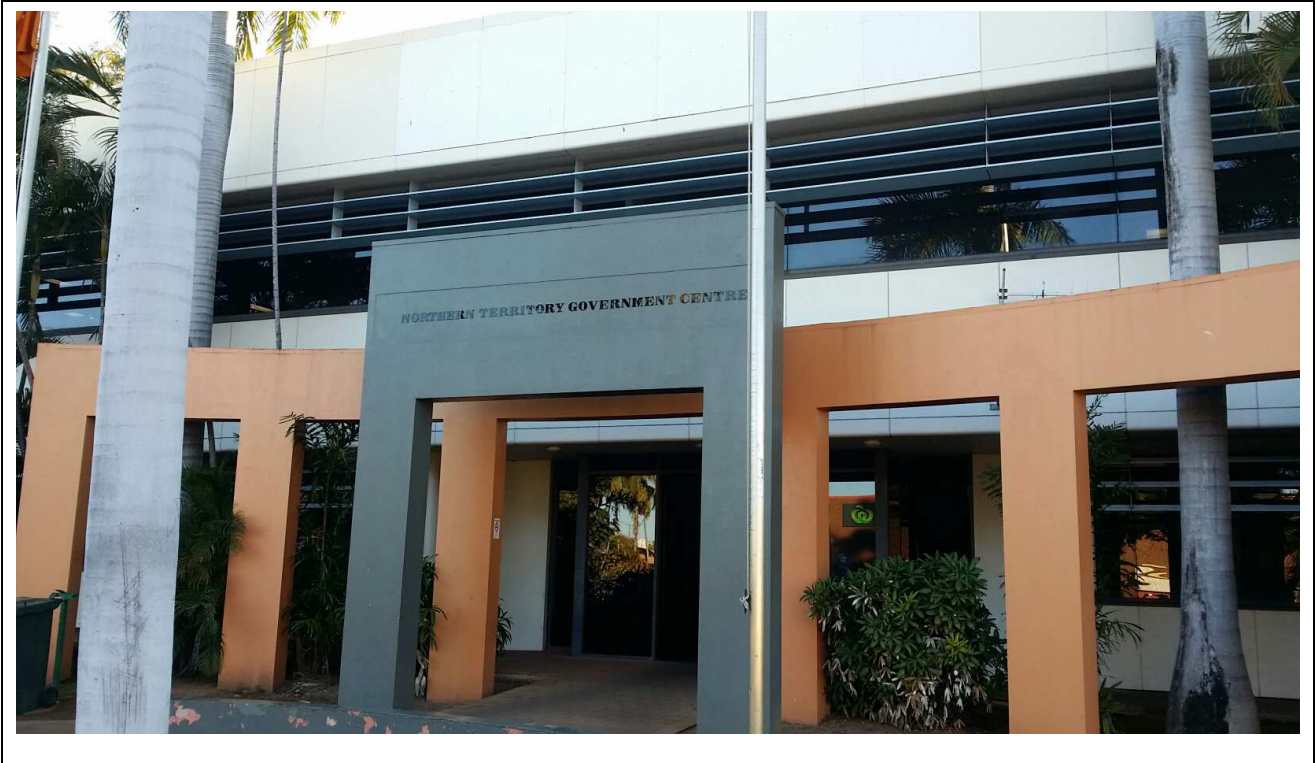
3 Photographs

Item No	Internal / External	Building / Structure	Location Description	Item / Type of Material	Matrix Stability	Sample Ref	Analytical Result	Comments / Condition	Priority Rating	Risk Rating
1	Internal	Main Building	Ceiling space throughout building	Sealant to joins of A/C Ductwork	Bonded	B31095	NAD	Sealed and in good condition	-	-
2	External	Main Building	Roof - Raised section of roof - south west elevation	Cement sheet wall cladding - both ends of raised section.	Bonded	B31144	NAD	Sealed and in good condition	-	-
3	External	Main Building	Roof - Raised section of roof - south west elevation	Thick cement sheet panel window awning	Bonded	B31094	NAD	Sealed and in good condition	-	-
4	External	Main Building	Roof - Raised section of roof - south west elevation	Cement Sheet eave cladding	Bonded	B31093	NAD	Sealed and in good condition	-	-
5	External	Main Building	Ground level and level 1	Thick cement sheet panel window awning	Bonded	B31091	NAD	Sealed and in good condition	-	-

6	External	Main Building	Throughout perimeter of building	Cement Sheet wall cladding	Bonded	31137	NAD	Sealed and in good condition	-	-
7	External	Main Building	Ground level and level 1	Cement Sheet eave cladding	Bonded	As per sample B31137	NAD	Sealed and in good condition	-	-
