ASBESTOS REGISTER

NO. NT0686c

RCG Centre

RCG Centre, 47 Mitchel St. Darwin 0800

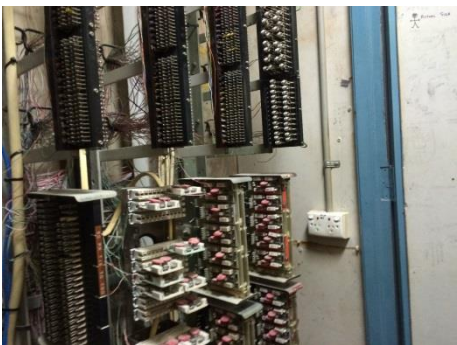
| 9. Inner door lining to Comms cupboard (4m ²) | | Fibre cement sheet material containing white (Chrysotile) and grey/brown (Amosite) asbestos (per sample no.2) | |

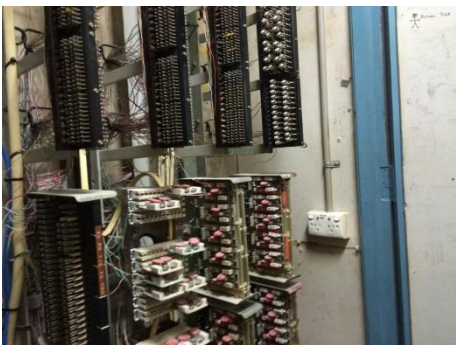
| 13. Inner door lining to Comms cupboard (4m ²) | | Fibre cement sheet material containing white (Chrysotile) and grey/brown (Amosite) asbestos (per sample no.2) | |
