Asbestos Register & Management Plan

City of Palmerston – Civic Centre

1 Chung Wah Tce, Palmerston NT 0830

Inspection By:	Paul Felvus
Report By:	Paul Felvus
Inspection Date:	03/05/2024
Report Date:	11/05/2024
Review Date:	03/05/2029
Project No:	A763.1
Status:	Released
Version:	1.0

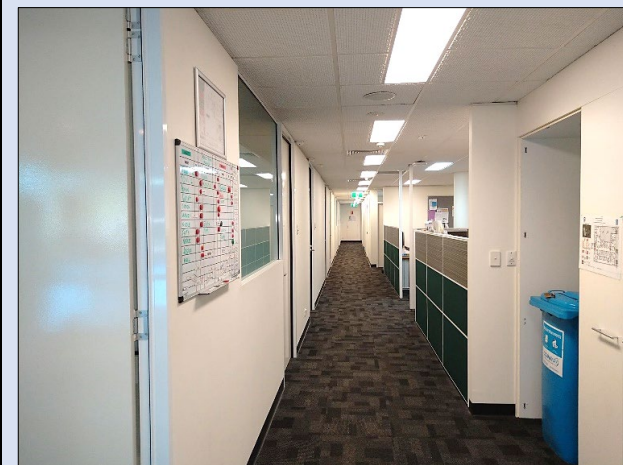
Sequence No:	11		Elevation:	Ground Floor
Area:	Internal		Friability	
Location:	TEMH Offices		Condition:	
Position	Ceilings, walls and floors		Sealed:	
Material Type:	No Suspect Materials Detected		Traffic:	
Quantity:	N/A	Sq. M	Risk Likelihood:	
Sample No:	N/A		Risk Consequence:	
Result:	No Suspect Materials Detected		Risk Rating:	
Comments:

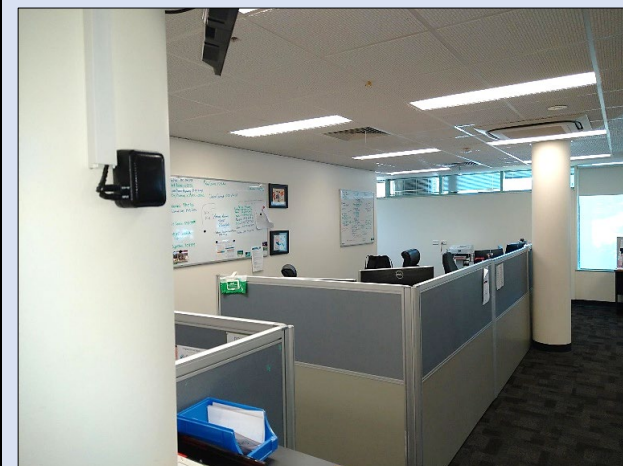
Sequence No:	12		Elevation:	Ground Floor
Area:	Internal		Friability	
Location:	TEMH Offices		Condition:	
Position	Ceilings, walls and floors		Enclosed	
Material Type:	Concrete block walls and steel sheet roof		Traffic:	
Quantity:	N/A	Sq. M	Risk Likelihood:	
Sample No:	N/A		Risk Consequence:	
Result:	No Suspect Materials Detected		Risk Rating:	
Comments:

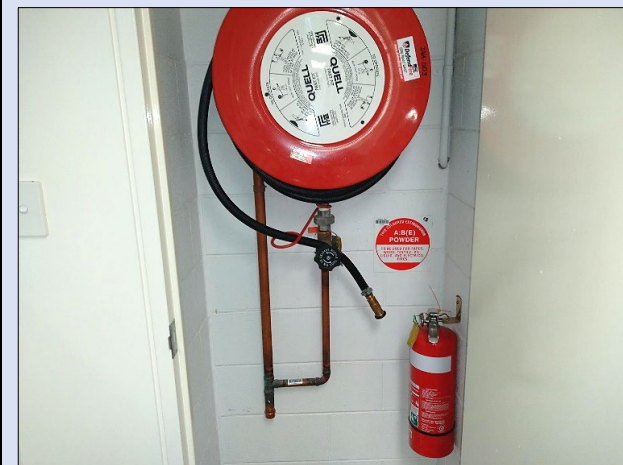
Sequence No:	13	Elevation:	Ground Floor
Area:	Internal	Friability	
Location:	TEMH Offices	Condition:	
Position	Fire hose reel cupboard	Sealed:	
Material Type:	Concrete block	Traffic:	
Quantity:	N/A	Risk Likelihood:	
Sample No:	N/A	Risk Consequence:	
Result:	No Suspect Materials Detected	Risk Rating:	
Comments:

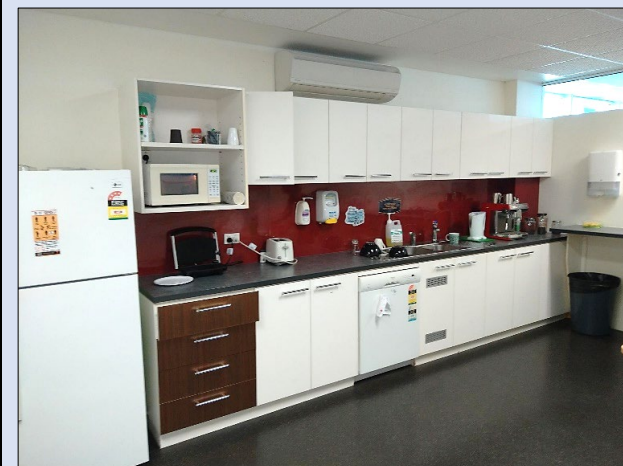
Sequence No:	14	Elevation:	Ground Floor
Area:	Internal	Friability	
Location:	TEMH Offices	Condition:	
Position	Staff kitchen ceilings, walls and floors	Enclosed	
Material Type:	No Suspect Materials Detected	Traffic:	
Quantity:	N/A	Risk Likelihood:	
Sample No:	N/A	Risk Consequence:	
Result:	No Suspect Materials Detected	Risk Rating:	
Comments:

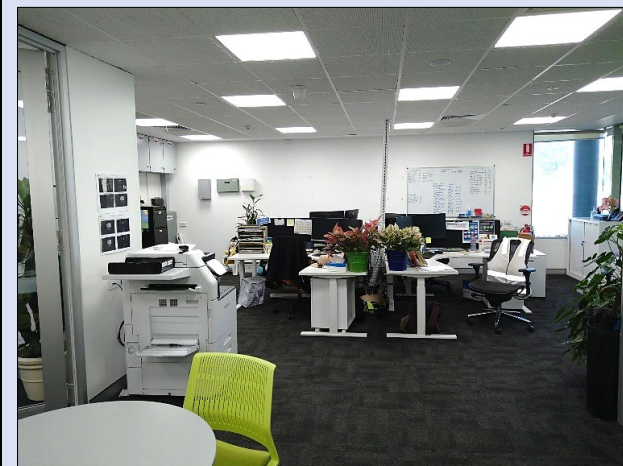
Sequence No:	15		Elevation:	Ground Floor
Area:	Internal		Friability	
Location:	Council Rangers Offices		Condition:	
Position	Ceilings, walls and floors		Sealed:	
Material Type:	No Suspect Materials Detected		Traffic:	
Quantity:	N/A	Sq. M	Risk Likelihood:	
Sample No:	N/A		Risk Consequence:	
Result:	No Suspect Materials Detected		Risk Rating:	
Comments:

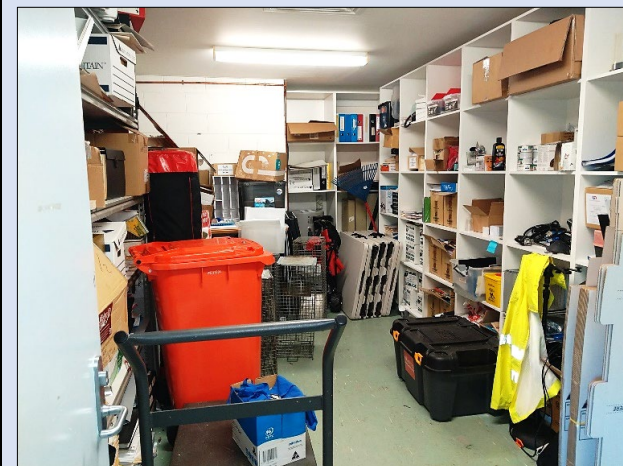
Sequence No:	16		Elevation:	Ground Floor
Area:	Internal		Friability	
Location:	Council Rangers Offices		Condition:	
Position	Storeroom ceilings, walls and floors		Enclosed	
Material Type:	No Suspect Materials Detected		Traffic:	
Quantity:	N/A	Sq. M	Risk Likelihood:	
Sample No:	N/A		Risk Consequence:	
Result:	No Suspect Materials Detected		Risk Rating:	
Comments:

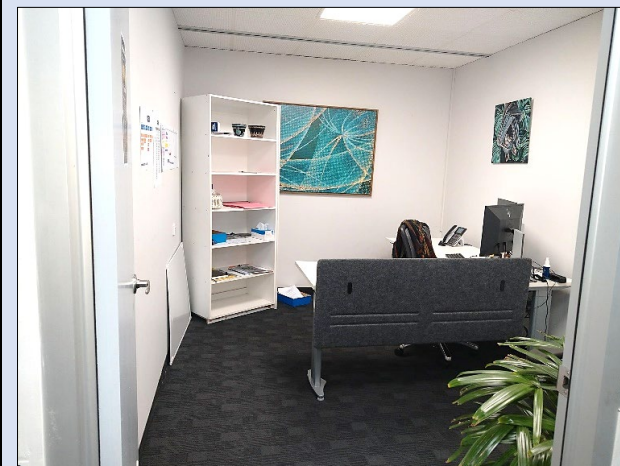
Sequence No:	17	Elevation:	Ground Floor
Area:	Internal	Friability	
Location:	Council Rangers Offices	Condition:	
Position	Office ceilings, walls and floors	Sealed:	
Material Type:	No Suspect Materials Detected	Traffic:	
Quantity:	N/A	Risk Likelihood:	
	Sq. M	Risk Consequence:	
Sample No:	N/A	Risk Rating:	
Result:	No Suspect Materials Detected		
Comments:

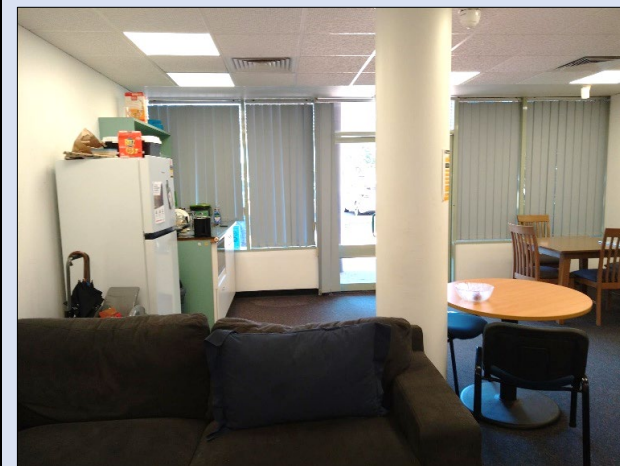
Sequence No:	18	Elevation:	Ground Floor
Area:	Internal	Friability	
Location:	Council Rangers Offices	Condition:	
Position	Staff kitchen ceilings, walls and floors	Enclosed	
Material Type:	No Suspect Materials Detected	Traffic:	
Quantity:	N/A	Risk Likelihood:	
	Sq. M	Risk Consequence:	
Sample No:	N/A	Risk Rating:	
Result:	No Suspect Materials Detected		
Comments:

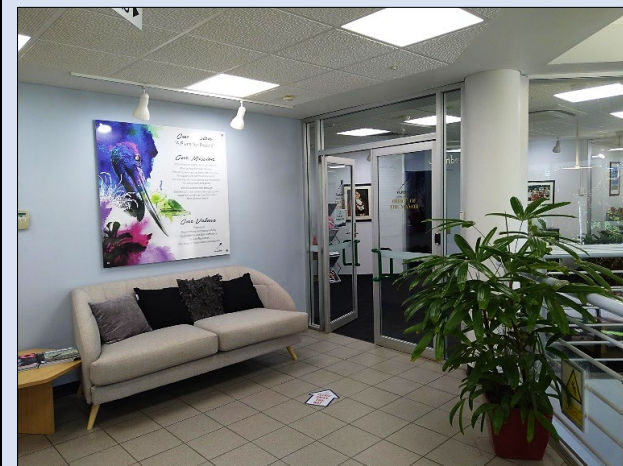
Sequence No:	19		Elevation:	Level 1
Area:	Internal		Friability	
Location:	Foyer and atrium		Condition:	
Position	Throughout		Sealed:	
Material Type:	No Suspect Materials Detected		Traffic:	
Quantity:	N/A	Sq. M	Risk Likelihood:	
Sample No:	N/A		Risk Consequence:	
Result:	No Suspect Materials Detected		Risk Rating:	
Comments:

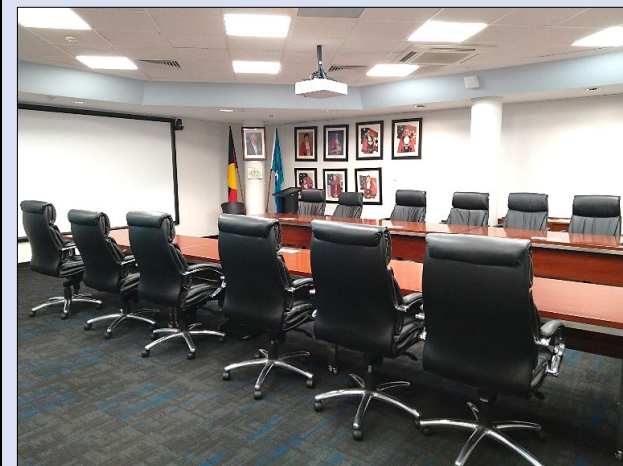
Sequence No:	20		Elevation:	Level 1
Area:	Internal		Friability	
Location:	Council Chamber		Condition:	
Position	Throughout		Enclosed	
Material Type:	No Suspect Materials Detected		Traffic:	
Quantity:	N/A	Sq. M	Risk Likelihood:	
Sample No:	N/A		Risk Consequence:	
Result:	No Suspect Materials Detected		Risk Rating:	
Comments:

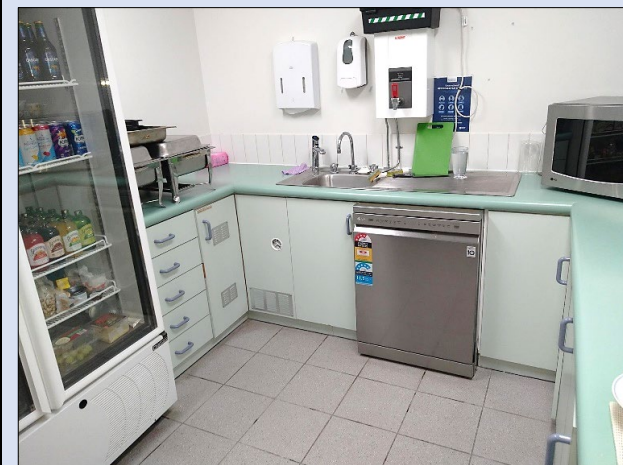
Sequence No:	21		Elevation:	Level 1
Area:	Internal		Friability	
Location:	Council Chamber kitchen		Condition:	
Position	Throughout		Sealed:	
Material Type:	No Suspect Materials Detected		Traffic:	
Quantity:	N/A	Sq. M	Risk Likelihood:	
Sample No:	N/A		Risk Consequence:	
Result:	No Suspect Materials Detected		Risk Rating:	
Comments:

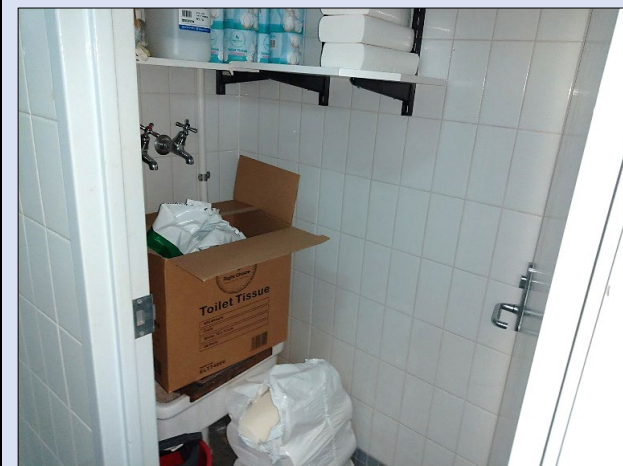
Sequence No:	22		Elevation:	Level 1
Area:	Internal		Friability	
Location:	Level 1 atrium Cleaner's Store		Condition:	
Position	Ceilings and walls		Enclosed	
Material Type:	Concrete block walls and plasterboard ceiling		Traffic:	
Quantity:	N/A	Sq. M	Risk Likelihood:	
Sample No:	N/A		Risk Consequence:	
Result:	No Suspect Materials Detected		Risk Rating:	
Comments:

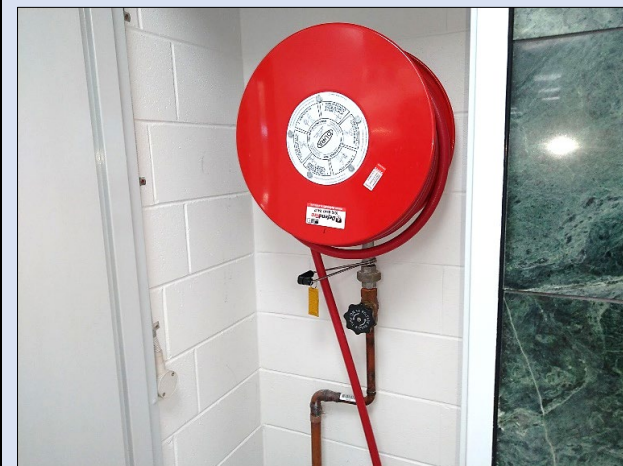
Sequence No:	25	Elevation:	Level 1
Area:	Internal	Friability	
Location:	Foyer/Atrium Fire hose reel cupboard	Condition:	
Position	Walls	Sealed:	
Material Type:	Concrete block	Traffic:	
Quantity:	N/A	Risk Likelihood:	
	Sq. M	Risk Consequence:	
Sample No:	N/A	Risk Rating:	
Result:	No Suspect Materials Detected		
Comments:

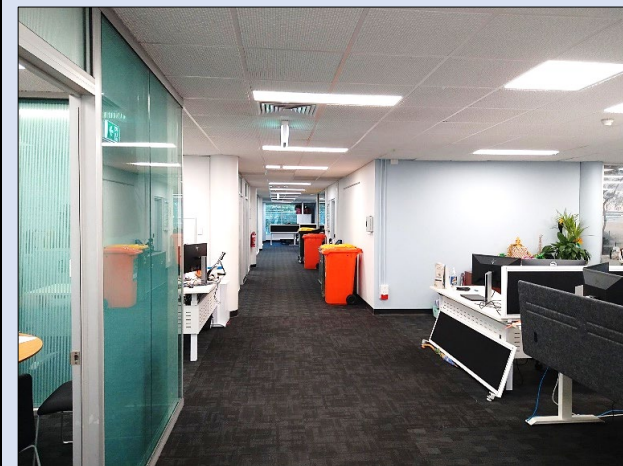
Sequence No:	26	Elevation:	Level 1
Area:	Internal	Friability	
Location:	City of Palmerston Offices	Condition:	
Position	Ceilings, walls and floors	Enclosed	
Material Type:	No Suspect Materials Detected	Traffic:	
Quantity:	N/A	Risk Likelihood:	
	Sq. M	Risk Consequence:	
Sample No:	N/A	Risk Rating:	
Result:	No Suspect Materials Detected		
Comments:

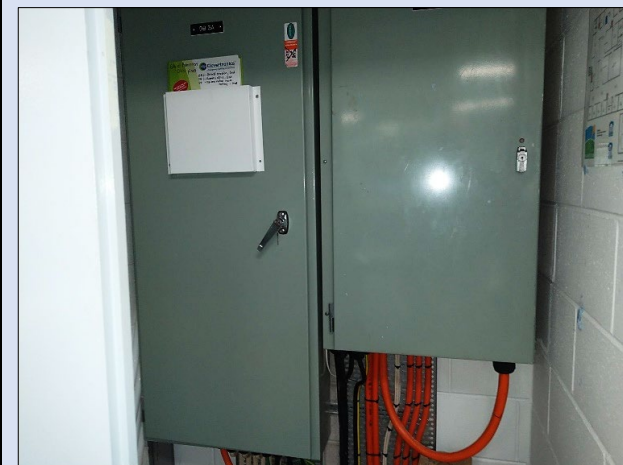
Sequence No:	27		Elevation:	Level 1
Area:	Internal		Friability	
Location:	City of Palmerston Offices		Condition:	
Position	Electrical switch cabinet		Sealed:	
Material Type:	No Suspect Materials Detected		Traffic:	
Quantity:	N/A	Sq. M	Risk Likelihood:	
Sample No:	N/A		Risk Consequence:	
Result:	No Suspect Materials Detected		Risk Rating:	
Comments:

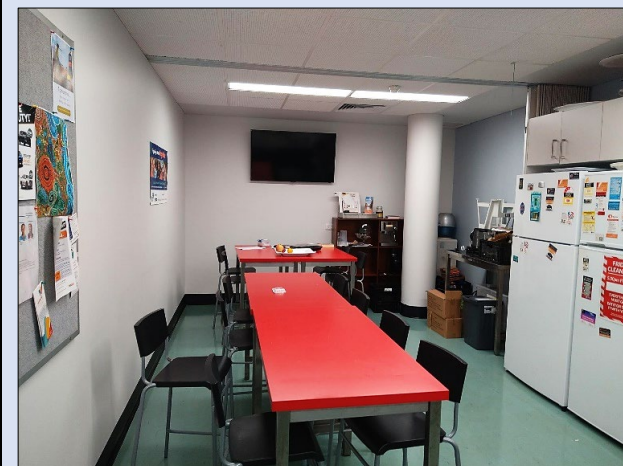
Sequence No:	28		Elevation:	Level 1
Area:	Internal		Friability	
Location:	City of Palmerston Offices		Condition:	
Position	Ceilings and walls		Enclosed	
Material Type:	Concrete block walls and steel sheet roof		Traffic:	
Quantity:	N/A	Sq. M	Risk Likelihood:	
Sample No:	N/A		Risk Consequence:	
Result:	No Suspect Materials Detected		Risk Rating:	
Comments:

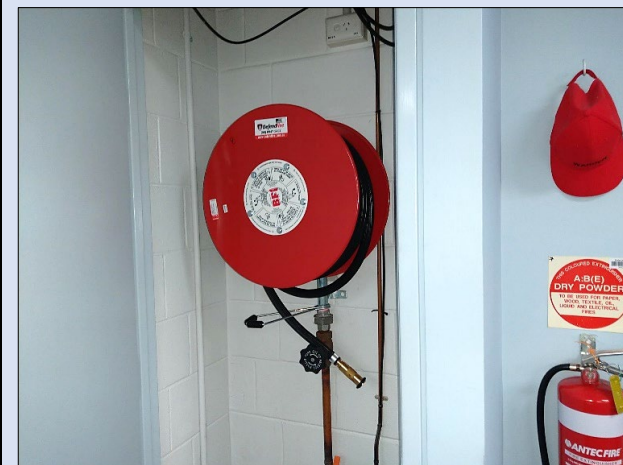
Sequence No:	29	Elevation:	Level 1
Area:	Internal	Friability	
Location:	City of Palmerston Offices	Condition:	
Position	Fire hose reel cupboard (near fire stairs)	Sealed:	
Material Type:	Concrete block walls	Traffic:	
Quantity:	N/A	Risk Likelihood:	
Sample No:	N/A	Risk Consequence:	
Result:	No Suspect Materials Detected	Risk Rating:

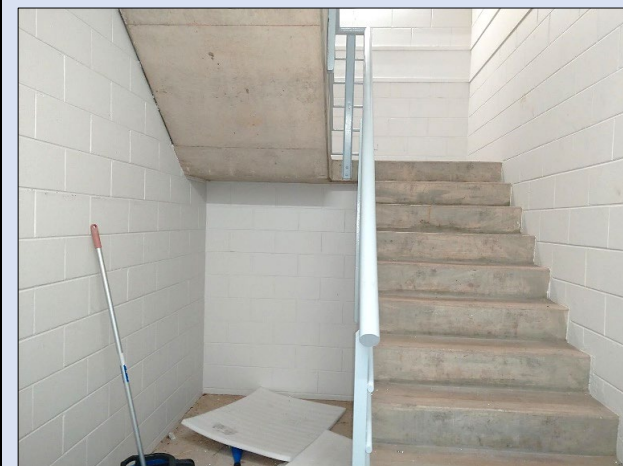
Sequence No:	30	Elevation:	Level 1
Area:	Internal	Friability	
Location:	Fires stairs at northern end of building	Condition:	
Position	Throughout	Enclosed	
Material Type:	Concrete	Traffic:	
Quantity:	N/A	Risk Likelihood:	
Sample No:	N/A	Risk Consequence:	
Result:	No Suspect Materials Detected	Risk Rating:

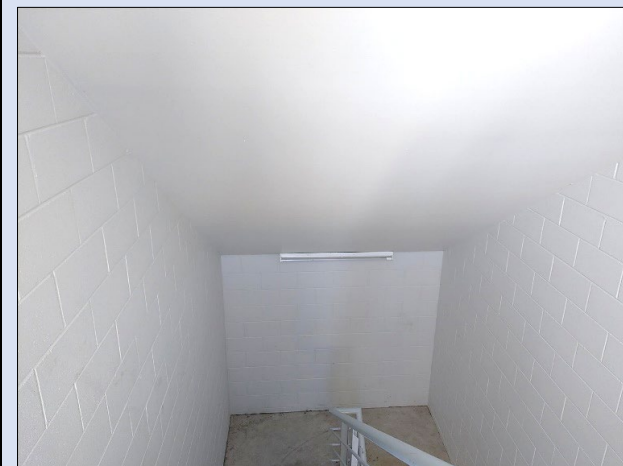
Sequence No:	31	Elevation:	Both Levels
Area:	Internal	Friability	
Location:	Fires stairs at northern end of building	Condition:	
Position	Ceiling lining on top level	Sealed:	
Material Type:	Plasterboard	Traffic:	
Quantity:	N/A	Risk Likelihood:	
	Sq. M	Risk Consequence:	
Sample No:	N/A	Risk Rating:	
Result:	No Suspect Materials Detected

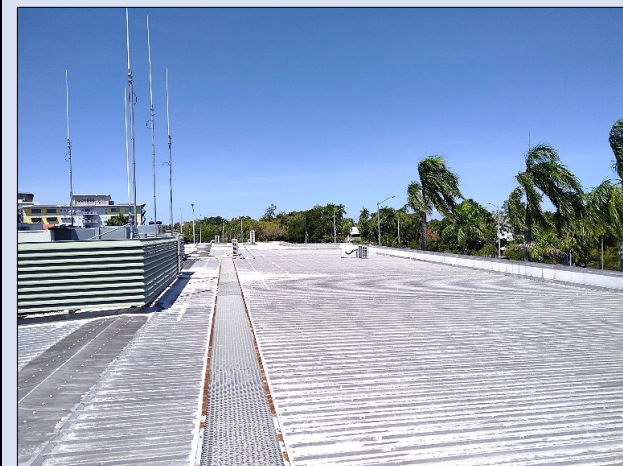
Sequence No:	32	Elevation:	Roof
Area:	External	Friability	
Location:	Roof	Condition:	
Position	Throughout	Enclosed	
Material Type:	No Suspect Materials Detected	Traffic:	
Quantity:	N/A	Risk Likelihood:	
	Sq. M	Risk Consequence:	
Sample No:	N/A	Risk Rating:	
Result:	No Suspect Materials Detected
