ASBESTOS REGISTER

NO. NT0686b

Darwin Plaza, 41 The Mall, Smith Street,
Darwin

December 2014
J130279

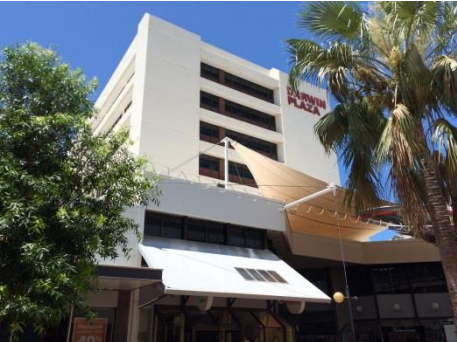
66. Eave lining to north side (10m ²)	Fibre cement sheet material containing White(Chrysotile) asbestos (per sample no. 1)		
Recommendation and Action			
Refer to Section 7.0: Policies & Management Procedures			
Situational Asbestos Risk Assessment:			
Friability	Condition	Signage	Risk Rating
Non-friable	Stable	No access	Low

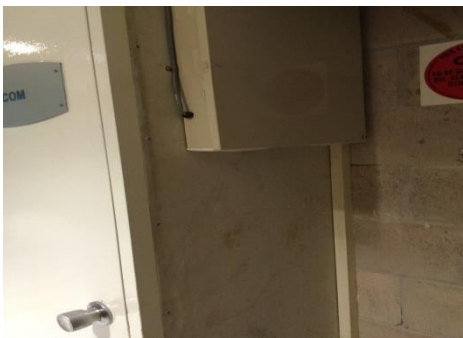
67. Lining to fire hose reel in front of elevators (1m ²)	Fibre cement sheet material containing White(Chrysotile) asbestos (per sample no. 3a)		
Recommendation and Action			
Refer to Section 7.0: Policies & Management Procedures			
Situational Asbestos Risk Assessment:			
Friability	Condition	Signage	Risk Rating
Non-friable	Stable	Installed 2 small warning signs	Low

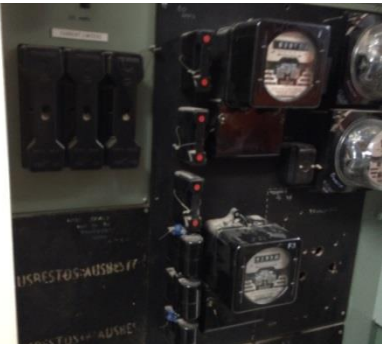
68. Electrical distribution boards in cupboard next to toilets (1.5m ²)	Area accessed but not sampled. Based on findings in similar areas, it is highly likely to contain asbestos.		
Recommendation and Action			
Refer to Section 7.0: Policies & Management Procedures			
Situational Asbestos Risk Assessment:			
Friability	Condition	Signage	Risk Rating
Non-friable	Stable	Installed 3 small warning signs	Low

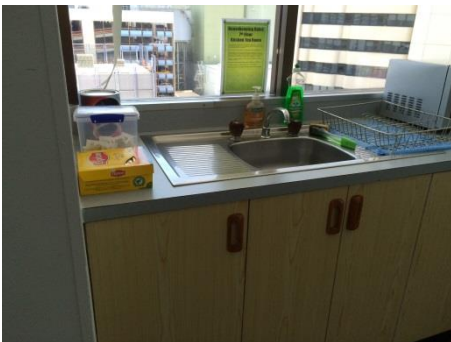
72. Sound dampener to kitchen sink, east side	Insulation material contains White(Chrysotile) asbestos (sample no. 9)		
Recommendation and Action			
Refer to Section 7.0: Policies & Management Procedures			
Situational Asbestos Risk Assessment:			
Friability	Condition	Signage	Risk Rating
Non-friable	Stable	nil	Low

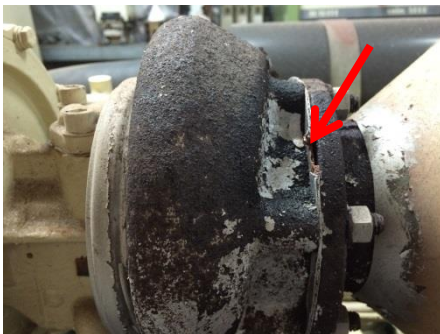
73. Gasket to plant room generator	Gasket material containing White(Chrysotile) asbestos (sample no. 5-2)		
Recommendation and Action			
Refer to Section 7.0: Policies & Management Procedures			
Situational Asbestos Risk Assessment:			
Friability	Condition	Signage	Risk Rating
Friable when exposed	Stable	Installed 1 small warning signs	Medium
