<b>Audit Number:</b>	00004169	<b>Client Name:</b>	Paspalis	<b>Client Contact:</b>	Darran Lum
<b>Version:</b>	1.0	<b>Site Name / Address:</b>	1/48-50 Smith St. Darwin

Site Name	
Paspalis Centrepoint Building Darwin	
Site Inspection Details	
<b>Asbestos Assessor:</b>	Adam Tucker
<b>Inspection Date:</b>	30/08/2016
<b>Re-inspection date:</b>	30/08/2019
Site Details	
<b>Number of Building / Structures:</b>	1
<b>Approximate Age of Buildings / Structures:</b>	1981

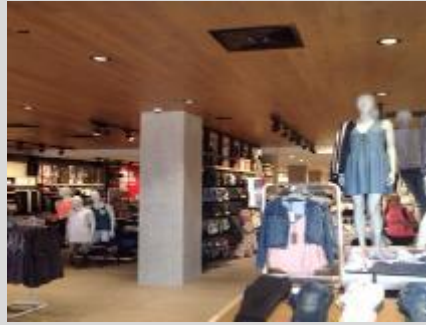
Location Details		Material Details		Results / Management Details		Photographs
Building ID:	Cotton On	Material Type:	Other – Refer to comments	Status:	Not Present (Not Tested)

Elevation:	Ground Floor	Quantity:	-	Sample #:	-	
Position Installed:	Walls / Floor / Ceiling	Condition:	-	Sample Result:	-	
Primary Location:	Internal	Friability:	-	Risk Rating:	-	
Secondary Location:	Throughout	Surface Treatment:	-	Recommendation:	-	
Comments:	Internals to Cotton On - No asbestos identified (non-asbestos materials, timber products, concrete, plasterboard)					Urgent Action Required?
						-

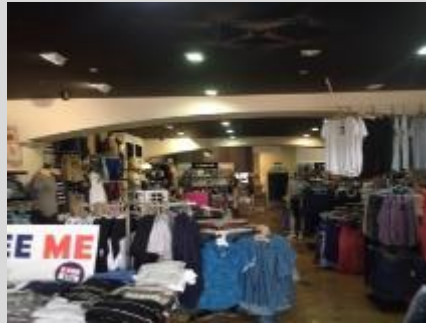
Location Details		Material Details		Results / Management Details		Photographs
Building ID:	Factorie	Material Type:	Other – Refer to comments	Status:	Not Present (Not Tested)

Elevation:	Ground Floor	Quantity:	-	Sample #:	-	
Position Installed:	Walls / Floor / Ceiling	Condition:	-	Sample Result:	-	
Primary Location:	Internal	Friability:	-	Risk Rating:	-	
Secondary Location:	Throughout	Surface Treatment:	-	Recommendation:	-	
Comments:	Internals to Factorie - No asbestos identified (non-asbestos materials, timber products, concrete, plasterboard)					Urgent Action Required?
						-

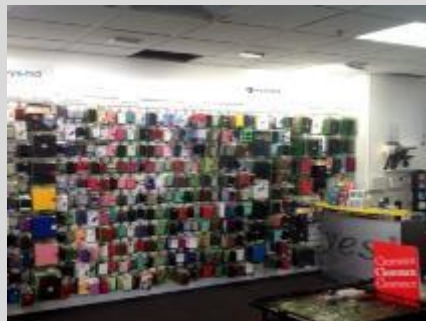
Location Details		Material Details		Results / Management Details		Photographs
Building ID:	Groovycom	Material Type:	Other – Refer to comments	Status:	Not Present (Not Tested)

Elevation:	Ground Floor	Quantity:	-	Sample #:	-	
Position Installed:	Walls / Floor / Ceiling	Condition:	-	Sample Result:	-	
Primary Location:	Internal	Friability:	-	Risk Rating:	-	
Secondary Location:	Throughout	Surface Treatment:	-	Recommendation:	-	
Comments:	Internals to Groovycom - No asbestos identified (non-asbestos materials, timber products, concrete, plasterboard)					Urgent Action Required?
						-

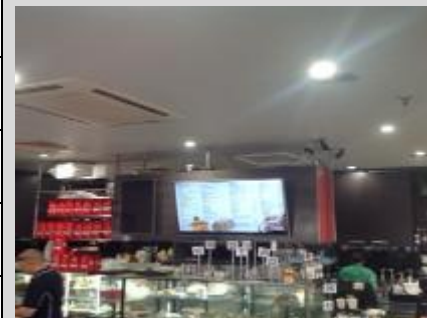
Location Details		Material Details		Results / Management Details		Photographs
<b>Building ID:</b>	Dolce Cafe	<b>Material Type:</b>	Other – Refer to comments	<b>Status:</b>	Not Present (Not Tested)

<b>Elevation:</b>	Ground Floor	<b>Quantity:</b>	-	<b>Sample #:</b>	-	
<b>Position Installed:</b>	Walls / Floor / Ceiling	<b>Condition:</b>	-	<b>Sample Result:</b>	-	
<b>Primary Location:</b>	Internal	<b>Friability:</b>	-	<b>Risk Rating:</b>	-	
<b>Secondary Location:</b>	Throughout	<b>Surface Treatment:</b>	-	<b>Recommendation:</b>	-	
<b>Comments:</b>	Internals to Dolce Cafe - No asbestos identified (non-asbestos materials, timber products, concrete, plasterboard)					<b>Urgent Action Required?</b> -

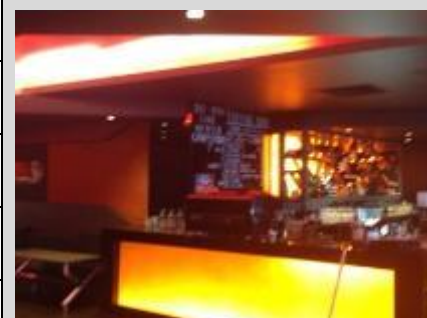
Location Details		Material Details		Results / Management Details		Photographs
<b>Building ID:</b>	Viva La Vida	<b>Material Type:</b>	Other – Refer to comments	<b>Status:</b>	Not Present (Not Tested)

<b>Elevation:</b>	Ground Floor	<b>Quantity:</b>	-	<b>Sample #:</b>	-	
<b>Position Installed:</b>	Walls / Floor / Ceiling	<b>Condition:</b>	-	<b>Sample Result:</b>	-	
<b>Primary Location:</b>	Internal	<b>Friability:</b>	-	<b>Risk Rating:</b>	-	
<b>Secondary Location:</b>	Throughout	<b>Surface Treatment:</b>	-	<b>Recommendation:</b>	-	
<b>Comments:</b>	Internals to Viva La Vida - No asbestos identified (non-asbestos materials, timber products, concrete, plasterboard)					<b>Urgent Action Required?</b> -

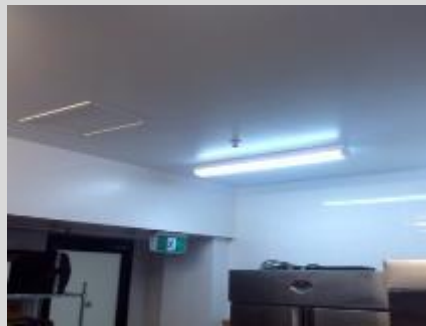
Location Details		Material Details		Results / Management Details		Photographs
<b>Building ID:</b>	Mr. Sushi	<b>Material Type:</b>	Other – Refer to comments	<b>Status:</b>	Not Present (Not Tested)

<b>Elevation:</b>	Ground Floor	<b>Quantity:</b>	-	<b>Sample #:</b>	-	
<b>Position Installed:</b>	Walls / Floor / Ceiling	<b>Condition:</b>	-	<b>Sample Result:</b>	-	
<b>Primary Location:</b>	Internal	<b>Friability:</b>	-	<b>Risk Rating:</b>	-	
<b>Secondary Location:</b>	Throughout	<b>Surface Treatment:</b>	-	<b>Recommendation:</b>	-	
<b>Comments:</b>	Internals to Mr. Sushi - No asbestos identified (non-asbestos materials, timber products, concrete, plasterboard)					<b>Urgent Action Required?</b> -

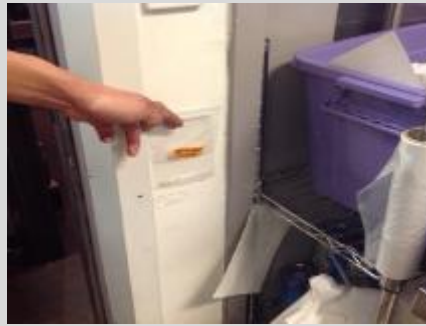
Location Details		Material Details		Results / Management Details		Photographs
<b>Building ID:</b>	Ruby kitchen	<b>Material Type:</b>	Cement Based	<b>Status:</b>	Not Present (Tested)

<b>Elevation:</b>	Ground Floor	<b>Quantity:</b>	80 - m2	<b>Sample #:</b>	37259	
<b>Position Installed:</b>	Wall	<b>Condition:</b>	-	<b>Sample Result:</b>	No Asbestos Detected	
<b>Primary Location:</b>	Internal	<b>Friability:</b>	-	<b>Risk Rating:</b>	-	
<b>Secondary Location:</b>	Throughout	<b>Surface Treatment:</b>	-	<b>Recommendation:</b>	-	
<b>Comments:</b>	Walls to Ruby Kitchen					<b>Urgent Action Required?</b> No

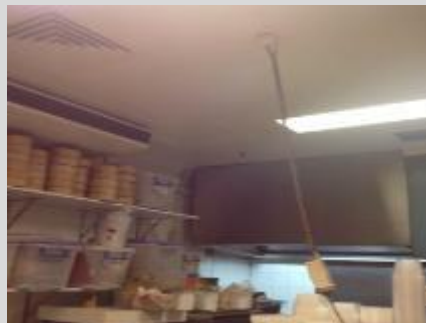
Location Details		Material Details		Results / Management Details		Photographs
Building ID:	Ruby kitchen	Material Type:	Other – Refer to comments	Status:	-

Elevation:	Ground Floor	Quantity:	-	Sample #:	-	
Position Installed:	Floor	Condition:	-	Sample Result:	-	
Primary Location:	Internal	Friability:	-	Risk Rating:	-	
Secondary Location:	Throughout	Surface Treatment:	-	Recommendation:	-	
Comments:	Floor to Ruby Kitchen - No asbestos identified (ceramic)					Urgent Action Required?
						-

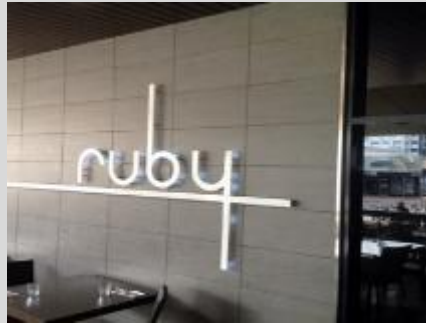
Location Details		Material Details		Results / Management Details		Photographs
Building ID:	Ruby restaurant area	Material Type:	Other – Refer to comments	Status:	-

Elevation:	Ground Floor	Quantity:	-	Sample #:	-	
Position Installed:	Walls / Floor / Ceiling	Condition:	-	Sample Result:	-	
Primary Location:	Internal	Friability:	-	Risk Rating:	-	
Secondary Location:	Throughout	Surface Treatment:	-	Recommendation:	-	
Comments:	Internals to front of Ruby - No asbestos identified (non-asbestos materials, timber products, concrete, plasterboard)					Urgent Action Required?
						-

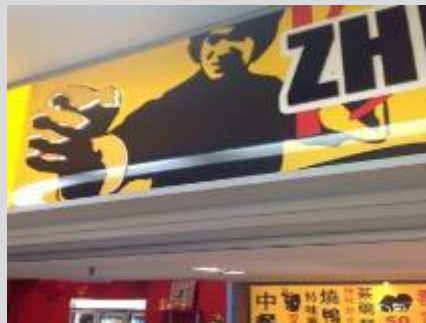
Location Details		Material Details		Results / Management Details		Photographs
Building ID:	Zhen's Kitchen	Material Type:	Other – Refer to comments	Status:	Not Present (Not Tested)

Elevation:	Ground Floor	Quantity:	-	Sample #:	-	
Position Installed:	Other - Refer to Comments	Condition:	-	Sample Result:	-	
Primary Location:	Internal	Friability:	-	Risk Rating:	-	
Secondary Location:	All elevations	Surface Treatment:	-	Recommendation:	-	
Comments:	Externals to Zhen's Kitchen - No asbestos identified (non-asbestos materials, timber products, concrete, plasterboard)					Urgent Action Required?
						-

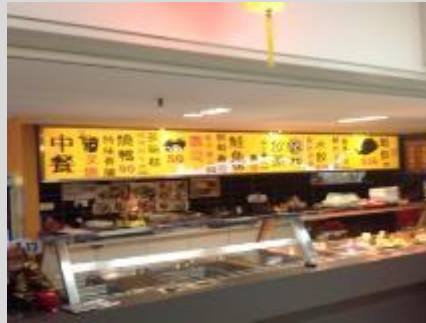
Location Details		Material Details		Results / Management Details		Photographs
<b>Building ID:</b>	Zhen's Kitchen	<b>Material Type:</b>	Other – Refer to comments	<b>Status:</b>	Not Present (Not Tested)

<b>Elevation:</b>	Ground Floor	<b>Quantity:</b>	-	<b>Sample #:</b>	-	
<b>Position Installed:</b>	Walls / Floor / Ceiling	<b>Condition:</b>	-	<b>Sample Result:</b>	-	
<b>Primary Location:</b>	Internal	<b>Friability:</b>	-	<b>Risk Rating:</b>	-	
<b>Secondary Location:</b>	Throughout	<b>Surface Treatment:</b>	-	<b>Recommendation:</b>	-	
<b>Comments:</b>	Internals to Zhen's Kitchen - No asbestos identified (non-asbestos materials, timber products, concrete, plasterboard)					<b>Urgent Action Required?</b> -

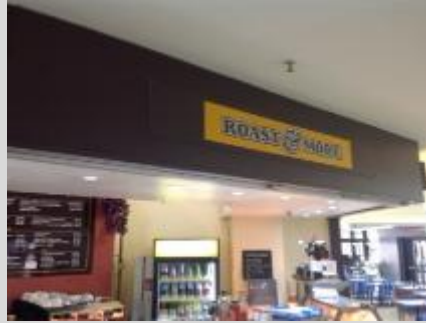
Location Details		Material Details		Results / Management Details		Photographs
<b>Building ID:</b>	Roast and More	<b>Material Type:</b>	Other – Refer to comments	<b>Status:</b>	Not Present (Not Tested)

<b>Elevation:</b>	Ground Floor	<b>Quantity:</b>	-	<b>Sample #:</b>	-	
<b>Position Installed:</b>	Other - Refer to Comments	<b>Condition:</b>	-	<b>Sample Result:</b>	-	
<b>Primary Location:</b>	Internal	<b>Friability:</b>	-	<b>Risk Rating:</b>	-	
<b>Secondary Location:</b>	All elevations	<b>Surface Treatment:</b>	-	<b>Recommendation:</b>	-	
<b>Comments:</b>	Externals to Roast and More - No asbestos identified (non-asbestos materials, timber products, concrete, plasterboard)					<b>Urgent Action Required?</b> -

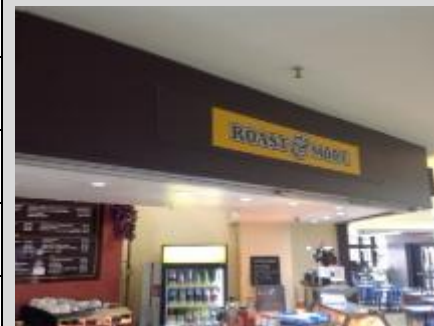
Location Details		Material Details		Results / Management Details		Photographs
<b>Building ID:</b>	Roast and More	<b>Material Type:</b>	Other – Refer to comments	<b>Status:</b>	Not Present (Not Tested)

<b>Elevation:</b>	Ground Floor	<b>Quantity:</b>	-	<b>Sample #:</b>	-	
<b>Position Installed:</b>	Walls / Floor / Ceiling	<b>Condition:</b>	-	<b>Sample Result:</b>	-	
<b>Primary Location:</b>	Internal	<b>Friability:</b>	-	<b>Risk Rating:</b>	-	
<b>Secondary Location:</b>	Throughout	<b>Surface Treatment:</b>	-	<b>Recommendation:</b>	-	
<b>Comments:</b>	Internals to Roast and More - No asbestos identified (non-asbestos materials, timber products, concrete, plasterboard)					<b>Urgent Action Required?</b> -

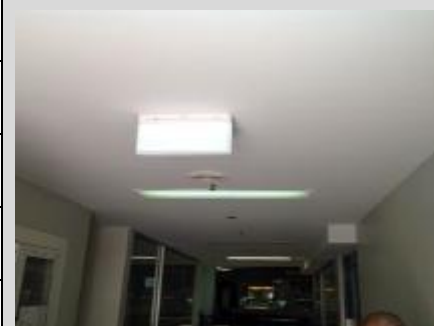
Location Details		Material Details		Results / Management Details		Photographs
<b>Building ID:</b>	Food Court Common Area	<b>Material Type:</b>	Other – Refer to comments	<b>Status:</b>	Not Present (Not Tested)

<b>Elevation:</b>	Ground Floor	<b>Quantity:</b>	-	<b>Sample #:</b>	-	
<b>Position Installed:</b>	Walls / Floor / Ceiling	<b>Condition:</b>	-	<b>Sample Result:</b>	-	
<b>Primary Location:</b>	Internal	<b>Friability:</b>	-	<b>Risk Rating:</b>	-	
<b>Secondary Location:</b>	Throughout	<b>Surface Treatment:</b>	-	<b>Recommendation:</b>	-	
<b>Comments:</b>	Internals to Food Court Common Area - No asbestos identified (non-asbestos materials, timber products, concrete, plasterboard)					<b>Urgent Action Required?</b> -

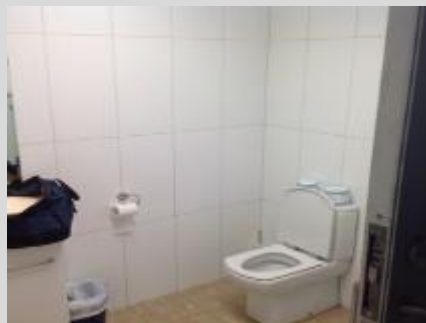
Location Details		Material Details		Results / Management Details		Photographs
Building ID:	Staff Restroom	Material Type:	Other – Refer to comments	Status:	Not Present (Not Tested)

Elevation:	Ground Floor	Quantity:	-	Sample #:	-	
Position Installed:	Walls / Floor / Ceiling	Condition:	-	Sample Result:	-	
Primary Location:	Internal	Friability:	-	Risk Rating:	-	
Secondary Location:	Throughout	Surface Treatment:	-	Recommendation:	-	
Comments:	Internals to Staff Restroom - No asbestos identified (non-asbestos materials, timber products, concrete, plasterboard)					Urgent Action Required?
						-

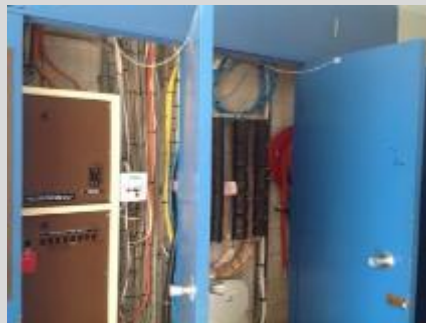
Location Details		Material Details		Results / Management Details		Photographs
Building ID:	Communications Cupboard	Material Type:	Other – Refer to comments	Status:	Not Present (Not Tested)

Elevation:	Ground Floor	Quantity:	-	Sample #:	-	
Position Installed:	Walls / Floor / Ceiling	Condition:	-	Sample Result:	-	
Primary Location:	Internal	Friability:	-	Risk Rating:	-	
Secondary Location:	Throughout	Surface Treatment:	-	Recommendation:	-	
Comments:	Internals to Communications Cupboard - No asbestos identified (non-asbestos materials, timber products, concrete, plasterboard)					Urgent Action Required?
						-

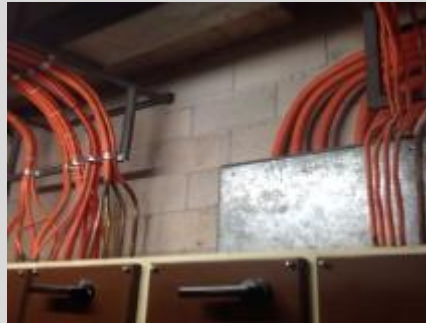
Location Details		Material Details		Results / Management Details		Photographs
<b>Building ID:</b>	Meter Room	<b>Material Type:</b>	Other – Refer to comments	<b>Status:</b>	Not Present (Not Tested)

<b>Elevation:</b>	Ground Floor	<b>Quantity:</b>	-	<b>Sample #:</b>	-	
<b>Position Installed:</b>	Walls / Floor / Ceiling	<b>Condition:</b>	-	<b>Sample Result:</b>	-	
<b>Primary Location:</b>	Internal	<b>Friability:</b>	-	<b>Risk Rating:</b>	-	
<b>Secondary Location:</b>	Throughout	<b>Surface Treatment:</b>	-	<b>Recommendation:</b>	-	
<b>Comments:</b>	Walls/Floors/Ceiling to Meter Room - No asbestos identified (non-asbestos materials, timber products, concrete, plasterboard)					<b>Urgent Action Required?</b> -

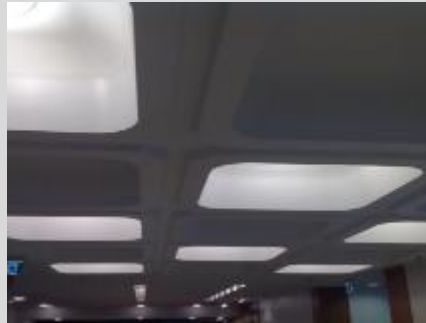
Location Details		Material Details		Results / Management Details		Photographs
<b>Building ID:</b>	Foyer	<b>Material Type:</b>	Other – Refer to comments	<b>Status:</b>	Not Present (Not Tested)

<b>Elevation:</b>	Ground Floor	<b>Quantity:</b>	-	<b>Sample #:</b>	-	
<b>Position Installed:</b>	Walls / Floor / Ceiling	<b>Condition:</b>	-	<b>Sample Result:</b>	-	
<b>Primary Location:</b>	Internal	<b>Friability:</b>	-	<b>Risk Rating:</b>	-	
<b>Secondary Location:</b>	Throughout	<b>Surface Treatment:</b>	-	<b>Recommendation:</b>	-	
<b>Comments:</b>	Walls/Floors/Ceiling to Foyer - No asbestos identified (non-asbestos materials, timber products, concrete, plasterboard)					<b>Urgent Action Required?</b> -

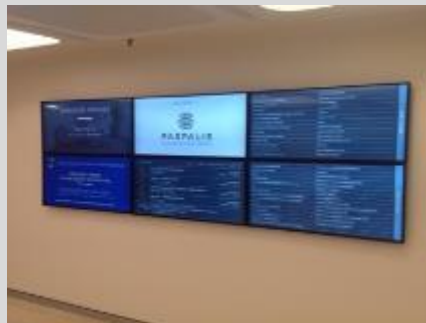
Location Details		Material Details		Results / Management Details		Photographs
Building ID:	Foyer	Material Type:	Other – Refer to comments	Status:	Not Present (Not Tested)

Elevation:	Level 1	Quantity:	-	Sample #:	-	
Position Installed:	Walls / Floor / Ceiling	Condition:	-	Sample Result:	-	
Primary Location:	Internal	Friability:	-	Risk Rating:	-	
Secondary Location:	Throughout	Surface Treatment:	-	Recommendation:	-	
Comments:	Walls/Floors/Ceiling to Foyer - No asbestos identified (non-asbestos materials, timber products, concrete, plasterboard)					Urgent Action Required?
						-

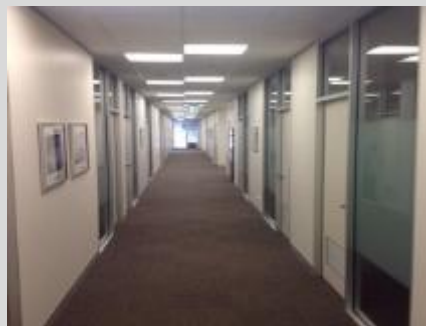
Location Details		Material Details		Results / Management Details		Photographs
<b>Building ID:</b>	Office spaces and common areas	<b>Material Type:</b>	Other – Refer to comments	<b>Status:</b>	Not Present (Not Tested)

<b>Elevation:</b>	Level 1	<b>Quantity:</b>	-	<b>Sample #:</b>	-	
<b>Position Installed:</b>	Walls / Floor / Ceiling	<b>Condition:</b>	-	<b>Sample Result:</b>	-	
<b>Primary Location:</b>	Internal	<b>Friability:</b>	-	<b>Risk Rating:</b>	-	
<b>Secondary Location:</b>	Throughout	<b>Surface Treatment:</b>	-	<b>Recommendation:</b>	-	
<b>Comments:</b>	Walls/Floors/Ceiling to Office spaces and common areas - No asbestos identified (non-asbestos materials, timber products, concrete, plasterboard)					<b>Urgent Action Required?</b> -

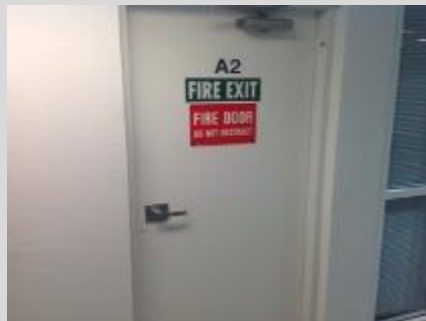
Location Details		Material Details		Results / Management Details		Photographs
Building ID:	Foyer	Material Type:	Fire Door	Status:	Presumed

Elevation:	Level 2	Quantity:	2 - m2	Sample #:	-	
Position Installed:	Fire Door	Condition:	Good	Sample Result:	-	
Primary Location:	Internal	Friability:	Unknown	Risk Rating:	6 - Moderate	
Secondary Location:	A2	Surface Treatment:	Partially Sealed	Recommendation:	Manage & Review	
Comments:	Fire door A2					Urgent Action Required?
						No

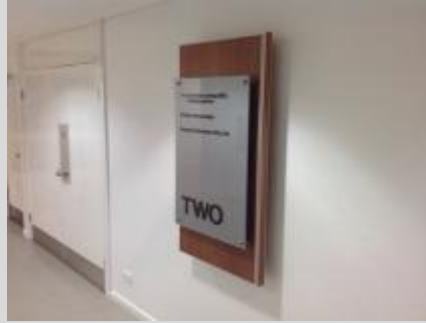
Location Details		Material Details		Results / Management Details		Photographs
Building ID:	Foyer	Material Type:	Other – Refer to comments	Status:	Not Present (Not Tested)

Elevation:	Level 2	Quantity:	-	Sample #:	-	
Position Installed:	Walls / Floor / Ceiling	Condition:	-	Sample Result:	-	
Primary Location:	Internal	Friability:	-	Risk Rating:	-	
Secondary Location:	Throughout	Surface Treatment:	-	Recommendation:	-	
Comments:	Walls/Floors/Ceiling to Foyer - No asbestos identified (non-asbestos materials, timber products, concrete, plasterboard)					Urgent Action Required?
						-

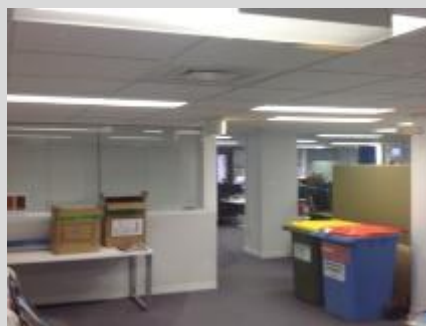
Location Details		Material Details		Results / Management Details		Photographs
<b>Building ID:</b>	Office tenancies and common areas	<b>Material Type:</b>	Other – Refer to comments	<b>Status:</b>	Not Present (Not Tested)

<b>Elevation:</b>	Level 2	<b>Quantity:</b>	-	<b>Sample #:</b>	-	
<b>Position Installed:</b>	Walls / Floor / Ceiling	<b>Condition:</b>	-	<b>Sample Result:</b>	-	
<b>Primary Location:</b>	Internal	<b>Friability:</b>	-	<b>Risk Rating:</b>	-	
<b>Secondary Location:</b>	Throughout	<b>Surface Treatment:</b>	-	<b>Recommendation:</b>	-	
<b>Comments:</b>	Walls/Floors/Ceiling to Office tenancies and common areas - No asbestos identified (non-asbestos materials, timber products, concrete, plasterboard)					<b>Urgent Action Required?</b> -

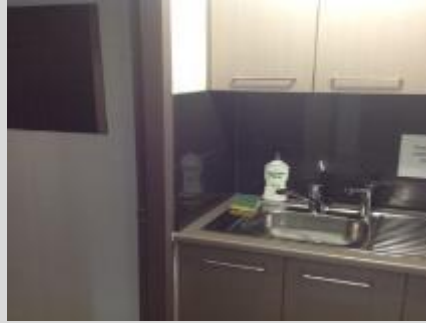
Location Details		Material Details		Results / Management Details		Photographs
<b>Building ID:</b>	Utility room	<b>Material Type:</b>	Other – Refer to comments	<b>Status:</b>	Not Present (Not Tested)

<b>Elevation:</b>	Level 2	<b>Quantity:</b>	-	<b>Sample #:</b>	-	
<b>Position Installed:</b>	Walls / Floor / Ceiling	<b>Condition:</b>	-	<b>Sample Result:</b>	-	
<b>Primary Location:</b>	Internal	<b>Friability:</b>	-	<b>Risk Rating:</b>	-	
<b>Secondary Location:</b>	Throughout	<b>Surface Treatment:</b>	-	<b>Recommendation:</b>	-	
<b>Comments:</b>	Potentially cement based walls behind ceramic tile - all other internals are non-asbestos materials, plasterboard, concrete					<b>Urgent Action Required?</b> -

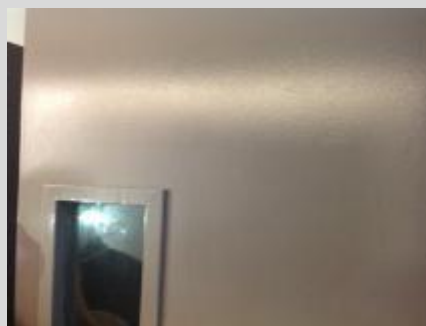
Location Details		Material Details		Results / Management Details		Photographs
Building ID:	Disabled toilet	Material Type:	Other – Refer to comments	Status:	Not Present (Not Tested)

Elevation:	Level 2	Quantity:	-	Sample #:	-	
Position Installed:	Walls / Floor / Ceiling	Condition:	-	Sample Result:	-	
Primary Location:	Internal	Friability:	-	Risk Rating:	-	
Secondary Location:	Throughout	Surface Treatment:	-	Recommendation:	-	
Comments:	Potentially cement based walls behind ceramic tile - all other internals are non-asbestos materials, plasterboard, concrete					Urgent Action Required?
						-

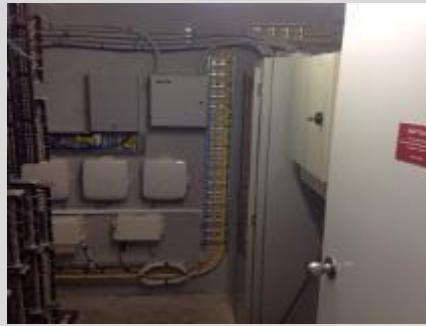
Location Details		Material Details		Results / Management Details		Photographs
Building ID:	MDF Room	Material Type:	Other – Refer to comments	Status:	Not Present (Not Tested)

Elevation:	Level 2	Quantity:	-	Sample #:	-	
Position Installed:	Walls / Floor / Ceiling	Condition:	-	Sample Result:	-	
Primary Location:	Internal	Friability:	-	Risk Rating:	-	
Secondary Location:	Throughout	Surface Treatment:	-	Recommendation:	-	
Comments:	Walls/Floors/Ceiling to MDF Room - No asbestos identified (non-asbestos materials, timber products, concrete, plasterboard)					Urgent Action Required?
						-

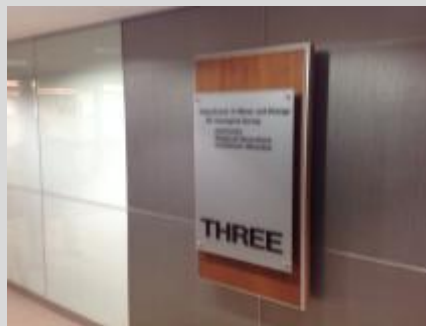
Location Details		Material Details		Results / Management Details		Photographs
Building ID:	Foyer	Material Type:	Other – Refer to comments	Status:	Not Present (Not Tested)

Elevation:	Level 3	Quantity:	-	Sample #:	-	
Position Installed:	Walls / Floor / Ceiling	Condition:	-	Sample Result:	-	
Primary Location:	Internal	Friability:	-	Risk Rating:	-	
Secondary Location:	Throughout	Surface Treatment:	-	Recommendation:	-	
Comments:	Walls/Floors/Ceiling to Foyer - No asbestos identified (non-asbestos materials, timber products, concrete, plasterboard)					Urgent Action Required?
						-

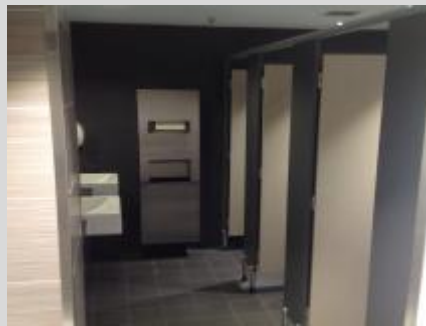
Location Details		Material Details		Results / Management Details		Photographs
Building ID:	Female Restrooms	Material Type:	-	Status:	Not Present (Not Tested)

Elevation:	Level 3	Quantity:	-	Sample #:	-	
Position Installed:	Walls / Floor / Ceiling	Condition:	-	Sample Result:	-	
Primary Location:	Internal	Friability:	-	Risk Rating:	-	
Secondary Location:	Throughout	Surface Treatment:	-	Recommendation:	-	
Comments:	Potentially cement based walls behind ceramic tile - all other internals are non-asbestos materials, plasterboard, concrete					Urgent Action Required?
						-

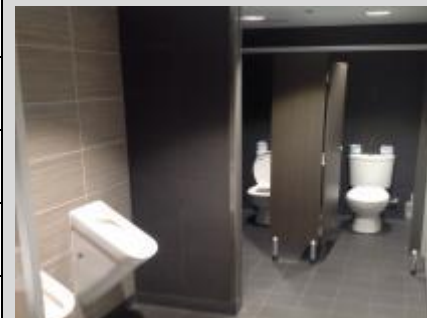
Location Details		Material Details		Results / Management Details		Photographs
<b>Building ID:</b>	Male Restrooms	<b>Material Type:</b>	Other – Refer to comments	<b>Status:</b>	Not Present (Not Tested)

<b>Elevation:</b>	Level 3	<b>Quantity:</b>	-	<b>Sample #:</b>	-	
<b>Position Installed:</b>	Walls / Floor / Ceiling	<b>Condition:</b>	-	<b>Sample Result:</b>	-	
<b>Primary Location:</b>	Internal	<b>Friability:</b>	-	<b>Risk Rating:</b>	-	
<b>Secondary Location:</b>	Throughout	<b>Surface Treatment:</b>	-	<b>Recommendation:</b>	-	
<b>Comments:</b>	Potentially cement based walls behind ceramic tile - all other internals are non-asbestos materials, plasterboard, concrete					<b>Urgent Action Required?</b> -

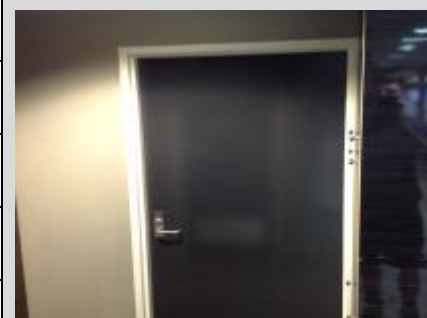
Location Details		Material Details		Results / Management Details		Photographs
<b>Building ID:</b>	Disabled Restrooms	<b>Material Type:</b>	Other – Refer to comments	<b>Status:</b>	Not Present (Not Tested)

<b>Elevation:</b>	Level 3	<b>Quantity:</b>	-	<b>Sample #:</b>	-	
<b>Position Installed:</b>	Walls / Floor / Ceiling	<b>Condition:</b>	-	<b>Sample Result:</b>	-	
<b>Primary Location:</b>	Internal	<b>Friability:</b>	-	<b>Risk Rating:</b>	-	
<b>Secondary Location:</b>	Throughout	<b>Surface Treatment:</b>	-	<b>Recommendation:</b>	-	
<b>Comments:</b>	Potentially cement based walls behind ceramic tile - all other internals are non-asbestos materials, plasterboard, concrete					<b>Urgent Action Required?</b> -

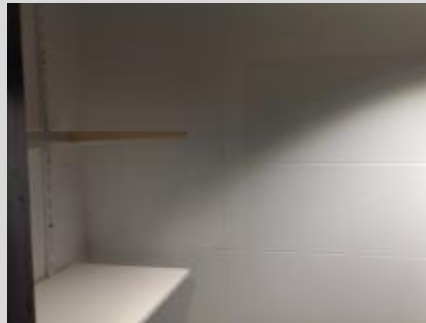
Location Details		Material Details		Results / Management Details		Photographs
Building ID:	Cleaners Room	Material Type:	Other – Refer to comments	Status:	Not Present (Not Tested)

Elevation:	Level 3	Quantity:	-	Sample #:	-	
Position Installed:	Walls / Floor / Ceiling	Condition:	-	Sample Result:	-	
Primary Location:	Internal	Friability:	-	Risk Rating:	-	
Secondary Location:	Throughout	Surface Treatment:	-	Recommendation:	-	
Comments:	Potentially cement based walls behind ceramic tile - all other internals are non-asbestos materials, plasterboard, concrete					Urgent Action Required?
						-

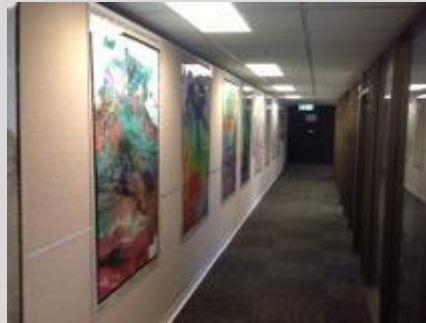
Location Details		Material Details		Results / Management Details		Photographs
Building ID:	Office tenancies and common areas	Material Type:	Other – Refer to comments	Status:	Not Present (Not Tested)

Elevation:	Level 3	Quantity:	-	Sample #:	-	
Position Installed:	Walls / Floor / Ceiling	Condition:	-	Sample Result:	-	
Primary Location:	Internal	Friability:	-	Risk Rating:	-	
Secondary Location:	Throughout	Surface Treatment:	-	Recommendation:	-	
Comments:	Walls/Floors/Ceiling to Office tenancies and common areas - No asbestos identified (non-asbestos materials, timber products, concrete, plasterboard)					Urgent Action Required?
						-

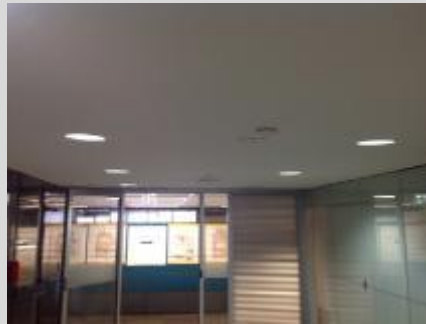
Location Details		Material Details		Results / Management Details		Photographs
Building ID:	Foyer	Material Type:	Other – Refer to comments	Status:	Not Present (Not Tested)

Elevation:	Level 4	Quantity:	-	Sample #:	-	
Position Installed:	Walls / Floor / Ceiling	Condition:	-	Sample Result:	-	
Primary Location:	Internal	Friability:	-	Risk Rating:	-	
Secondary Location:	Throughout	Surface Treatment:	-	Recommendation:	-	
Comments:	Walls/Floors/Ceiling to Foyer - No asbestos identified (non-asbestos materials, timber products, concrete, plasterboard)					Urgent Action Required?
						-

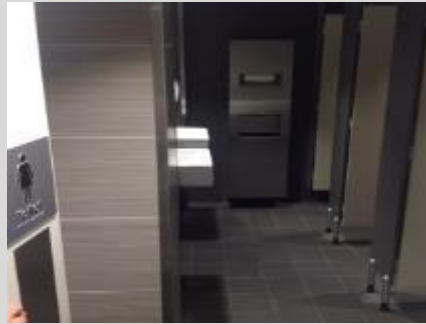
Location Details		Material Details		Results / Management Details		Photographs
Building ID:	Female Restrooms	Material Type:	Other – Refer to comments	Status:	Not Present (Not Tested)

Elevation:	Level 4	Quantity:	-	Sample #:	-	
Position Installed:	Walls / Floor / Ceiling	Condition:	-	Sample Result:	-	
Primary Location:	Internal	Friability:	-	Risk Rating:	-	
Secondary Location:	Throughout	Surface Treatment:	-	Recommendation:	-	
Comments:	Potentially cement based walls behind ceramic tile - all other internals are non-asbestos materials, plasterboard, concrete					Urgent Action Required?
						-

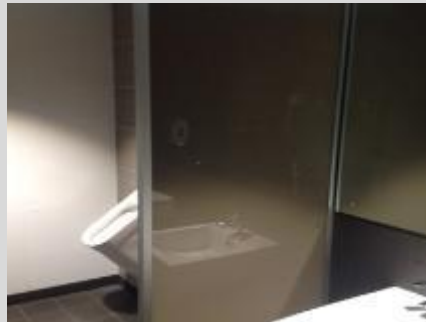
Location Details		Material Details		Results / Management Details		Photographs
<b>Building ID:</b>	Male Restrooms	<b>Material Type:</b>	Other – Refer to comments	<b>Status:</b>	Not Present (Not Tested)

<b>Elevation:</b>	Level 4	<b>Quantity:</b>	-	<b>Sample #:</b>	-	
<b>Position Installed:</b>	Walls / Floor / Ceiling	<b>Condition:</b>	-	<b>Sample Result:</b>	-	
<b>Primary Location:</b>	Internal	<b>Friability:</b>	-	<b>Risk Rating:</b>	-	
<b>Secondary Location:</b>	Throughout	<b>Surface Treatment:</b>	-	<b>Recommendation:</b>	-	
<b>Comments:</b>	Potentially cement based walls behind ceramic tile - all other internals are non-asbestos materials, plasterboard, concrete					<b>Urgent Action Required?</b> -

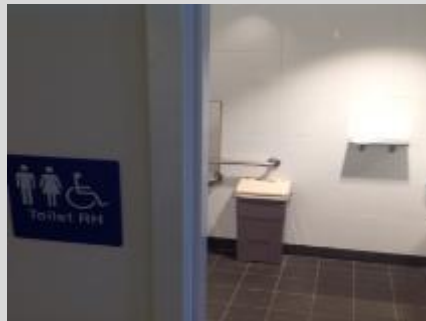
Location Details		Material Details		Results / Management Details		Photographs
<b>Building ID:</b>	Disabled Restrooms	<b>Material Type:</b>	Other – Refer to comments	<b>Status:</b>	Not Present (Not Tested)

<b>Elevation:</b>	Level 4	<b>Quantity:</b>	-	<b>Sample #:</b>	-	
<b>Position Installed:</b>	Walls / Floor / Ceiling	<b>Condition:</b>	-	<b>Sample Result:</b>	-	
<b>Primary Location:</b>	Internal	<b>Friability:</b>	-	<b>Risk Rating:</b>	-	
<b>Secondary Location:</b>	Throughout	<b>Surface Treatment:</b>	-	<b>Recommendation:</b>	-	
<b>Comments:</b>	Potentially cement based walls behind ceramic tile - all other internals are non-asbestos materials, plasterboard, concrete					<b>Urgent Action Required?</b> -

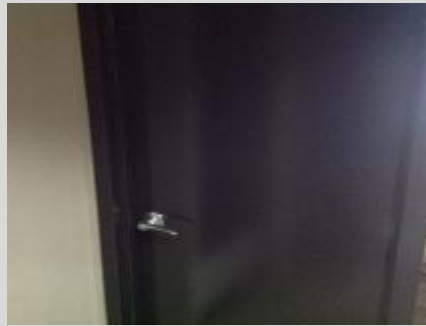
Location Details		Material Details		Results / Management Details		Photographs
Building ID:	Cleaners Room	Material Type:	Other – Refer to comments	Status:	Not Present (Not Tested)

Elevation:	Level 4	Quantity:	-	Sample #:	-	
Position Installed:	Walls / Floor / Ceiling	Condition:	-	Sample Result:	-	
Primary Location:	Internal	Friability:	-	Risk Rating:	-	
Secondary Location:	Throughout	Surface Treatment:	-	Recommendation:	-	
Comments:	Potentially cement based walls behind ceramic tile - all other internals are non-asbestos materials, plasterboard, concrete					Urgent Action Required?
						-

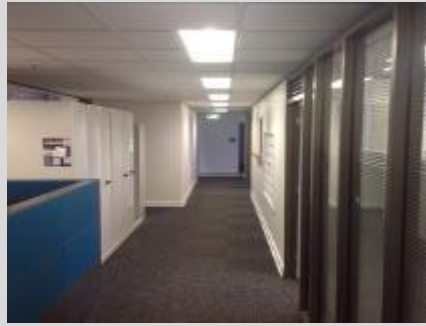
Location Details		Material Details		Results / Management Details		Photographs
Building ID:	Office tenancies and common areas	Material Type:	Other – Refer to comments	Status:	Not Present (Not Tested)

Elevation:	Level 4	Quantity:	-	Sample #:	-	
Position Installed:	Walls / Floor / Ceiling	Condition:	-	Sample Result:	-	
Primary Location:	Internal	Friability:	-	Risk Rating:	-	
Secondary Location:	Throughout	Surface Treatment:	-	Recommendation:	-	
Comments:	Walls/Floors/Ceiling to Office tenancies and common areas - No asbestos identified (non-asbestos materials, timber products, concrete, plasterboard)					Urgent Action Required?
						-

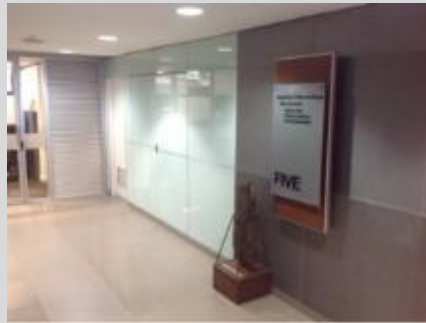
Location Details		Material Details		Results / Management Details		Photographs
Building ID:	Foyer	Material Type:	Other – Refer to comments	Status:	Not Present (Not Tested)

Elevation:	Level 5	Quantity:	-	Sample #:	-	
Position Installed:	Walls / Floor / Ceiling	Condition:	-	Sample Result:	-	
Primary Location:	Internal	Friability:	-	Risk Rating:	-	
Secondary Location:	Throughout	Surface Treatment:	-	Recommendation:	-	
Comments:	Walls/Floors/Ceiling to Foyer - No asbestos identified (non-asbestos materials, timber products, concrete, plasterboard)					Urgent Action Required?
						-

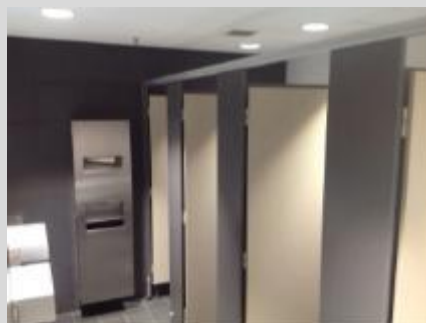
Location Details		Material Details		Results / Management Details		Photographs
Building ID:	Female Restrooms	Material Type:	Other – Refer to comments	Status:	Not Present (Not Tested)

Elevation:	Level 5	Quantity:	-	Sample #:	-	
Position Installed:	Walls / Floor / Ceiling	Condition:	-	Sample Result:	-	
Primary Location:	Internal	Friability:	-	Risk Rating:	-	
Secondary Location:	Throughout	Surface Treatment:	-	Recommendation:	-	
Comments:	Potentially cement based walls behind ceramic tile - all other internals are non-asbestos materials, plasterboard, concrete					Urgent Action Required?
						-

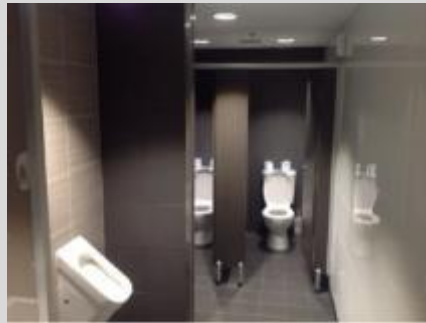
Location Details		Material Details		Results / Management Details		Photographs
Building ID:	Male Restrooms	Material Type:	Other – Refer to comments	Status:	Not Present (Not Tested)

Elevation:	Level 5	Quantity:	-	Sample #:	-	
Position Installed:	Walls / Floor / Ceiling	Condition:	-	Sample Result:	-	
Primary Location:	Internal	Friability:	-	Risk Rating:	-	
Secondary Location:	Throughout	Surface Treatment:	-	Recommendation:	-	
Comments:	Potentially cement based walls behind ceramic tile - all other internals are non-asbestos materials, plasterboard, concrete					Urgent Action Required?
						-

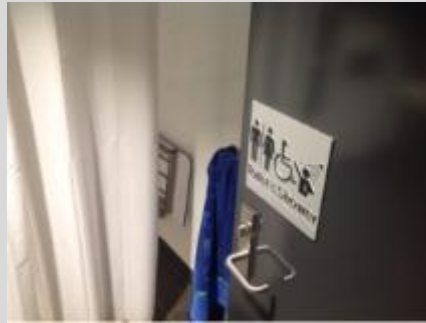
Location Details		Material Details		Results / Management Details		Photographs
Building ID:	Disabled Restrooms	Material Type:	Other – Refer to comments	Status:	Not Present (Not Tested)

Elevation:	Level 5	Quantity:	-	Sample #:	-	
Position Installed:	Walls / Floor / Ceiling	Condition:	-	Sample Result:	-	
Primary Location:	Internal	Friability:	-	Risk Rating:	-	
Secondary Location:	Throughout	Surface Treatment:	-	Recommendation:	-	
Comments:	Potentially cement based walls behind ceramic tile - all other internals are non-asbestos materials, plasterboard, concrete					Urgent Action Required?
						-

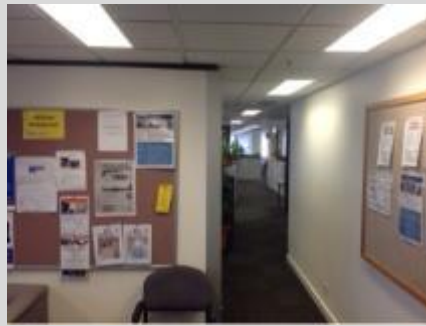
Location Details		Material Details		Results / Management Details		Photographs
<b>Building ID:</b>	Office tenancies and common areas	<b>Material Type:</b>	Other – Refer to comments	<b>Status:</b>	Not Present (Not Tested)

<b>Elevation:</b>	Level 5	<b>Quantity:</b>	-	<b>Sample #:</b>	-	
<b>Position Installed:</b>	Walls / Floor / Ceiling	<b>Condition:</b>	-	<b>Sample Result:</b>	-	
<b>Primary Location:</b>	Internal	<b>Friability:</b>	-	<b>Risk Rating:</b>	-	
<b>Secondary Location:</b>	Throughout	<b>Surface Treatment:</b>	-	<b>Recommendation:</b>	-	
<b>Comments:</b>	Walls/Floors/Ceiling to Office tenancies and common areas - No asbestos identified (non-asbestos materials, timber products, concrete, plasterboard)					<b>Urgent Action Required?</b> -

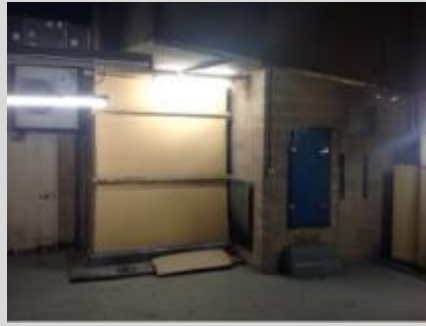
Location Details		Material Details		Results / Management Details		Photographs
Building ID:	Plant Rooms	Material Type:	-	Status:	-

Elevation:	Level 6	Quantity:	-	Sample #:	-	
Position Installed:	Plant, Equipment & Machinery	Condition:	-	Sample Result:	-	
Primary Location:	Internal	Friability:	-	Risk Rating:	-	
Secondary Location:	Throughout	Surface Treatment:	-	Recommendation:	-	
Comments:	Internal plant and machinery - internal mechanisms not accessed					Urgent Action Required?
						-
