ASBESTOS REGISTER

FOR THE PROPERTY AT: Katherine Central NT
Katherine Terrace / Savannah Way,
Katherine, NT

CLIENT: Centro Properties Group

DATE INSPECTED: 7th December, 2010

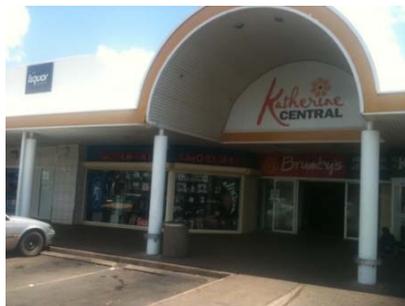
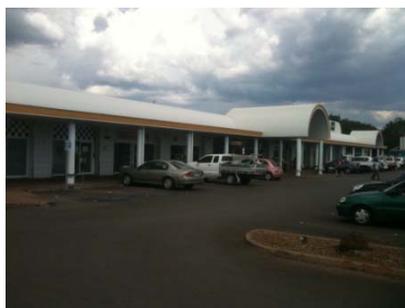
BUILDING – KATHERINE CENTRAL NT

4 main inspection points throughout the building were above suspended ceilings in vacant tenancy 7, from open ceiling area in mall area cleaners store and open rear ceiling space sections of Woolworths and Target stores - Typical perimeter building construction is besser block walls, tops of metal studwork, non-insulated structural steel 'I' beams, steel 'z' roofing purlins, underside of glass fibre insulation blanket directly beneath sheet-metal roof, pvc downpipes, sheet-metal air-conditioning ductwork all assumed typical throughout. No inspection to ceiling spaces of individual tenancies due to access restrictions at time of inspection.
