# **Hazard Materials Asbestos Register**

**Shop 7, 36 Parap Road  
(Off Vimy Lane) Parap NT**

**Document:** Hazard Materials - Asbestos Register

**Reference No.:** 01412477

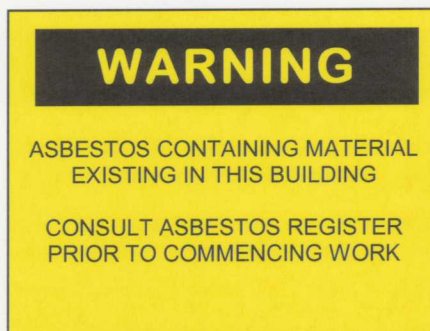
Example of warning signs and labels are listed in the “*Code of Practice for the Safe Removal of Asbestos 2<sup>nd</sup> Edition* [NOHSC: 2002(2005)]”. Labels as shown below are for illustration purposes only.

The purpose of these cautionary warning signs is to ensure that the asbestos is not worked upon without correct precautions being taken and to ensure that, in the event of damage, the occurrence is reported immediately so that corrective action can be taken.

Asbestos signs can be installed on the external of buildings containing asbestos referring to the asbestos register. Internal labels can be installed on asbestos ceilings, walls, floors etc.

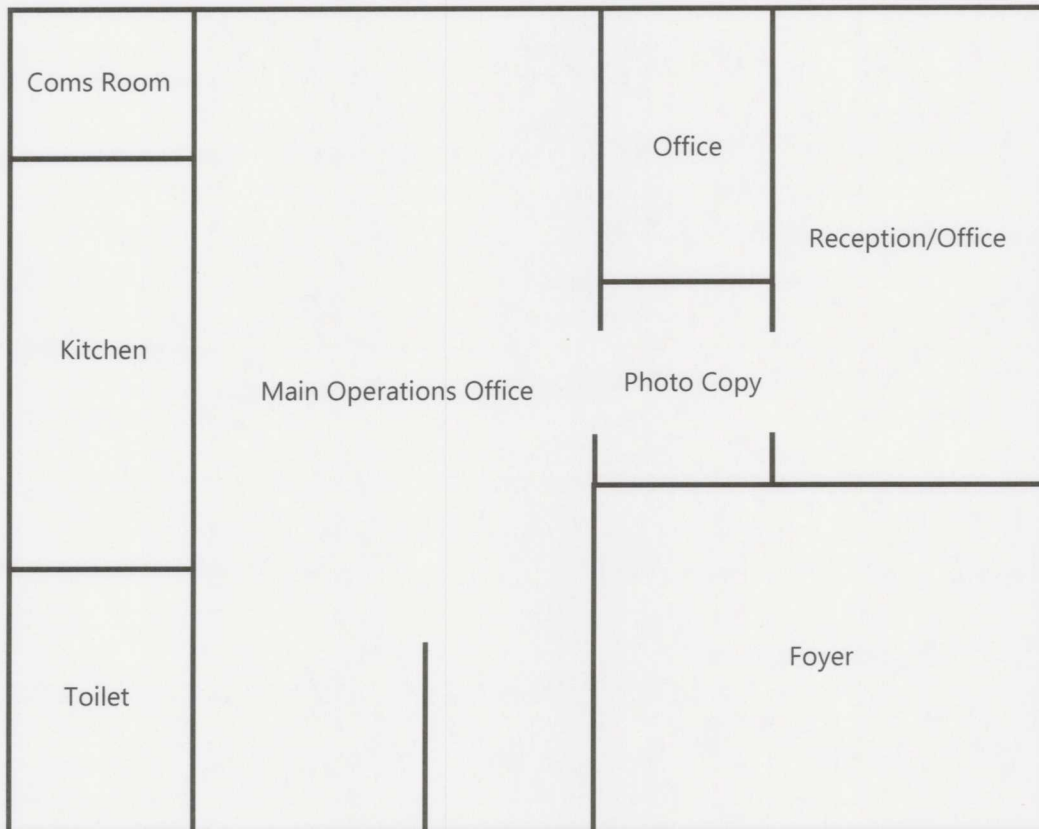
## **12 Floor Plan Police Beat Parap**

Not to scale

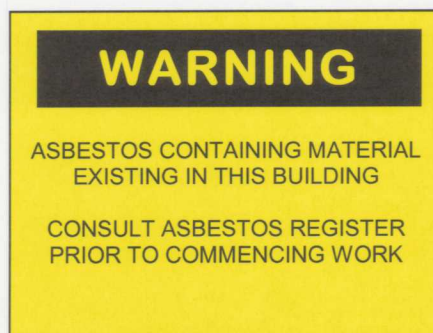
Example of warning signs and labels are listed in the “*Code of Practice for the Safe Removal of Asbestos 2<sup>nd</sup> Edition [NOHSC: 2002(2005)]*”. Labels as shown below are for illustration purposes only.

The purpose of these cautionary warning signs is to ensure that the asbestos is not worked upon without correct precautions being taken and to ensure that, in the event of damage, the occurrence is reported immediately so that corrective action can be taken.

Asbestos signs can be installed on the external of buildings containing asbestos referring to the asbestos register. Internal labels can be installed on asbestos ceilings, walls, floors etc.
