# COMPLIANCE ASBESTOS INSPECTION AND RISK ASSESSMENT

MARCH 2022

J038274

76 Esplanade  
Darwin City NT  
0800

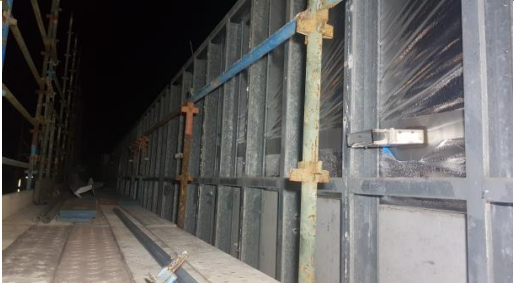
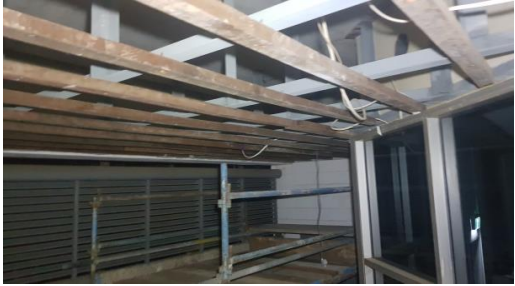
<b>SITE ADDRESS:</b>	76 The Esplanade	
<b>SUBURB:</b>	Darwin City, NT	
<b>ASBESTOS ASSESSOR:</b>	Peter Carthew Licence No. NTWS-AA-456689	
<b>WORKS UNDERTAKEN</b>	The removal of soffit and fascia panels from the building, as per the scope of works. Stage one of works	
<b>LIMITATIONS / COMMENTS</b>	This clearance only applies to the removal of soffit and fascia panels from the building, as per the scope of works. Stage one of works. Other ACM remains in-situ until stage two of the project.	
<b>INSPECTION NOTES</b>	Asbestos residue / debris in the asbestos removal work area, in the immediate vicinity of the work area (in accessible areas) or in the waste transit route was not visible. Airborne Fibre Monitoring was conducted, and the airborne fibre level was less than 0.01 fibres per ml.
