Asbestos Containing Materials Survey - Part 5

Property Number (PMS): SC009

Property Name: Yap Property Investments Pty Ltd

Property Address: 9 Scaturchio Street Casuarina NT
0811

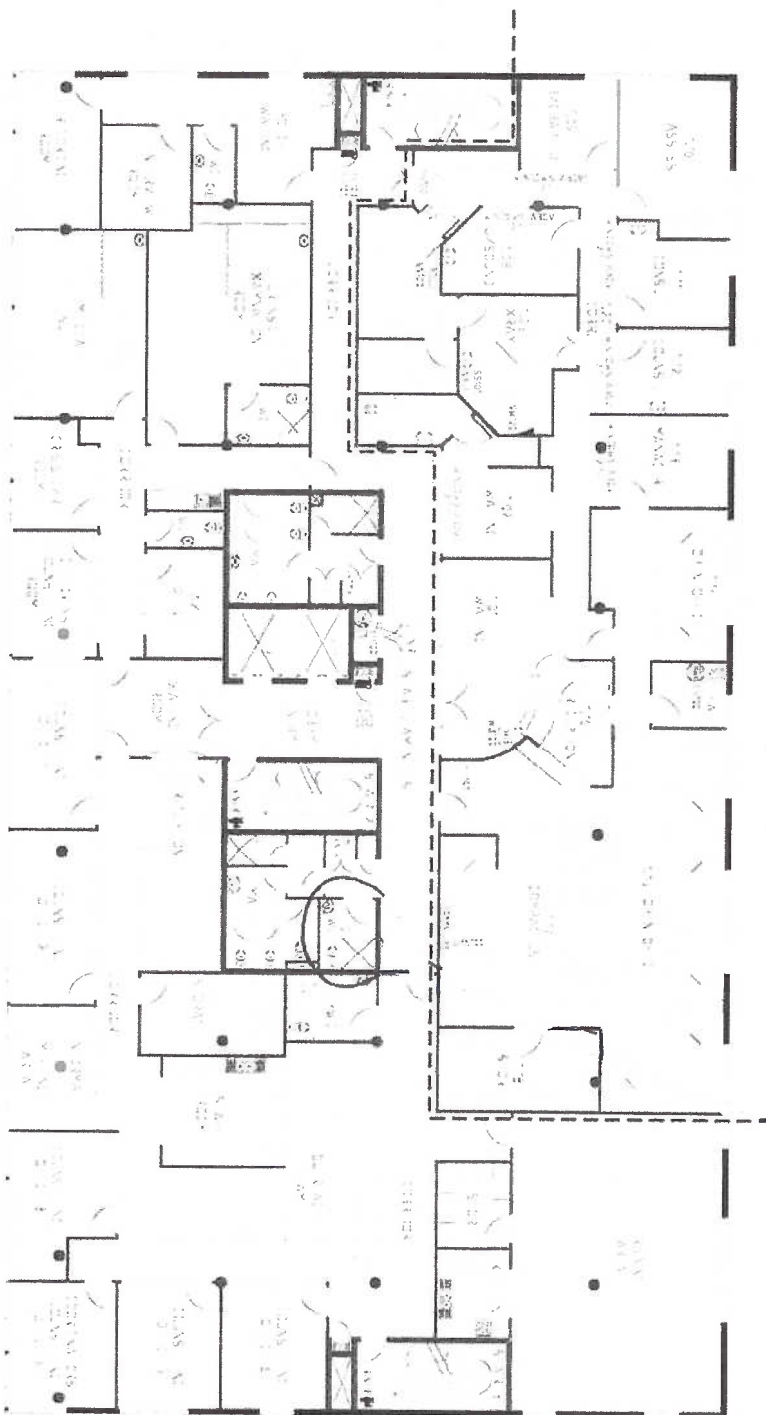
01013BG

Casuarina 9 Seaside street CASUARINA
 Address: preliminary floor plan
 Lot: 09290
 AMS NUMBER
 NTB-01013-0B-00G

Appendix C: Site Plan

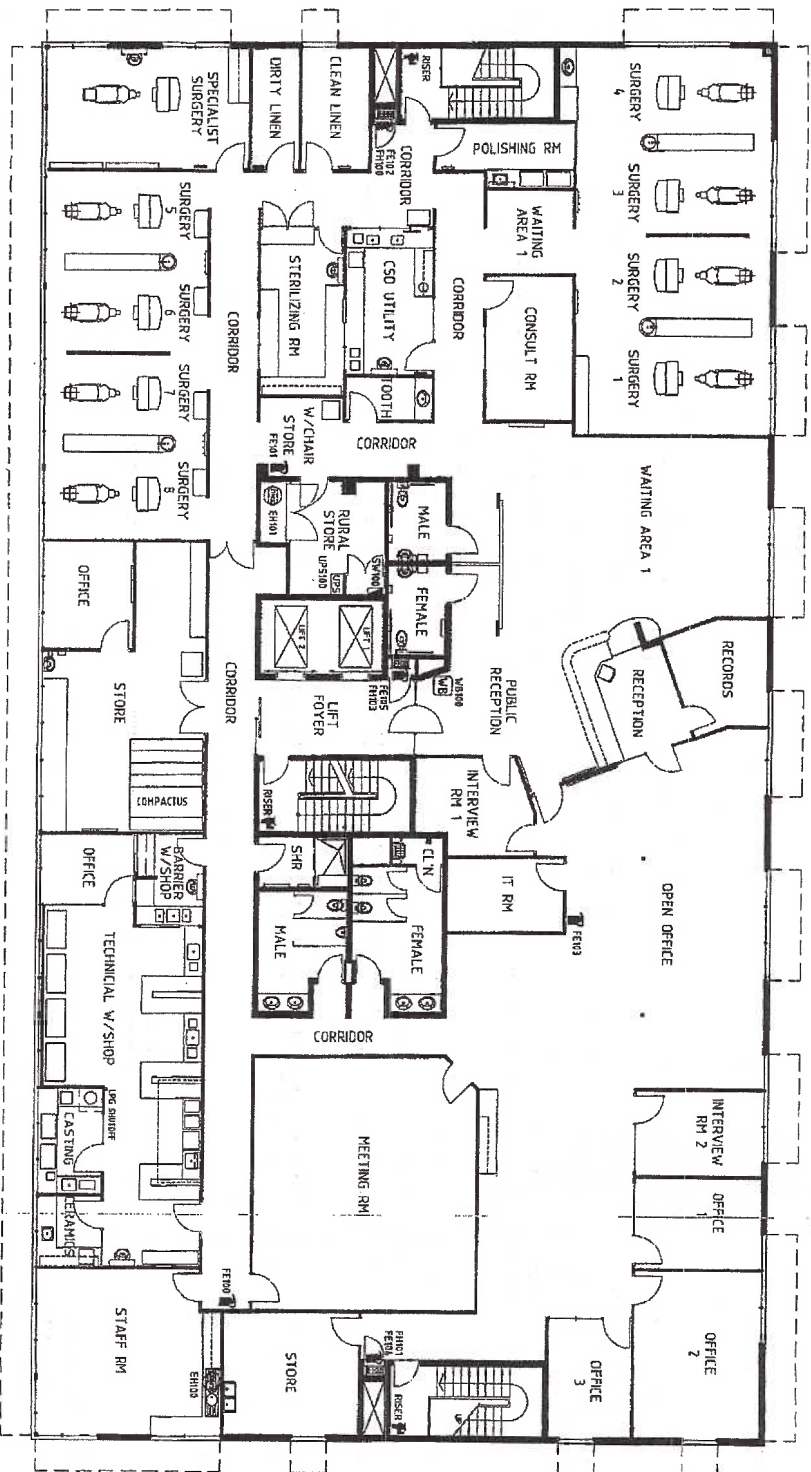
01013B1
Lot: 09290
AMS NUMBER
NTB-01013-0B-001

0B-002
SECOND FLOOR

CASUARINA HEALTH COMPLEX
BUILDING
SECOND FLOOR.

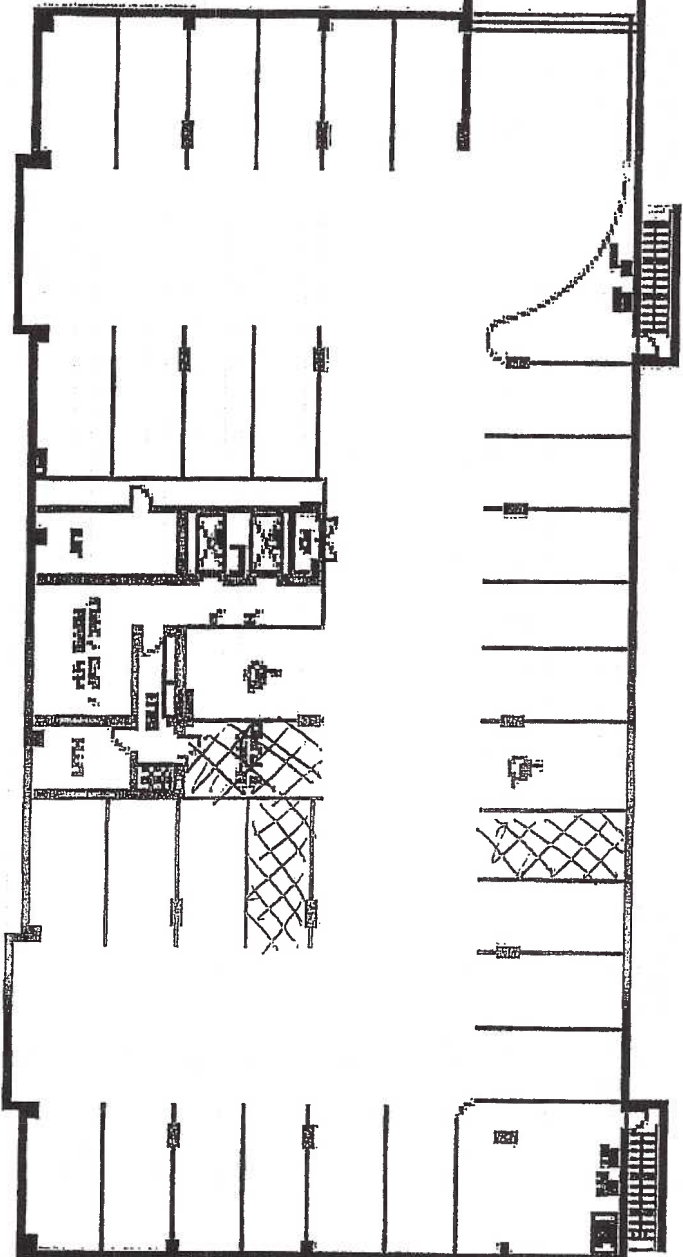
BB

BASEMENT

CHARAPINA HEALTH COMPLEX
BUILDING
BASEMENT
