ASBESTOS REGISTER

Location: **Arnhem House, Endeavor Square, Nhulunbuy**

REPORT NUMBER: AR-0002

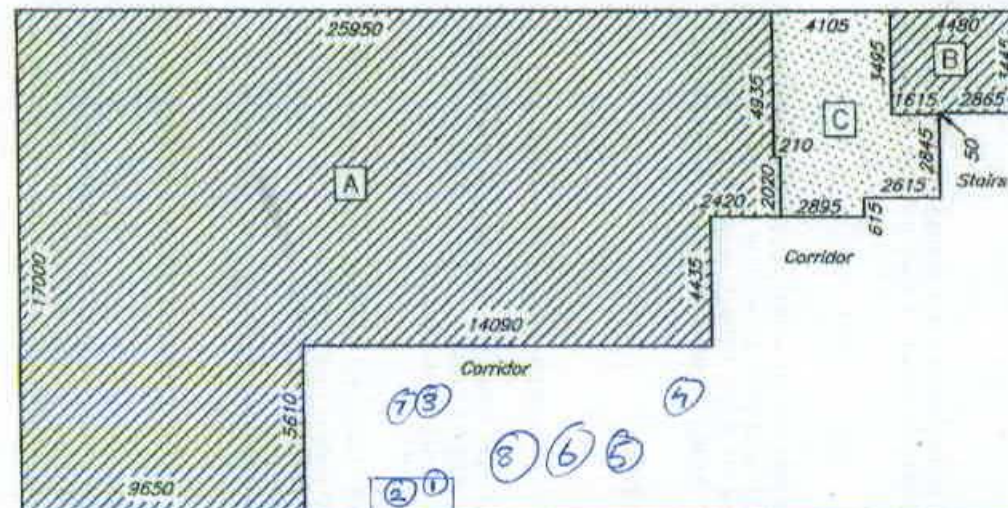
Net Lettable Area
Part First Floor
Arnheim House
Nhulunbuy

NLA:- Area A 340.3 m²

NLA:- Area B 15.5 m²

NLA:- Area C 32.1 m²

TOTAL NET LETTABLE AREA
387.9 m²
